FLAGSTAFF MOUNTAIN RESORT
A PLANNED RESORT COMMUNITY
DEER VALLEY, UTAH

HISTORIC PRESERVATION PLAN
EXHIBIT 6

HISTORIC PRESERVATION PLAN

**HISTORIC PRESERVATION PLAN
FOR FLAGSTAFF MOUNTAIN RESORT
PARK CITY, SUMMIT COUNTY, UTAH**

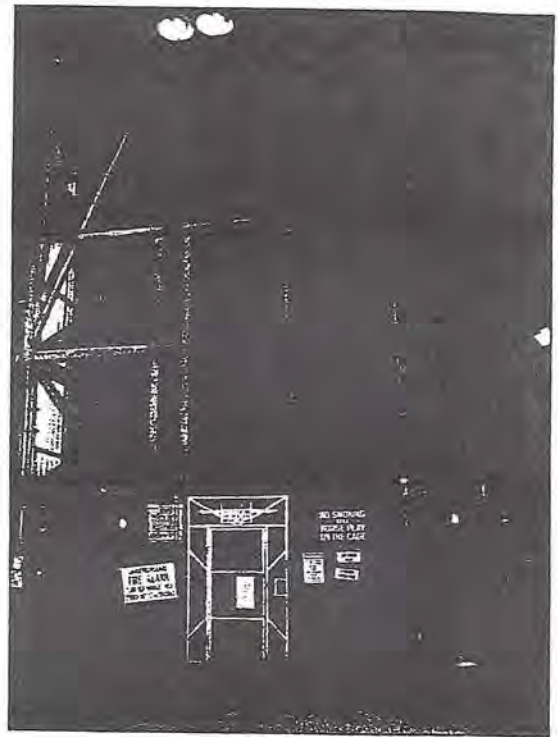
Figure 5 – (Right) – Shaft No. 3 as it exists today.

No stabilization work is recommended for this feature at this time.

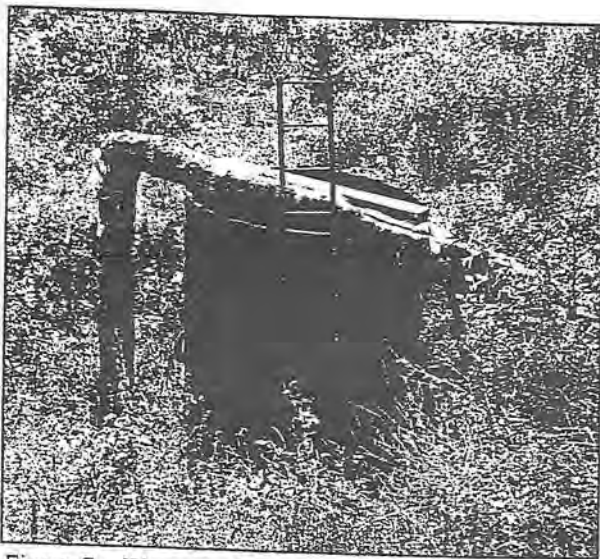
Figure 7 – Water Tank D.

Only two of the tanks appear to be historic. These include Tank D (Figure 7), the smallest tank in the group of three tanks, and Tank E (Figure 7), the larger tank located in the trees to the west of the group of three tanks. However, there is a possibility that the other tanks (A, B, and C) may have been built to replace earlier tanks and that there could be some historic implications if they were removed. If historical associations can be established for tanks A, B, and C, then they may also warrant stabilization treatment.

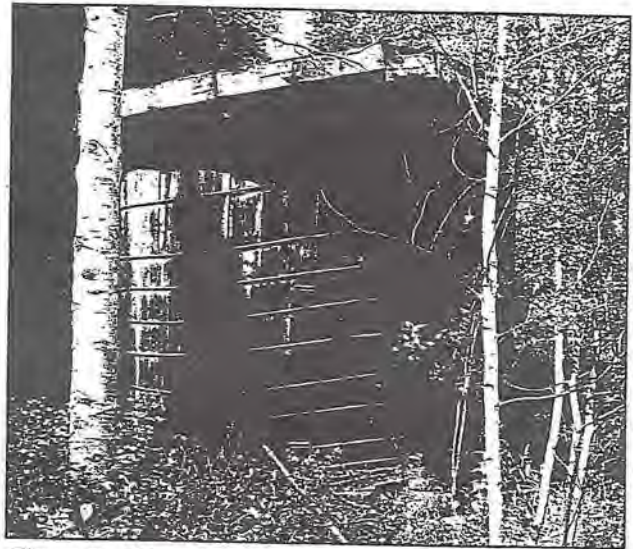
Figure 8 – Water Tank E.

West of this group of three tanks, at the end of a short dirt road, is a fifth tank (Tank E, Figure 8) that is surrounded by trees and cannot be seen from State Road 224 when the trees are in foliage. This tank has not been used in recent times and is listing to one side. It appears to be the oldest of the five tanks and can be considered historic. This tank, like the others, is circular, but it rests upon timbers that in turn rest upon a set of four historic-period mortared stone footings. The layout of the footings does not correspond to the form of the wooden tank, which raises the possibility that the current wooden tank is a historic-period replacement for an earlier tank. A water pipe with an outside diameter of approximately 4-1/2 inches and a valve with a hand-wheel are still connected to the tank. The tank is approximately 10 feet in height and 38

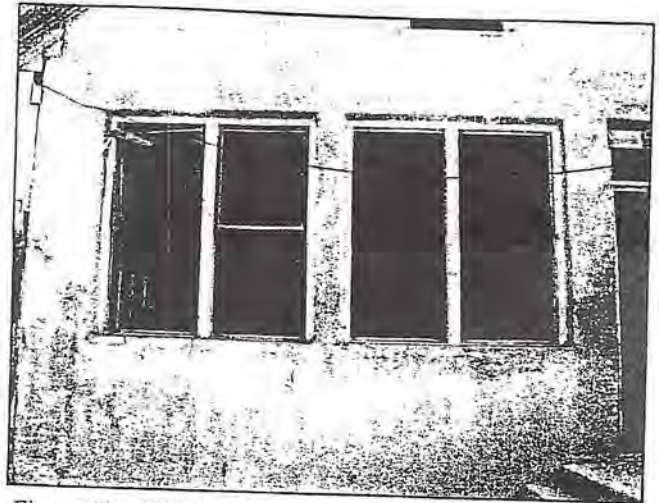
Figure 20 – Window frames in front wall.

Deficiency Description – The door and window frames and their associated interior trim components are still intact and in fair condition (Figure 20), but almost all of the window sashes and doors are missing. This situation allows moisture, wind, debris, and animals to enter the structure and damage various components. It also allows unauthorized human access.

Suggested Mitigation Work – Plywood or Lexan fillers could be installed in the window openings. Lexan (or a similar polycarbonate material) is break resistant and allows light to penetrate into the structure, which may be an advantage under certain circumstances. Heavy-duty, lockable doors should be installed. These doors

could be constructed of thick plywood sheets. Optionally, if a historic photo or building plan could be located, doors that are stylistically appropriate could be installed.

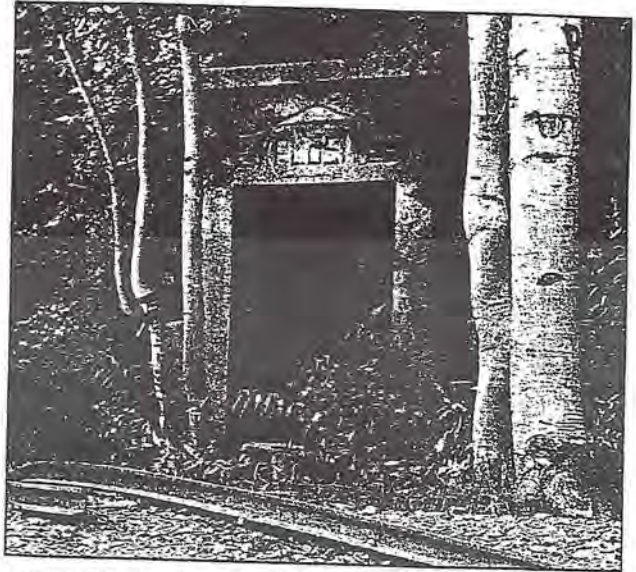
This feature appears to be in excellent condition and unaltered, with the possible exception of some hasps or locking hardware that might be original, but could have been welded to the steel door at a later date. However, the interior of the structure was not available for inspection, so its condition is unknown.

Figure 24 – Explosives Bunker, J. M. & S. Co.

Assuming that there are no structural problems or safety hazards associated with this feature, no stabilization work is recommended at this time.

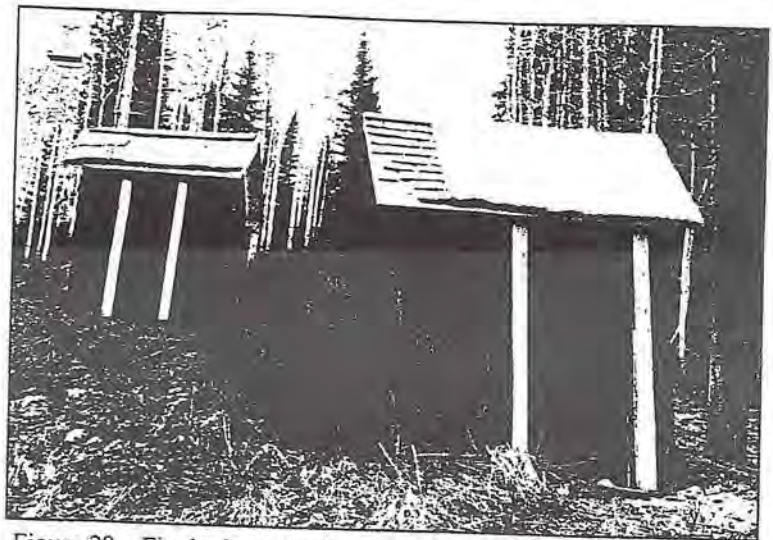
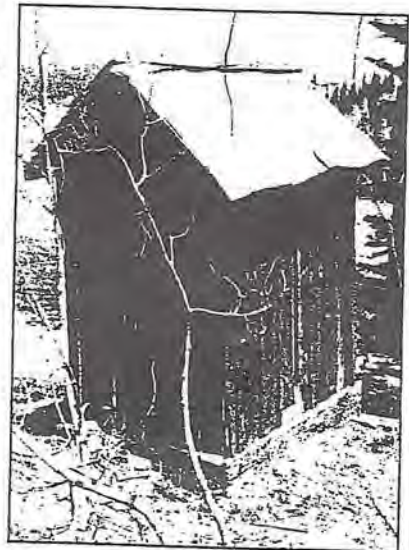
Condition – Fair

Priority – Medium

Figure 29 – Fire hydrant shacks at the Daly-West Mine site.

Figure 30 – Another fire shack.

Deficiency Description – Other than some missing galvanized roofing panels and typical weathering, these sheds are in reasonably good condition and do not appear to have been significantly altered over time. It is possible that the wooden sills may have some deterioration below ground level, but this could not be ascertained without invasive testing. Some of the paint appears quite old, and demonstrates considerable weathering, especially on the south-facing sides.

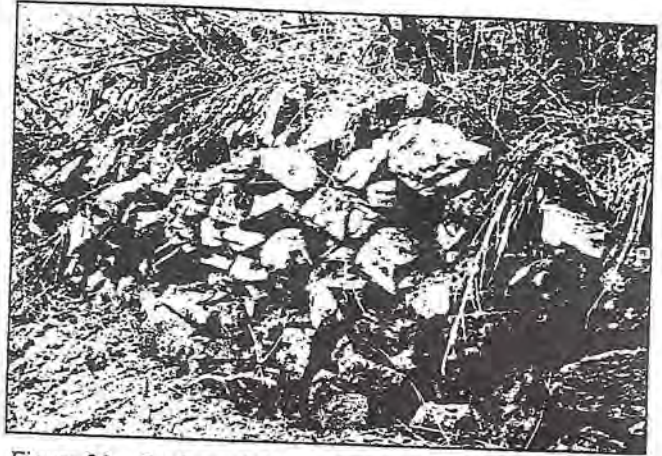
This feature is a rock wall (Figure 31) located directly upslope from the Daly-West shaft and adjacent to a fenced-in transformer area. This wall is approximately 30 feet in length and averages about three feet in height. It is constructed of uncoursed and unmortared irregular rocks of varying sizes, and it is in reasonably good condition.

Figure 31 – Rock retaining wall by transformer platform.

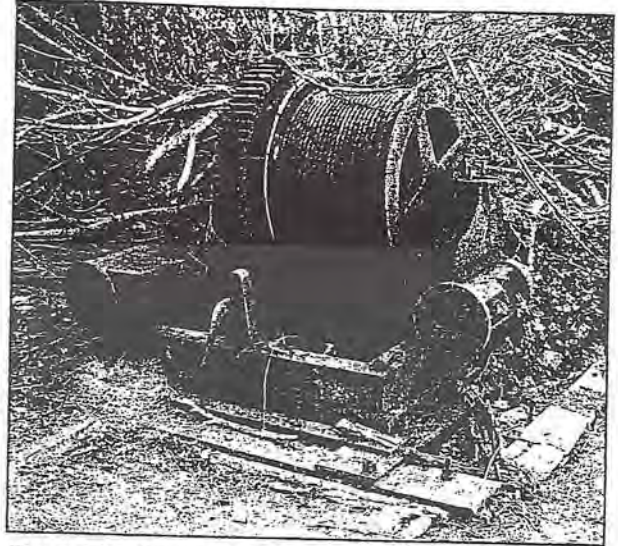
A two-cylinder steam-driven hoist is still mounted on its concrete pad. The hoist is powered by a double-acting, crosshead-type engine, which, like many hoist engines and marine windlasses, is integrated into the same iron frame as the hoist. Historic photos (Figure 33 and Figure 34) depict what appears to be the same kind of hoist being used as a winch at the Anchor Mine for raising ore cars in an incline. This hoist could even be the same hoist as the one at the Quincy, since it was common to buy, sell, trade, and move equipment from one mine to another.

Figure 32 – Two-cylinder, steam-driven hoist.

Deficiency Description – One of the hoist engine cylinders has been removed, as well as some other parts, but many of the pieces are still intact, and it is possible that several of the missing parts could still be found in the immediate vicinity. The adjustable cutoff and reversing mechanism for one of the cylinders is still intact. The cable is still wrapped around the drum, and appears to be in good condition, with traces of hardened grease still clinging to the cable. No markings were visible regarding manufacturer, model, serial no., etc., although a portion of the hoist was obscured by vegetation and debris, making a complete surface inspection of the hoist impossible without site clean-up work.

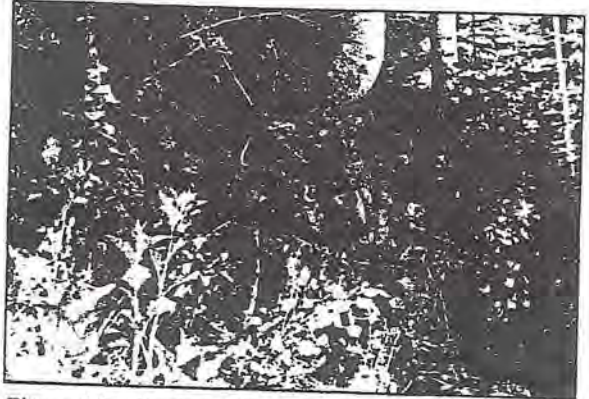
This feature is a rock wall (Figure 36) located in the middle of Empire Canyon, approximately 100 feet east of the Quincy Mine hoist plant. This wall consists of uncoursed, unmortared irregular rocks. The majority of the rocks appear to be in the 6- to 8-inch size range. The wall is largely obscured by soil and vegetation. Its specific purpose is unknown at this time, although it appears to have been a retaining wall, such as often depicted in historic photos in front of mine offices or boarding houses and constructed to provide a small yard area adjacent to the house.

Figure 36 – Rock wall near the Quincy Mine.

Judging by the size of the aspen trees that have grown up inside the perceived perimeter of the wall, and in some cases through the wall itself, the built-up area behind the wall has been abandoned for a considerable period, probably over 70 years.

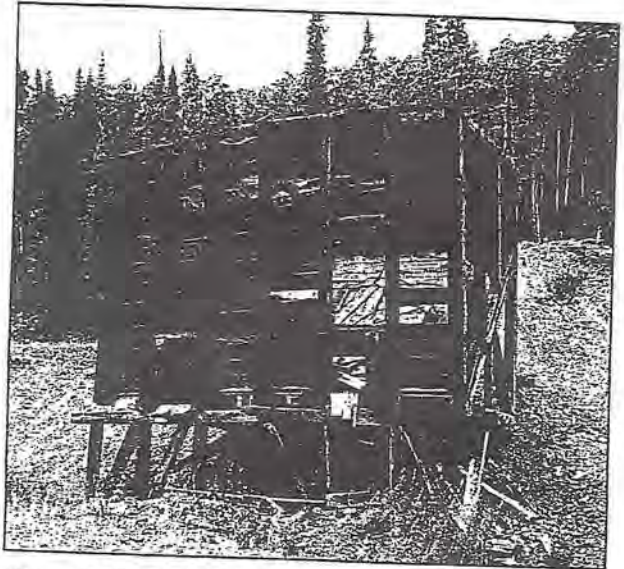
The Little Bell ore bin or "bunker" (Figure 37) is a historic structure in middle Empire Canyon, located on the east-facing slope of the Little Bell Mine waste dump and approximately 175 feet east of the Little Bell Mine shaft.

Figure 37 – Little Bell ore bin.

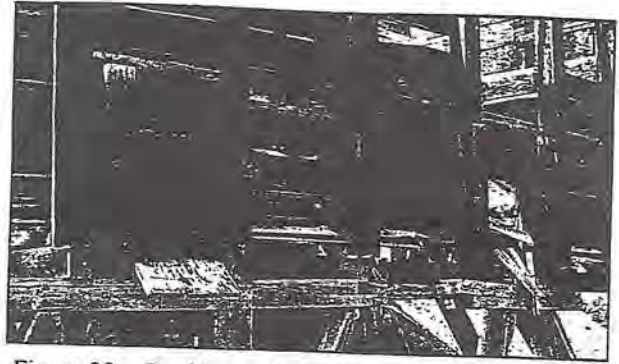
The two gate doors (Figure 39) were operated by a rack-and-pinion mechanism that raised and lowered them inside a cast-iron track mounted inside the jambs. Two cast-iron rack gears are still riveted to each of the steel gate doors, but the pinion assemblies are missing.

Figure 39 – Ore bin loading gates.

The original mounting points for the pinion assemblies are clearly visible on the wooden jambs around the gate openings. One of the gate doors is still in place and the other is lying on the ground in front of the ore bin. A historic photo (Figure 38) of a similar ore bin shows a round, hand-operated wheel, probably of cast-iron construction, attached to the pinion shaft. The similarity between the placement of the mechanism, the gate doors, and other features suggest that the same type of mechanism was probably used on the Little Bell ore bin.

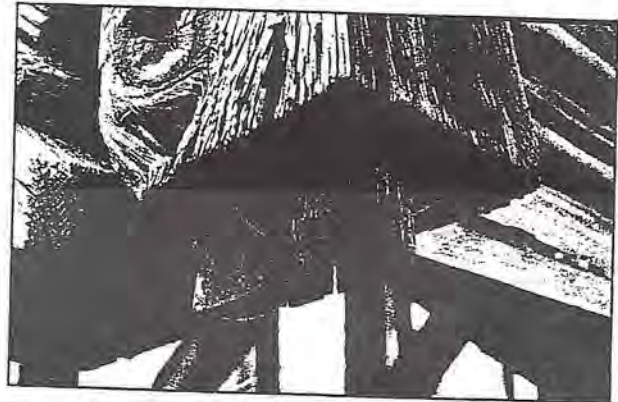
A missing beam has exposed a tenon (Figure 40) at the lower end of a post, indicating the use of mortise-and-tenon joints in the framework of the ore bin itself, although the support timbers under the bin do not appear to use mortise-and-tenon joints.

Figure 40 – Tenon of a mortise and tenon joint.

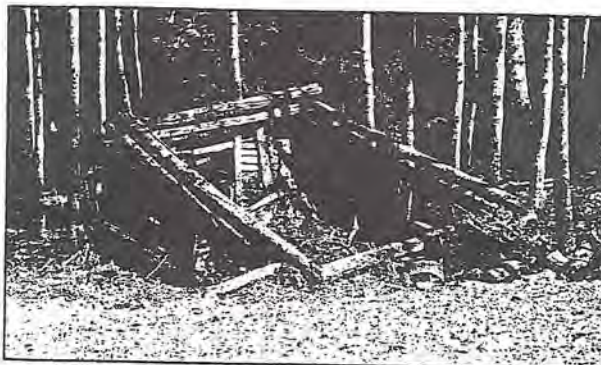
The remains of a log structure (Figure 45) are located below the White Pine Mine and above the Anchor Mine. It has been suggested that this structure may have been a miner's cabin associated with the White Pine Mine (Compton N.D., N.P.). Further research would be necessary to determine its history.

Figure 45 – Log Structure next to ski slope.

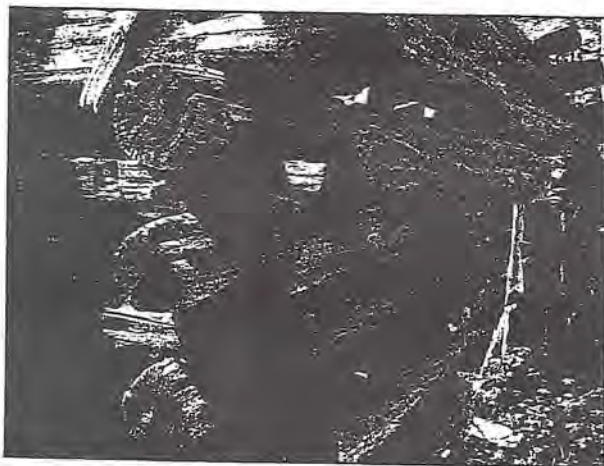
The wall logs were built with V-notch construction (Figure 46), also known as "sharp notch," and vary somewhat in size, typically ranging from about 8 to 11 inches in diameter. The sides of a number of the wall logs, both inside and outside of the structure, have been hewn to form a slightly flattened surface.

Figure 46 – V-notch log construction.
