AGENDA

823 Norfolk – Reconstruction and Material Deconstruction—Landmark Site. The applicant is proposing to reconstruct the historic shed. In addition, the applicant will be removing non-historic shed, removing non-historic retaining walls, removing the roof for structural upgrades, removing non-historic windows and doors, removing two historic chimneys, removing non-historic foundation, and removing non-historic porch elements and historic porch roof.

PL-15-02909 41
*Planner
 Grahn*

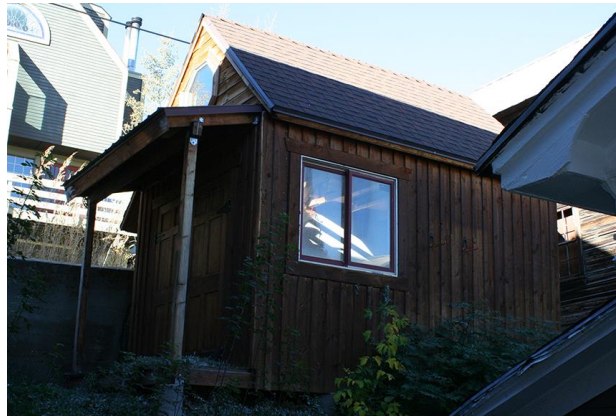
There are currently two sheds on site. There is a historic barn (sometimes referred to as a shed) in the northwest corner of the site that first appears in the 1907 Sanborn Fire Insurance Maps as 823 ½ Norfolk Avenue; this barn was attached to the house sometime after 1927 and likely during the 1970s-1980s. The second barn is located in the southwest corner of the site. This barn is not historic and is new construction, evident by its construction methods and materials. The applicant proposes to demolish this non-historic barn, pictured below.

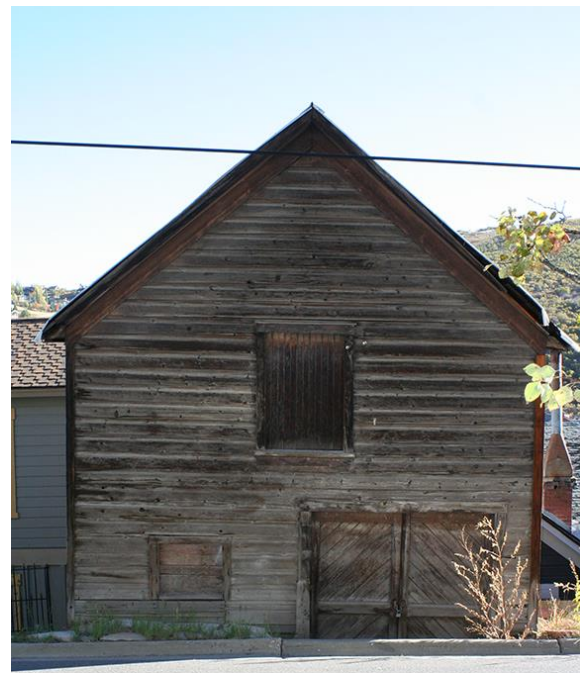
Current photograph of c.1907 historic barn, Crescent Tram elevation

Deputy Chief Building Official Michelle Downard inspected the site on April 14th and her observations have been included as (Exhibit G). She found that the historic barn has a visible lean to the southwest of approximately 6 inches. This was likely caused by the structure's inability to retain the uphill slope of the property along Crescent Tram. The drainage and topography of the site have contributed to the deterioration of the foundation framing, exterior walls, and exterior doors. The foundation, which consists of small rocks and sand, has settled and does not consistently support the barn's wood framing. Some of these framing members have rotted and deteriorated to the extent that they are no longer in contact with the ground and foundation. There are also active leaks and gaps in the roof structure, which has exposed the structure's attic to the elements.

"The back portion of the building appears to be a barn that has been attached to the main house. The walls of this structure have moved 5" to 7" horizontally. Existing framing is 2x4 at 24" o.c. The framing does not meet code and needs to be modified. Due to the racking of the building the existing material is in stress and its structural integrity compromised. We would not recommend using this material as its capacity is unknown, we recommend replacing it. This portion of the existing building shall be removed and replaced."

There is no foundation beneath the existing barn. Historically, the barn was constructed so that its main floor was at street level with Crescent Tram. The area below the first floor was filled with stone and debris to create a makeshift foundation. The limited posts that created footings for the floor framing have disconnected from the structure and no longer support the weight of the barn. This has caused the barn to rack, as noted by the structural engineer, as the walls are pulling and settling in different directions. A portion of the structure is supported by Crescent Tram, which has since been raised in street level.

The exterior walls consist of 2"x4" non-historic framing, covered with 1" thick wood plank. The existing siding is unfinished wood drop novelty siding; however, as it was never painted, it has severely deteriorated. Staff finds that if the applicant attempted to remove the individual siding to reuse on the reconstructed building, they would likely disintegrate as they were removed, causing greater damage to the historic material.

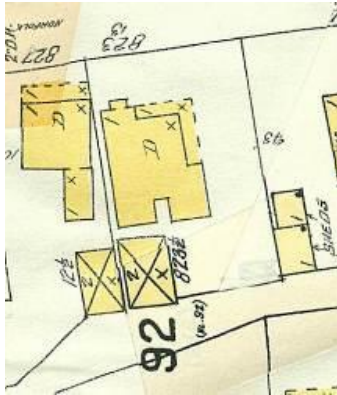
The house remains largely unchanged in the 1927 Sanborn Fire Insurance Map; the major change is that the one-story wood-frame barn seen on the southwest corner of the property has been demolished by 1927:

1927 Sanborn Fire Insurance Map

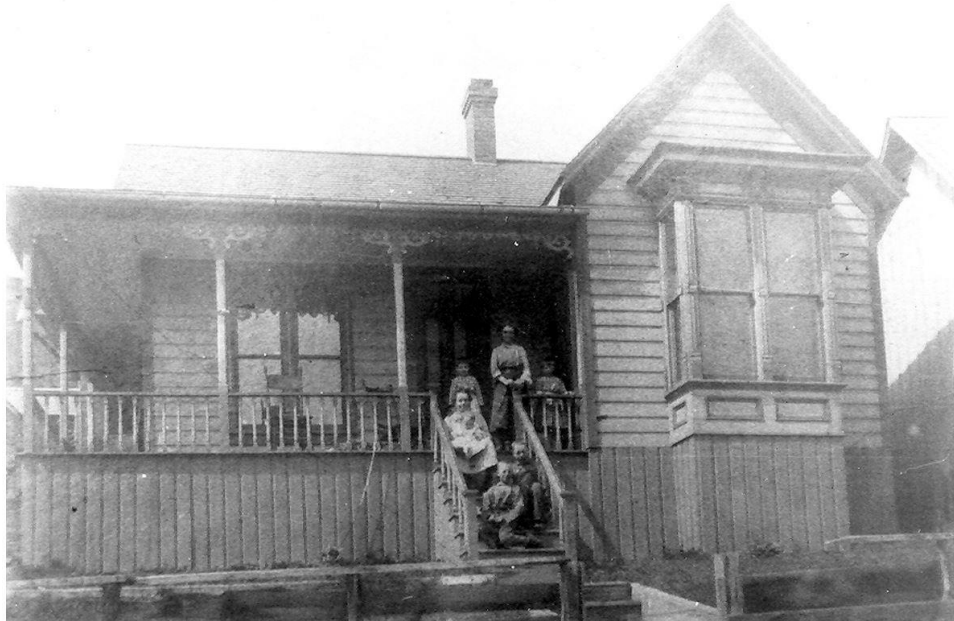
The house largely appeared as it did in the pre-1927 historic photograph:

This photograph, taken prior to 1927 shows the original porch, porch's architectural ornamentation, box bay, and original chimney.

The existing doors on the house are not historic. The wood front door is not historic and is not original to the house; the historic photograph shows a two-panel arched light door. There is an existing interior door that matches this profile and will be used to reconstruct the front door. On the sunporch, there is an east-facing door which will be removed and replaced with windows.

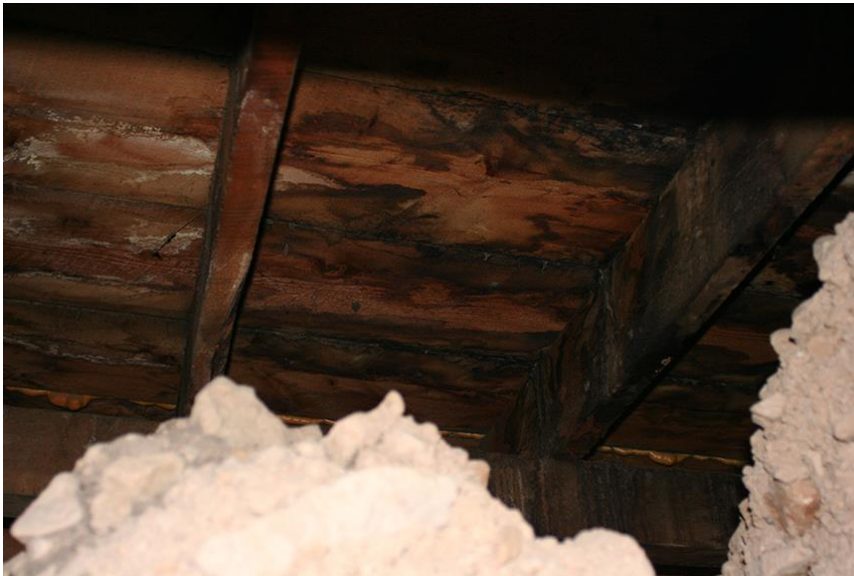
The existing roof joists used on the roof structure are 2x4s at 24" on center. These roof joists span approximately 8 feet to 12 feet and are covered by a 1x wood plank wood decking installed perpendicular to the existing joists. Per the Engineer's Report, the 12-foot roof joists are at 12% capacity per code and need to be upgraded or replaced. Further, new 5/8 inch plywood or OSB board will need to be installed as new roof sheathing as there currently is no capacity of shear diaphragm value.

Photo of existing roof structure above the house.

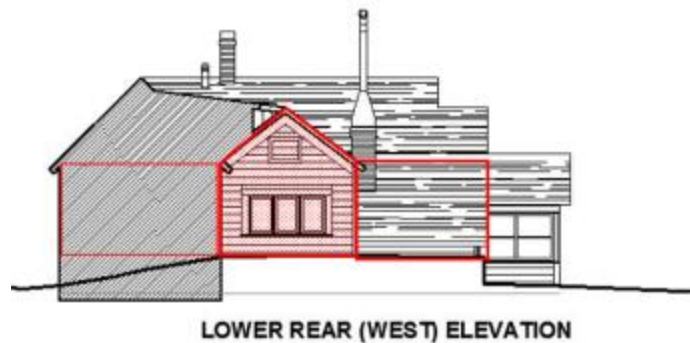
Two of the three rear additions along the west (rear) elevation of the house, facing Crescent Tram, were constructed prior to 1927 (outlined in red below) with the central addition being constructed post-1930 (shaded on the drawing below).

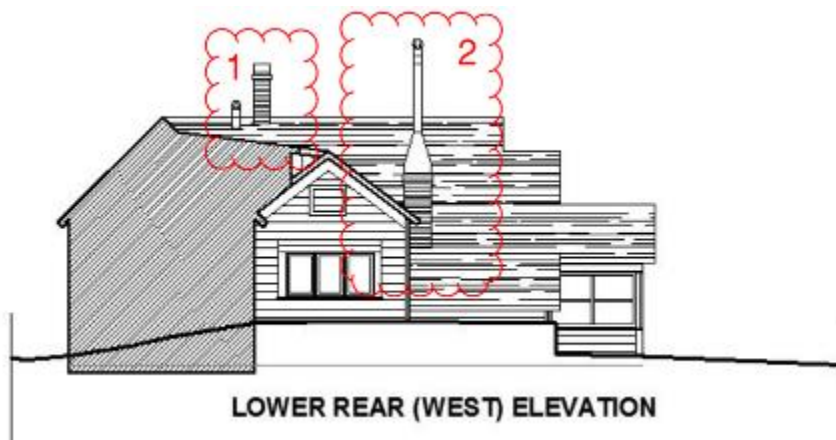
3. CHIMNEY

There are two historic chimneys on this house—(1) brick chimney located on the ridge of the north-south stem wing and (2) a brick chimney constructed on an early rear addition. The applicant proposes to disassemble and reconstruct Chimney #1 using the existing historic bricks and compatible mortar in order to preserve this character-defining feature. Chimney #2 rises 6 feet above the roof surface and is capped with a non-historic metal flue; the applicant proposes to remove this chimney.

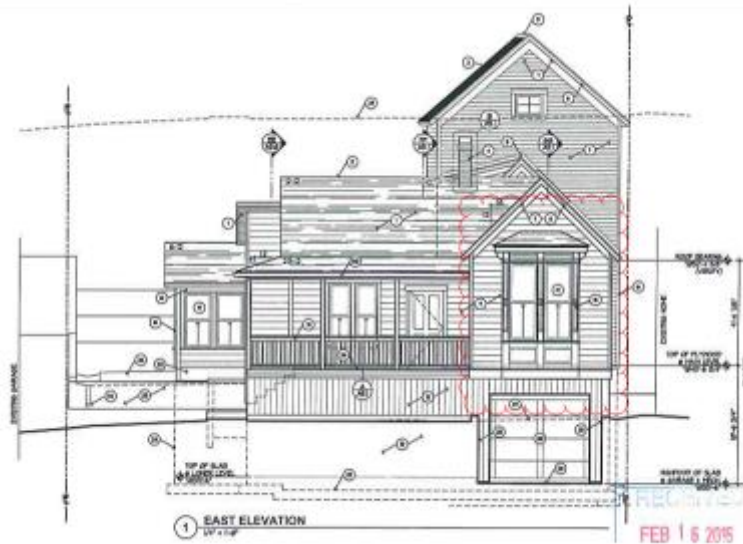
5. HISTORIC BAY

The Sanborn Map analysis and historic photograph indicate that there was a box bay window historically located on the east façade, facing Norfolk Avenue, of the east-west stem wing. This bay was likely removed as part of the renovations that occurred between 1940 and 1950; however, the applicant proposes to reconstruct the box bay based on physical and photographic evidence. Universal Design Guideline #4 encourages owners to reproduce missing historic elements that were original to the building, but have removed. Staff finds that the partial demolition of the existing wall, necessary to construct the box bay, is required as part of the restoration of this key feature.

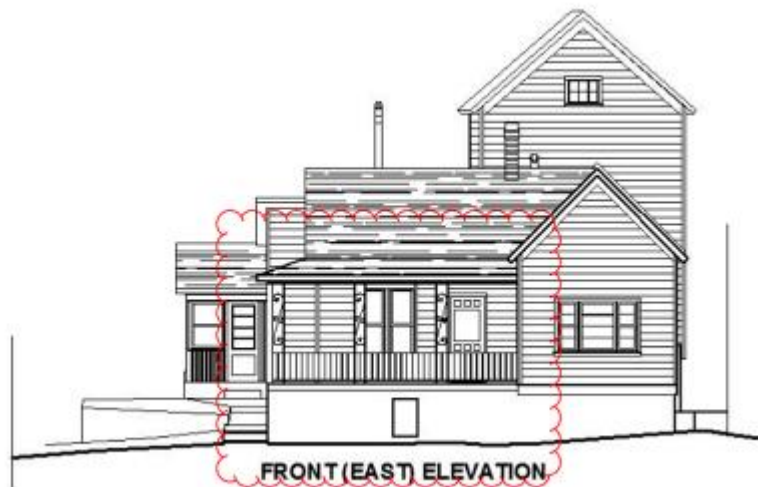
The existing historic porch on the Norfolk Façade consists of an elevated concrete deck and unreinforced masonry block foundation, ornamental iron columns, and iron railing. These improvements to the historic porch were likely added in the 1940s are part of the larger renovation of the house.

The applicant also proposes to reframe the existing porch roof. The applicant proposes to remove the existing porch ceiling in order to determine the roof structure of the porch. Currently, the applicant predicts that it is framed with 2x4s at 24 inches on center. The applicant proposes to either sister these existing framing members or completely rebuild the porch, depending on the results of further exploratory demolition. Staff recommends adding Condition of Approval 4 in order to address this:

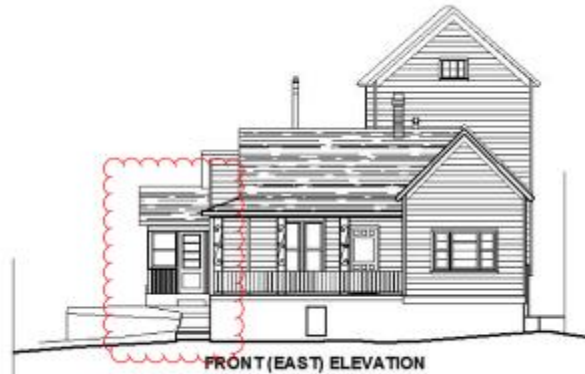
A second porch was constructed on the south elevation of the home after the Mature Mining Era (1894-1930) and was enclosed at a later date. In looking at the construction methods and materials used on this addition, staff finds that it was likely enclosed in the 1950s or later.

The applicant is proposing to replace the existing windows, remove the exterior doors, and demolish the two-riser step on the exterior of this sunporch to create interior living space. Staff finds that the proposed changes will not damage or

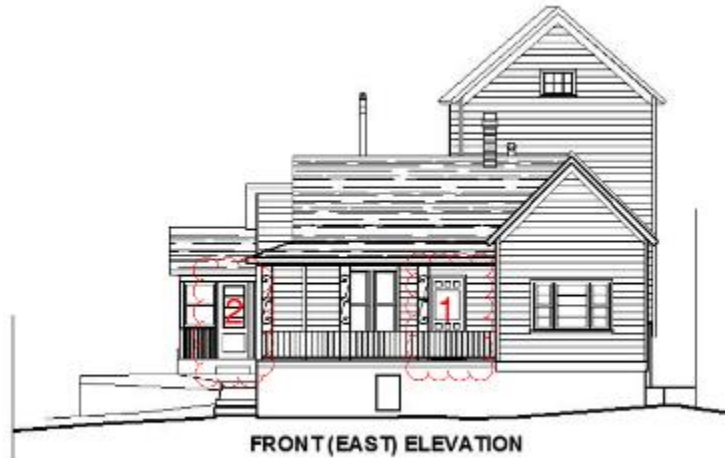
8. DOORS

Staff finds that the proposed demolition of the front door is necessary in order to restore the original entry door (1). The door on the sunporch addition (2) is necessary as part of the structure's rehabilitation and does not damage or destroy the exterior architectural features of the subject property which are compatible with the character of the historic site.
