## Historic Preservation Board Staff Report

**Author:** Hannah M. Tyler, Planner  
**Subject:** Reorientation and Material Deconstruction Review  
**Address:** 424 Woodside Avenue  
**Project Number:** PL-16-03379  
**Date:** July 19, 2017  
**Type of Item:** Administrative – Reorientation (Rotation and Lifting) and Disassembly/Reassembly (Panelization)

**Address:** 424 Woodside Avenue  
**Zoning:** Historic Residential (HR-1) District  
**Designation:** Significant  
**Applicant:** Jon and Heather Berkley (Represented by Jonathan DeGray, Architect)  
**Proposal:** (1) Reorient the Historic Structure towards Woodside Avenue (west). The primary façade of the Historic Structure currently faces towards Main Street (east), and the applicant is proposing to reorient the building 180 degrees towards Woodside Avenue. The Historic Structure will be lifted 7 feet 7 ¾ inches upon reorientation.  
(2) Panelize the Historic Structure in order to facilitate the reorientation.

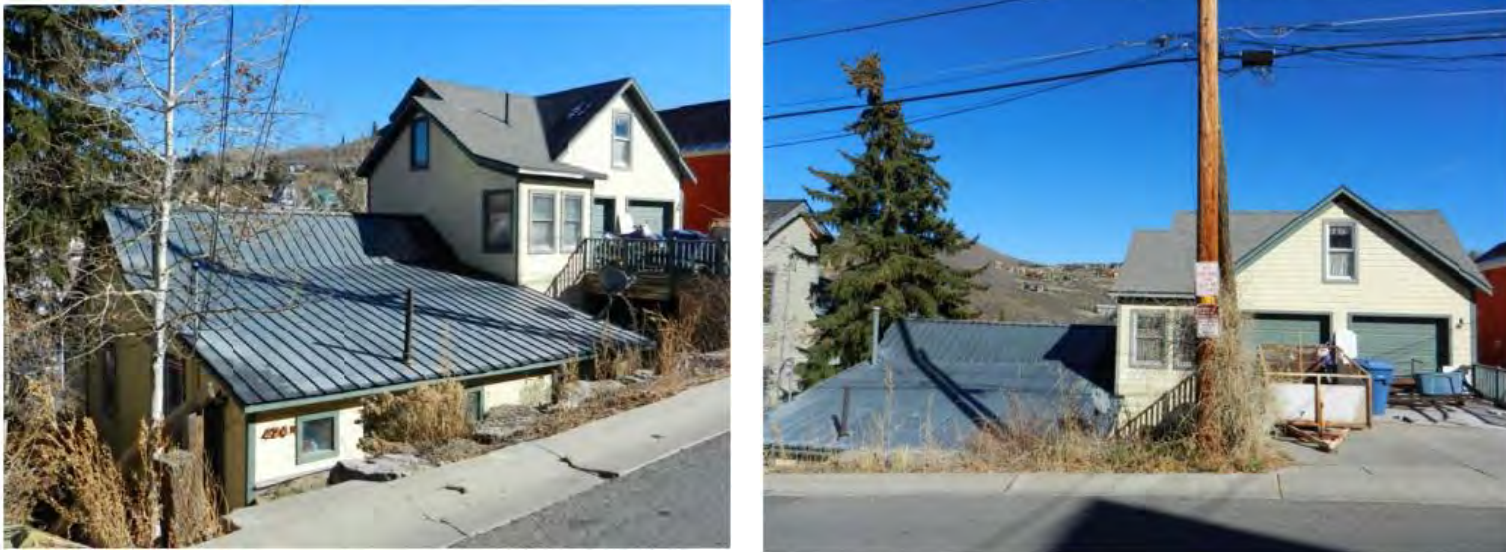
**Figure 1a:** *Current Site Orientation – Photographs West Façade*

Figures 1a through 1f identify the current conditions and existing orientation of the Historic Structure towards Main Street (east). Renderings provided by Jonathan DeGray. Photographs provided by Jonathan DeGray and CRSA.

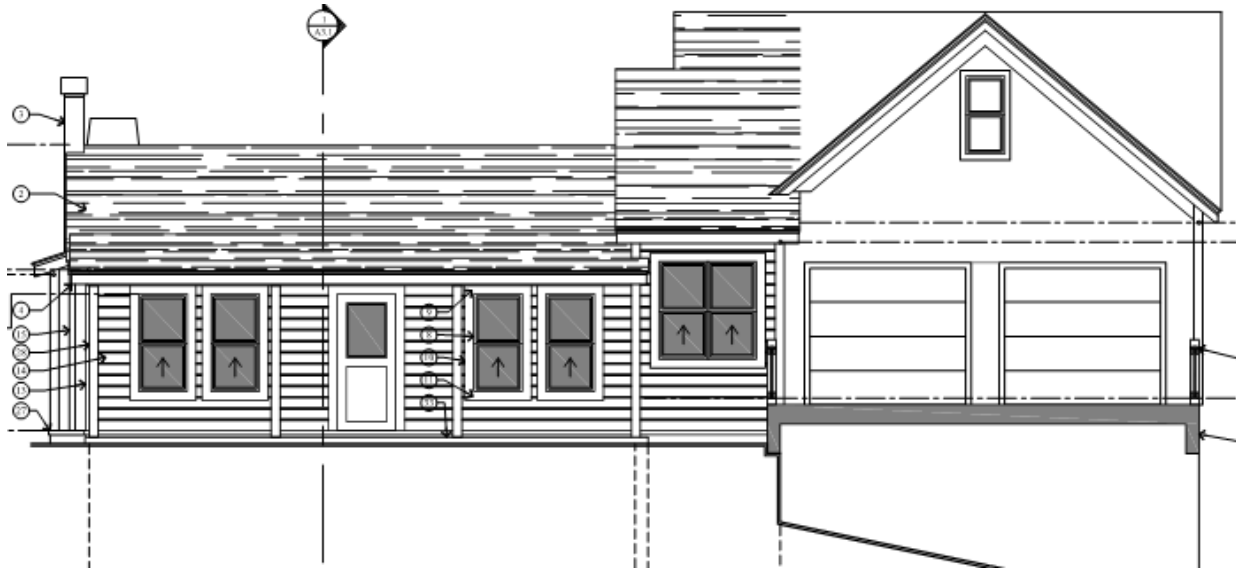
**Figure 2a:** *Proposed Reorientation – West Façade*

Figures 2a-2d identify the proposed reorientation of the Historic Structures towards Woodside Avenue (west). Renderings provided by Jonathan DeGray.

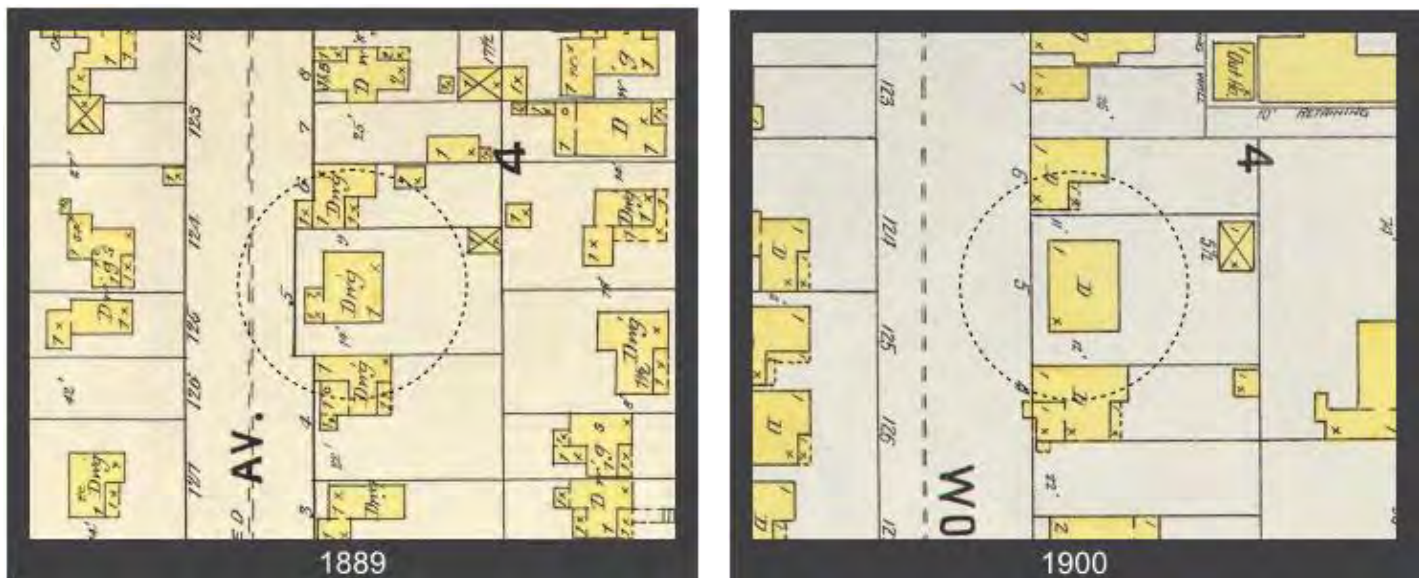
**Figure 3: 1889 and 1900 Sanborn Fire Insurance Map**

- Originally, the Historic Structure was a hall-parlor type single-family dwelling with a side-gabled roof; it was built on a relatively steep slope that was terraced toward the rear of the house (the Woodside Avenue side) to provide a more level building lot.
- The Historic Structure first appears on the 1889 Sanborn Fire Insurance Map as a wood-framed and wood-sided house originally faced east, providing a view of Main Street. Physical evidence and the 1889 Sanborn map indicate that it had a small shed-roofed wing on the south end of the rear (west) side but no front porch.
- By 1900, the original shed-roofed wing had been extended across the rear (west) side.

Figure 1. Sanborn Fire Insurance maps showing property at 424 Woodside 1889-1941 (from Carmen 2015).

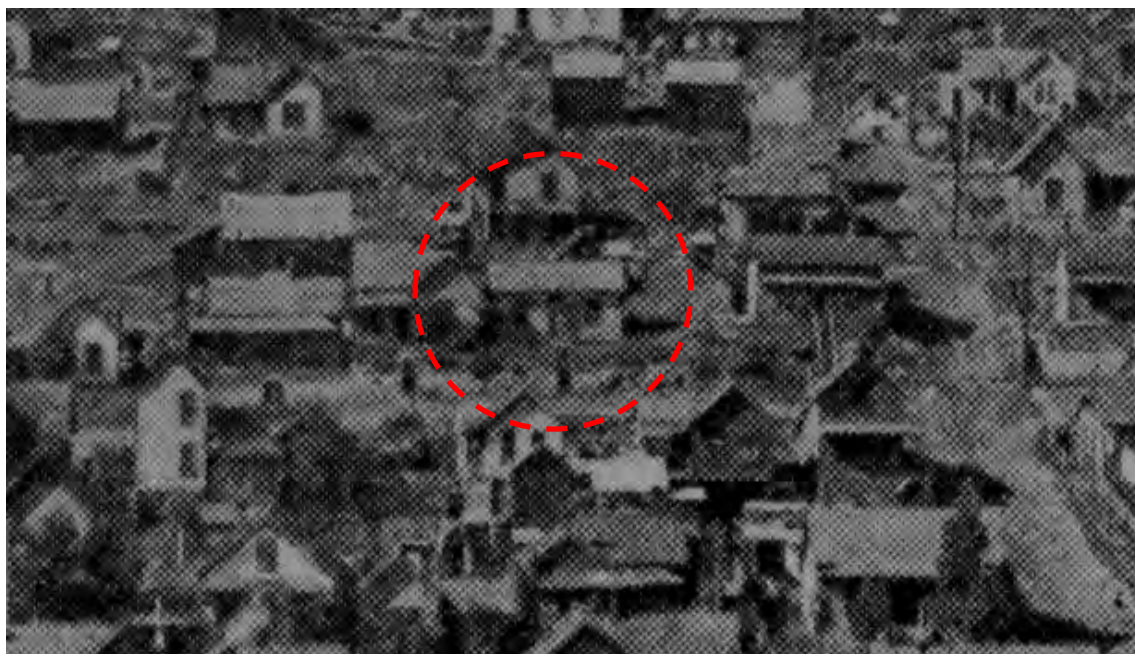
**Figure 5:** View of property ca. 1905-1907, facing west-northwest (circled in red). Note retention of simple hall-parlor form and continued absence of front porch on east side. Photograph provided by Jonathan DeGray courtesy of Park City Historical Society and Museum

**Figure 2.** View of property at 424 Woodside ca. 1905-1907, facing west-northwest. Note retention of simple hall-parlor form and continued absence of front porch on east side. Photograph no. 1985-6-001.

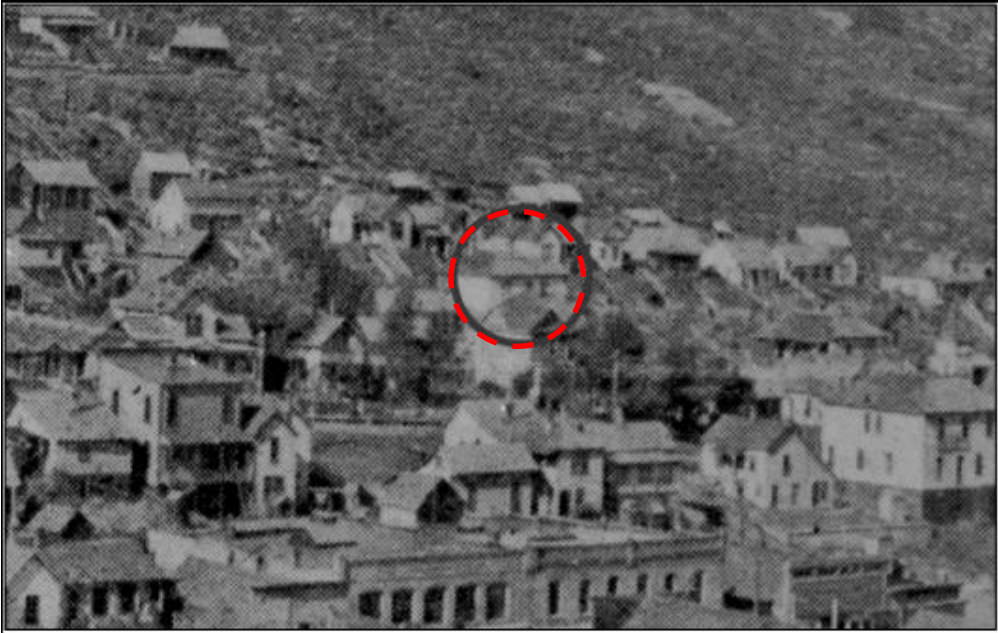
**Figure 6:** View of property ca. 1905-1907 facing north-west (circled in red). Note retention of simple hall-parlor form and continued absence of front porch on east side. Photograph provided by Jonathan DeGray courtesy of Park City Historical Society and Museum

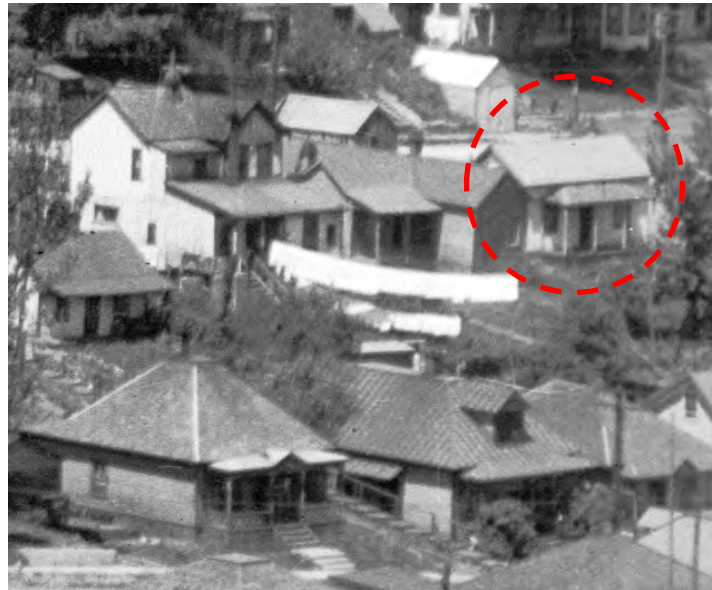
**Figure 9:** View of property at 424 Woodside in 1930, facing northwest. Note the retention of the simple hall-parlor form and addition of hip-roofed front porch, which was removed by 1941 according to the Sanborn Map. Photograph provided by Jonathan DeGray courtesy of Park City Historical Society and Museum.

**Figure 4.** View of property at 424 Woodside in 1930, facing northwest. Note the retention of the simple hall-parlor form and addition of hip-roofed front porch, which was removed by 1941 according to the Sanborn map. Photograph no. 1987-2-134.

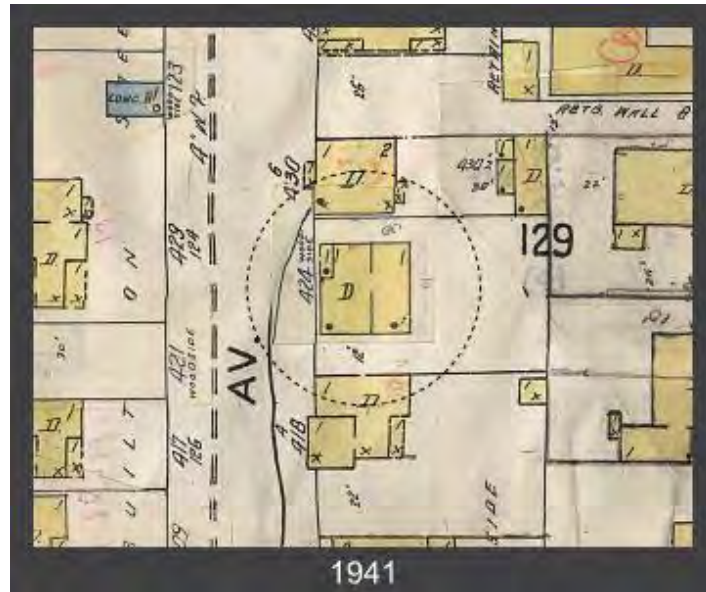
**Figure 10:** 1941 Sanborn Fire Insurance Map

- By 1941, a second shed-roofed addition had been built across the west side, incorporating the 1907 rear screened porch and essentially filling the terrace between the rear wall of the house and the retaining wall so that the eave was nearly at grade. The front porch had been removed and asbestos shingles had been applied over the original wood siding by this time.

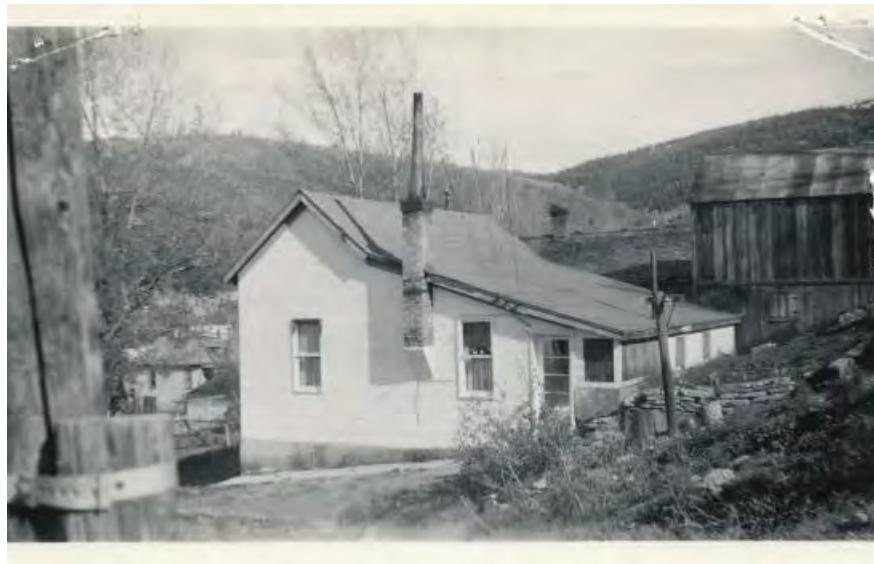
**Figure 11:** Tax appraisal photograph of property at 424 Woodside dating to ca. 1941, facing southeast.

**Figure 5.** Tax appraisal photograph of property at 424 Woodside dating to ca. 1941, facing southeast.

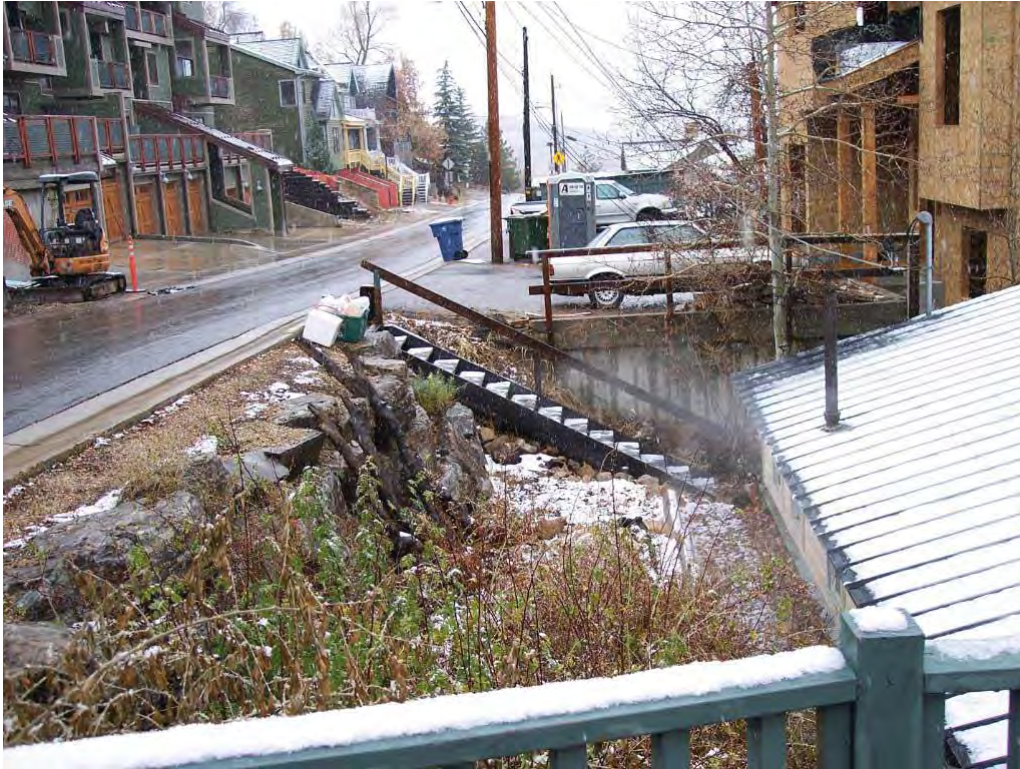
***The front of the property off Woodside Avenue has rock retaining wall that runs parallel with the street. The entry stairs are wood and are in fair shape. Stone walkway leads from the entry to the rear yard. All vegetation is natural and maintained.***

***Rock retaining wall and entry stairs along west elevation***

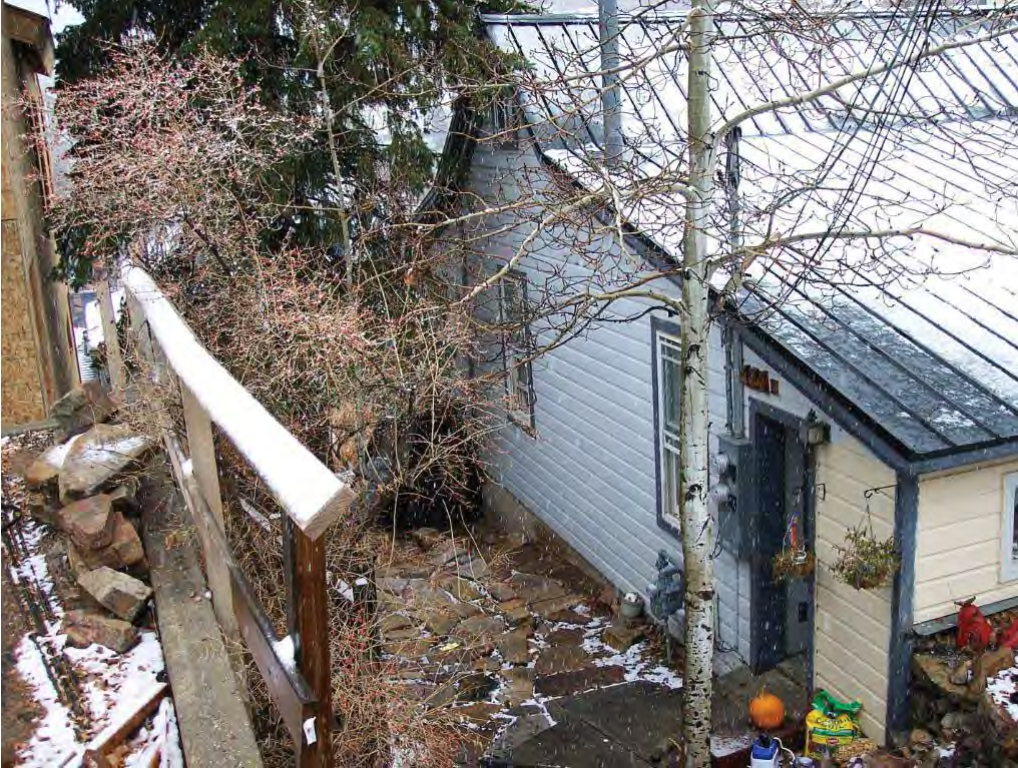
***Stone walkway at entry leading to rear yard (north elevation)***

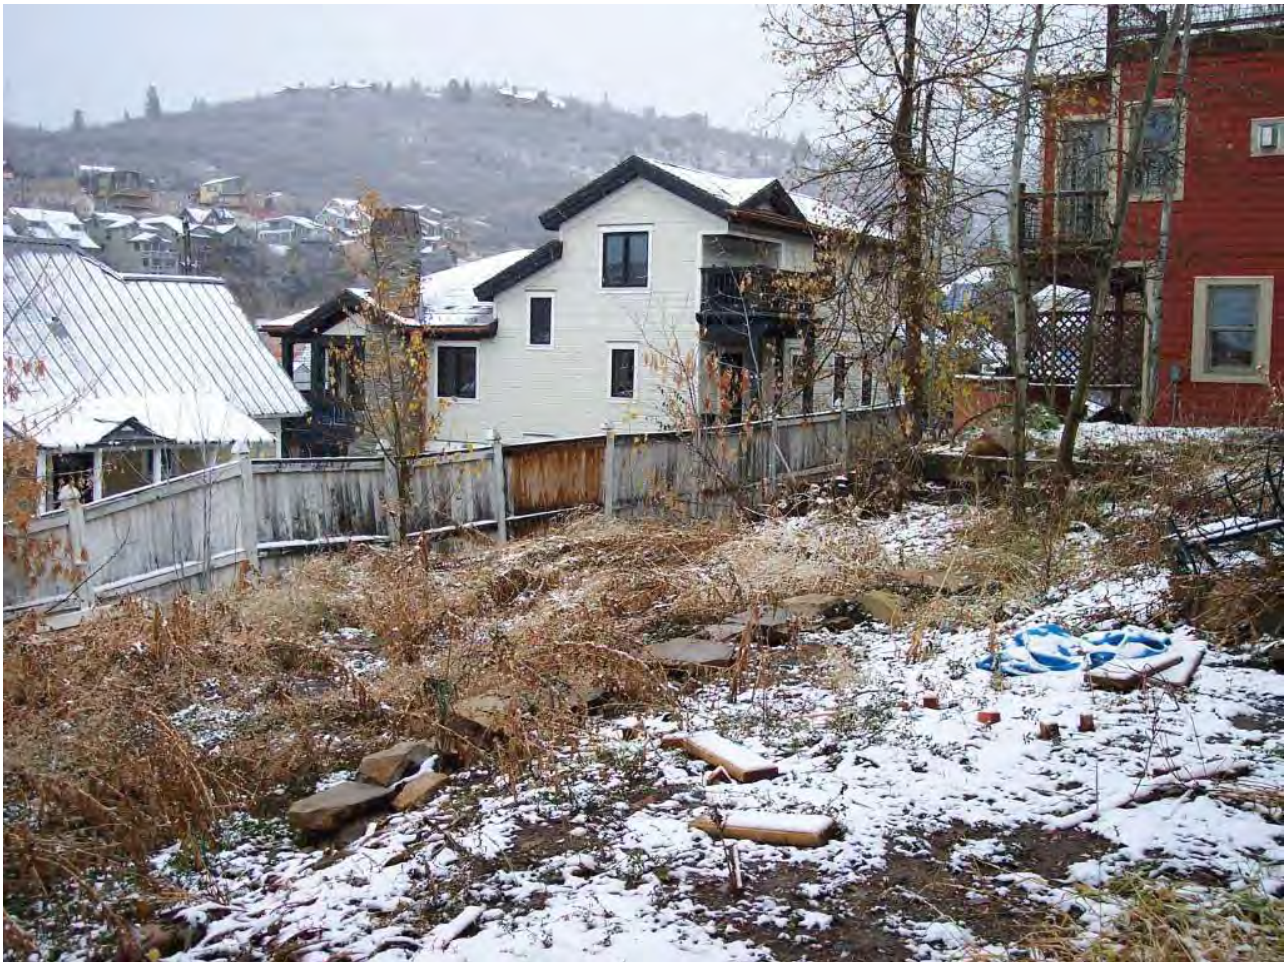
***Rear yard fence***

***The rear fence (owned by adjacent property) runs north to south and is 4x4 wood post with 1x4 wood slats in need of repair. The wood fence along the north property line is 6' length sections of 1x6 dog eared cedar slats and in need of repair.***

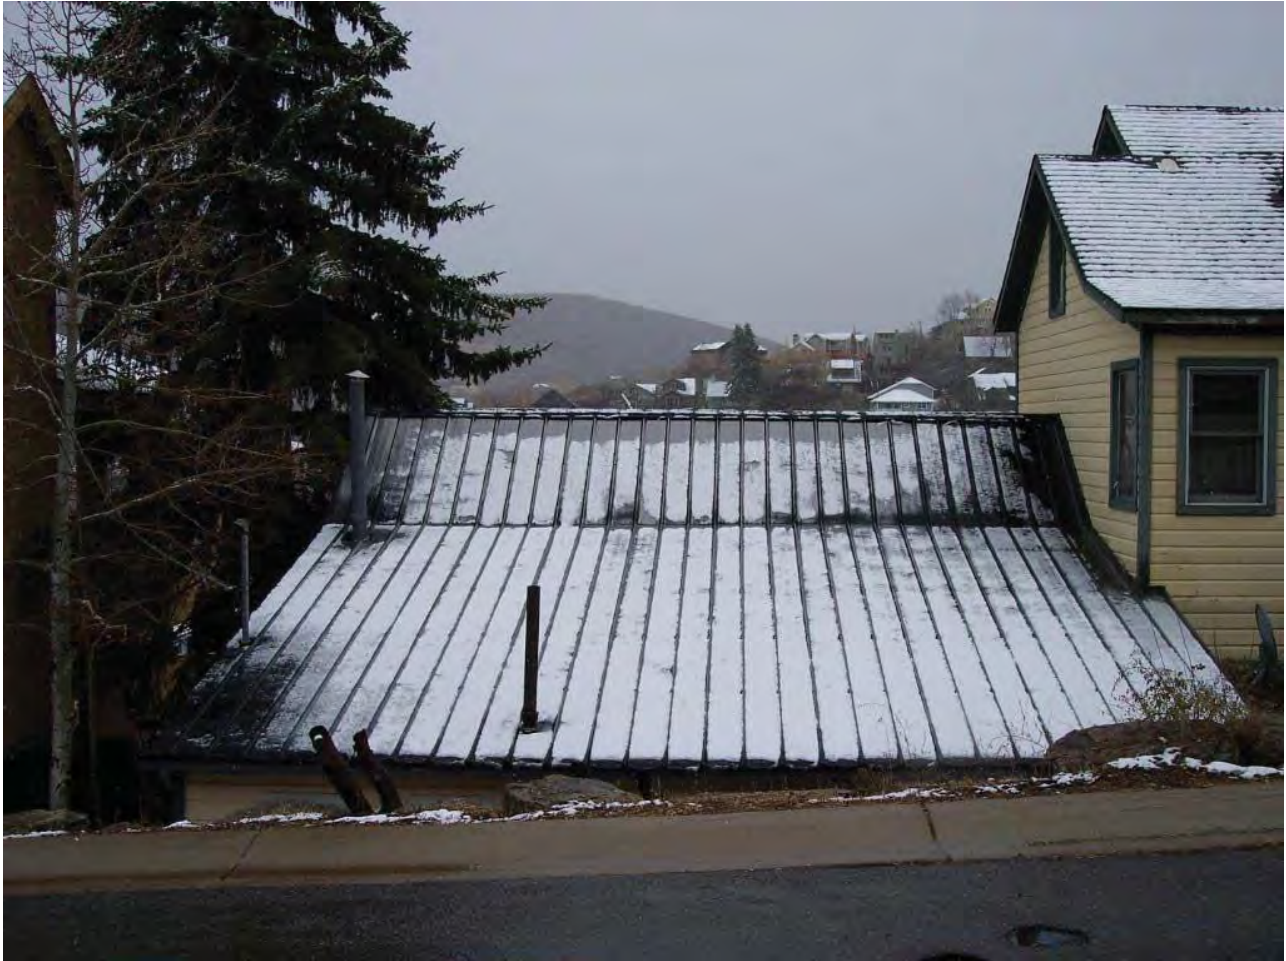
***Roof looking east***

***The roof is simple gable with a 10/12 pitch with a shed running west at a 2.5/12 pitch. This form was the original built about 1900. The shed roof running east off the main gable is a 4/12 pitch and was added after 1978. The roof material is standing seam metal applied after 1978. The main gable form is standing seam metal roof over historic wood shake over historic 1x8 skip plank over historic 2x4 truss at 24" o.c., the truss has 2x4 bottom chord with 1x4 kickers. The two sheds of the gable running east and west were updated after 1978 with standing seam metal over 5/8" plywood over 2x12 joist at 24" o.c.***

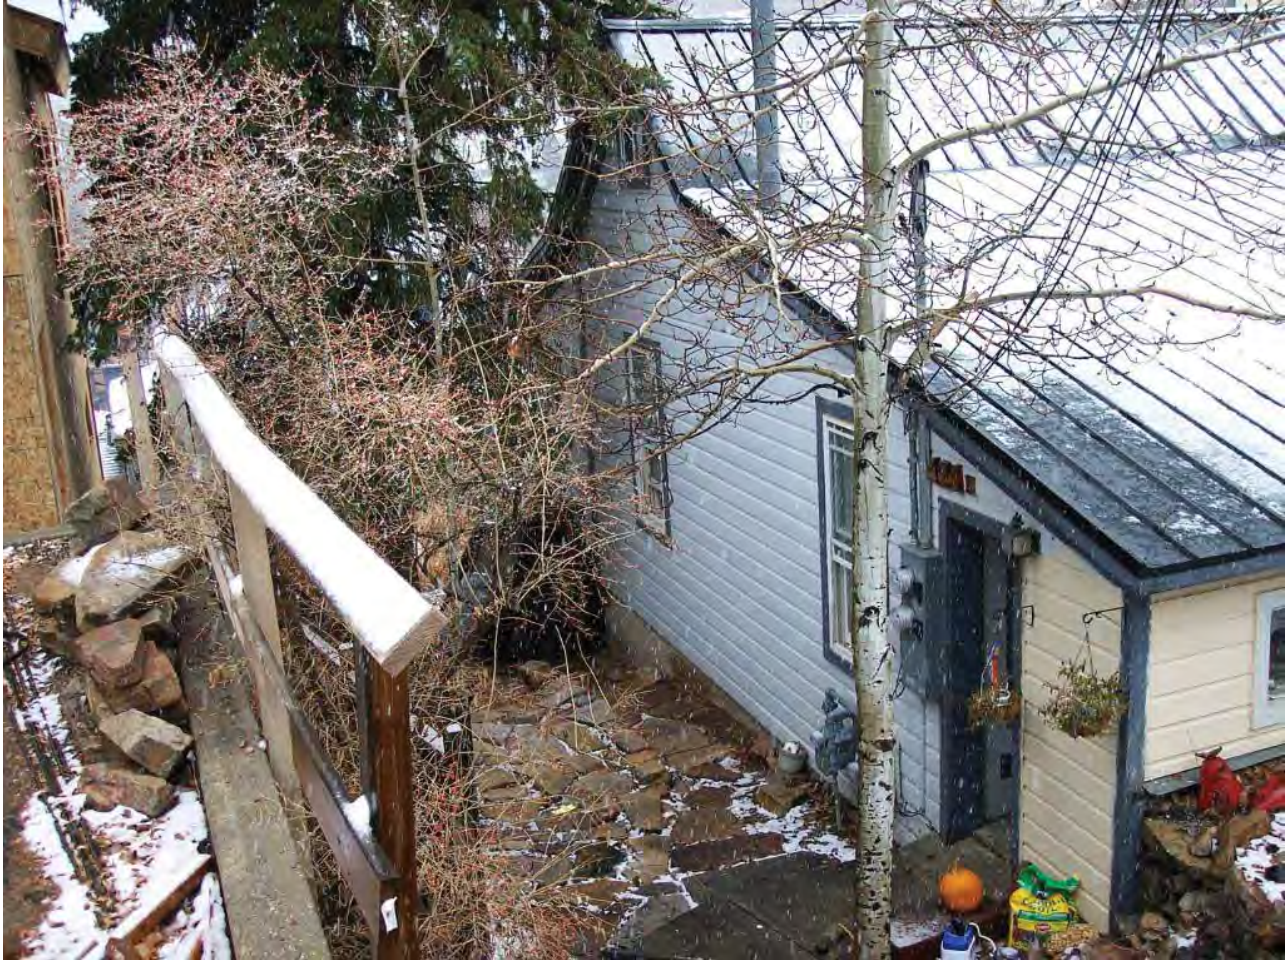
***North elevation***

***The north elevation is 1x8 horizontal lap siding applied after 1978, over historic 1x12 vertical plank on 2x4 studs at 24" o.c.***

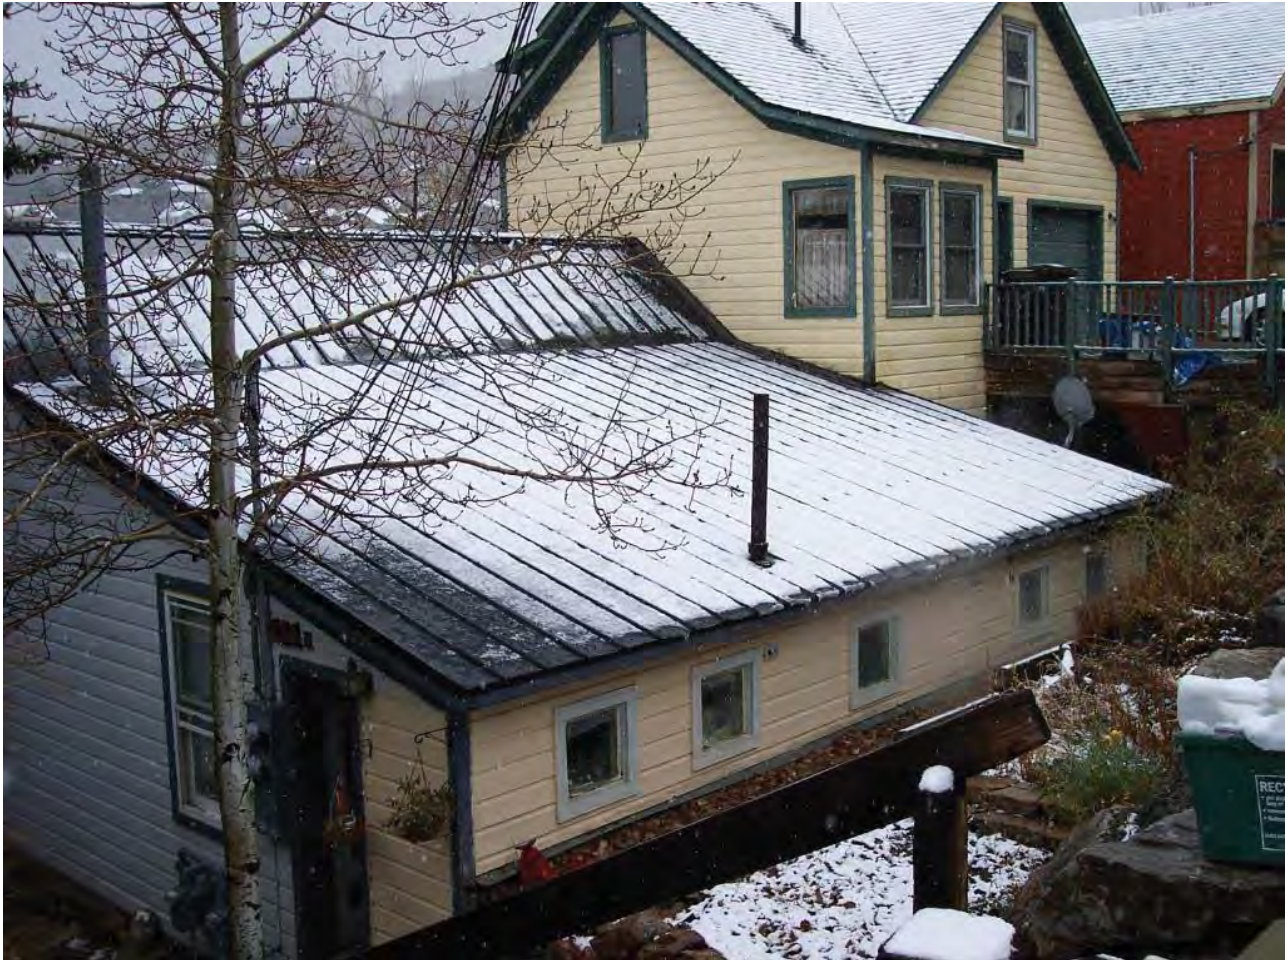
***West elevation***

***The west elevation is 1x8 horizontal lap siding applied after 1978, over historic 1x12 vertical plank on 2x4 studs at 24" o.c***

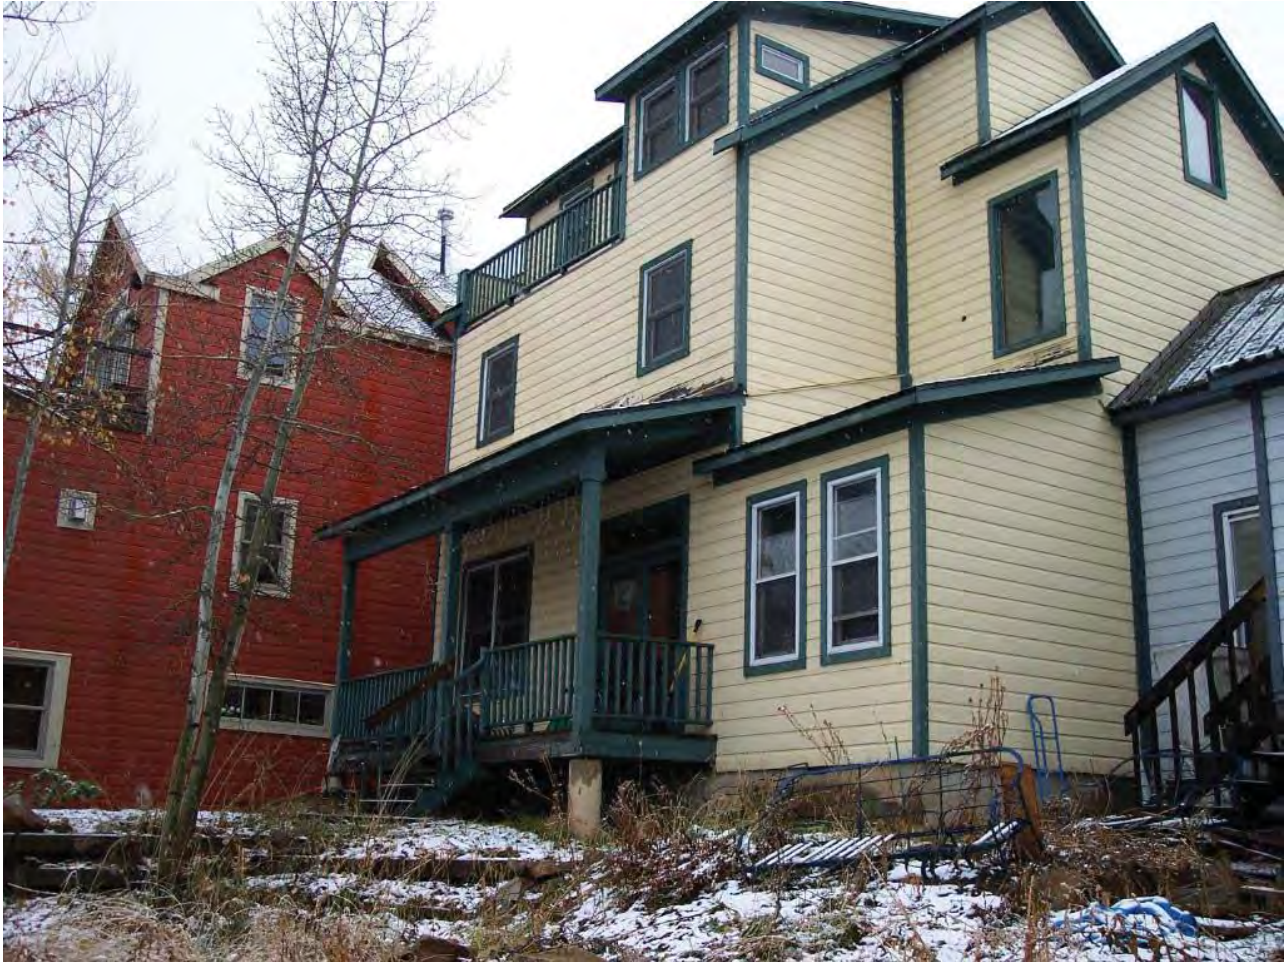
***The south elevation has an addition built after 1993.***

***Addition on the south elevation built after 1993***

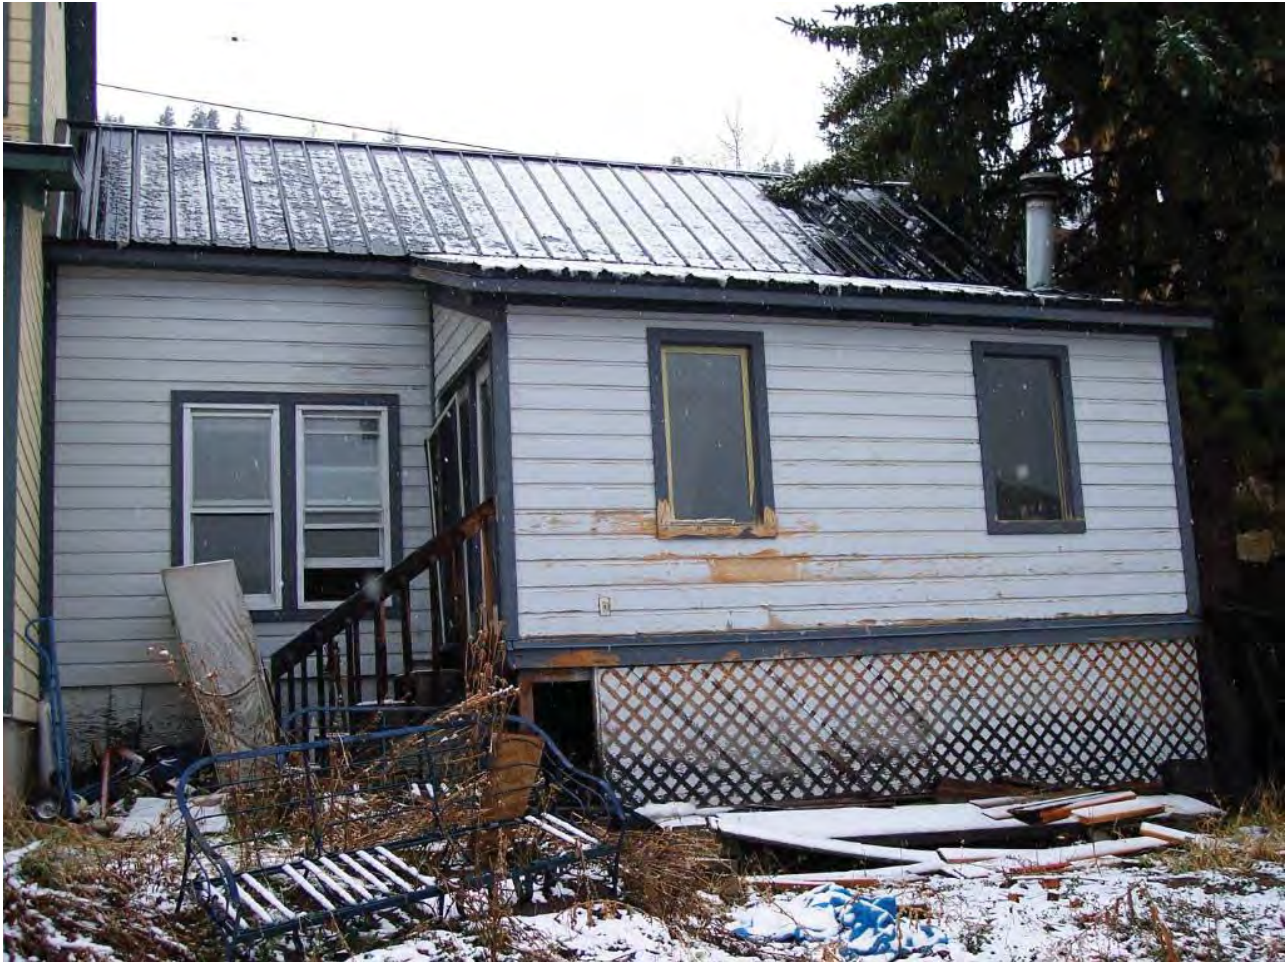
***East elevation***

***The east elevation is 1x8 horizontal lap siding applied after 1978, over 5/8" plywood on 2x4 studs at 24" o.c***

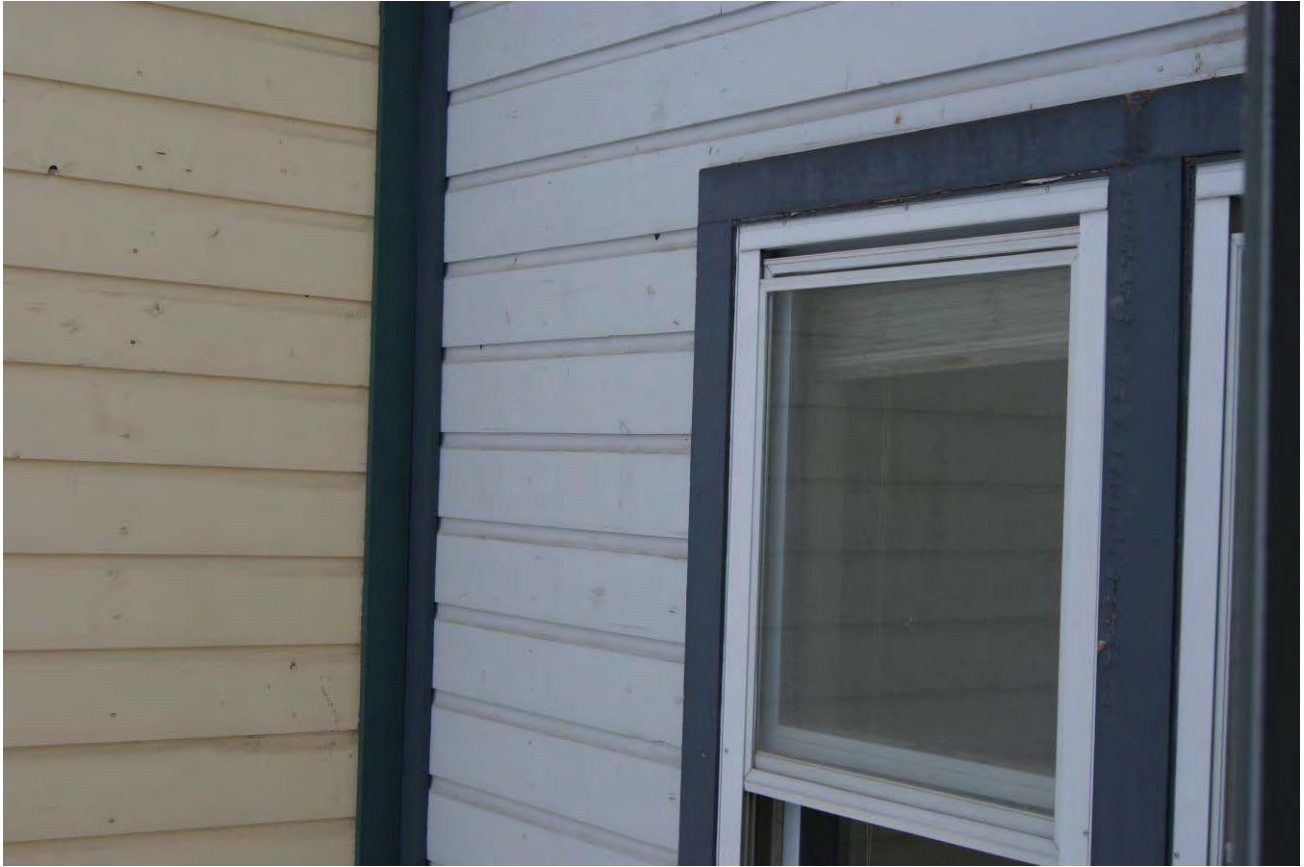
***The windows were updated after 1978 with insulated wood aluminum clad. No historic windows remain.***

***Wood aluminum clad window- typical***

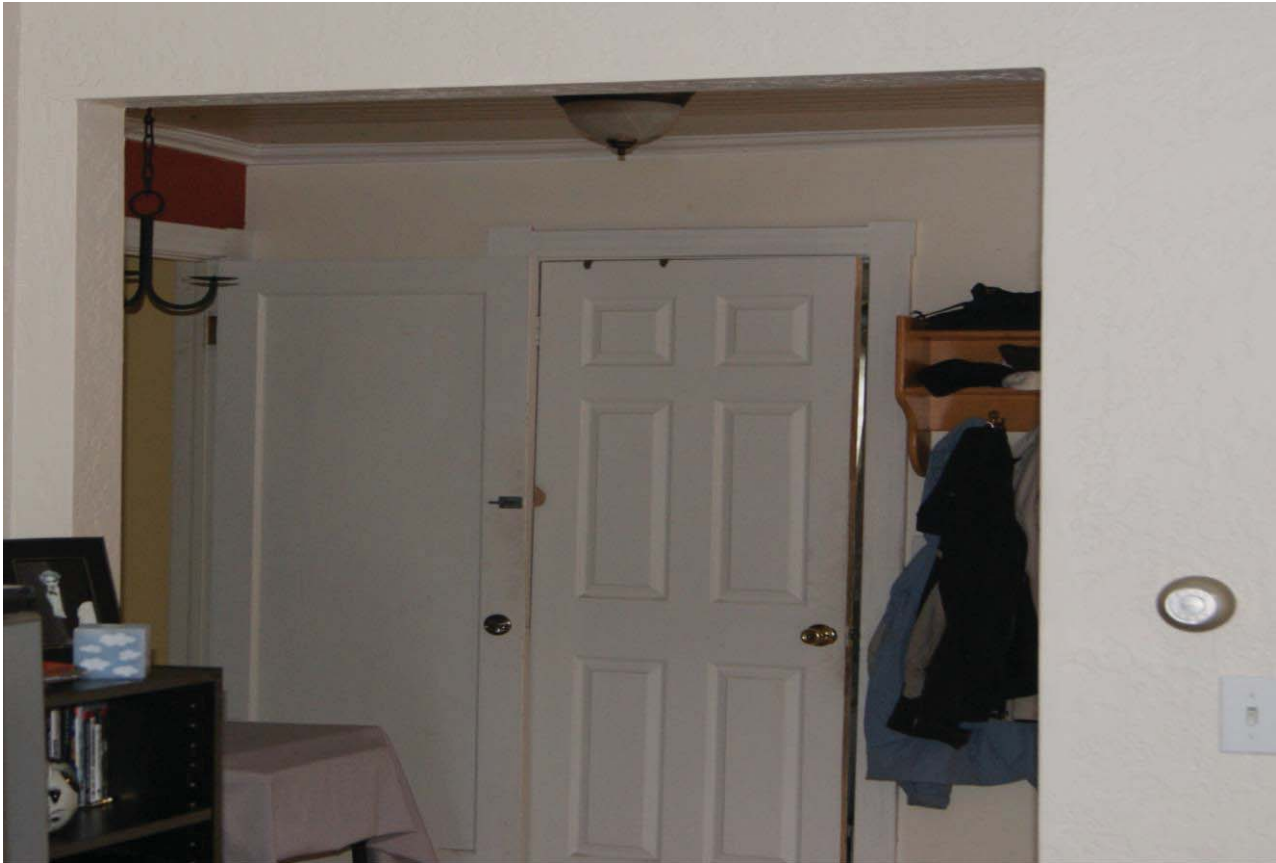
***Interior doors***

***The doors were updated after 1978 with solid core interior doors and the exterior patio door is insulated wood clad aluminum. No historic doors remain.***

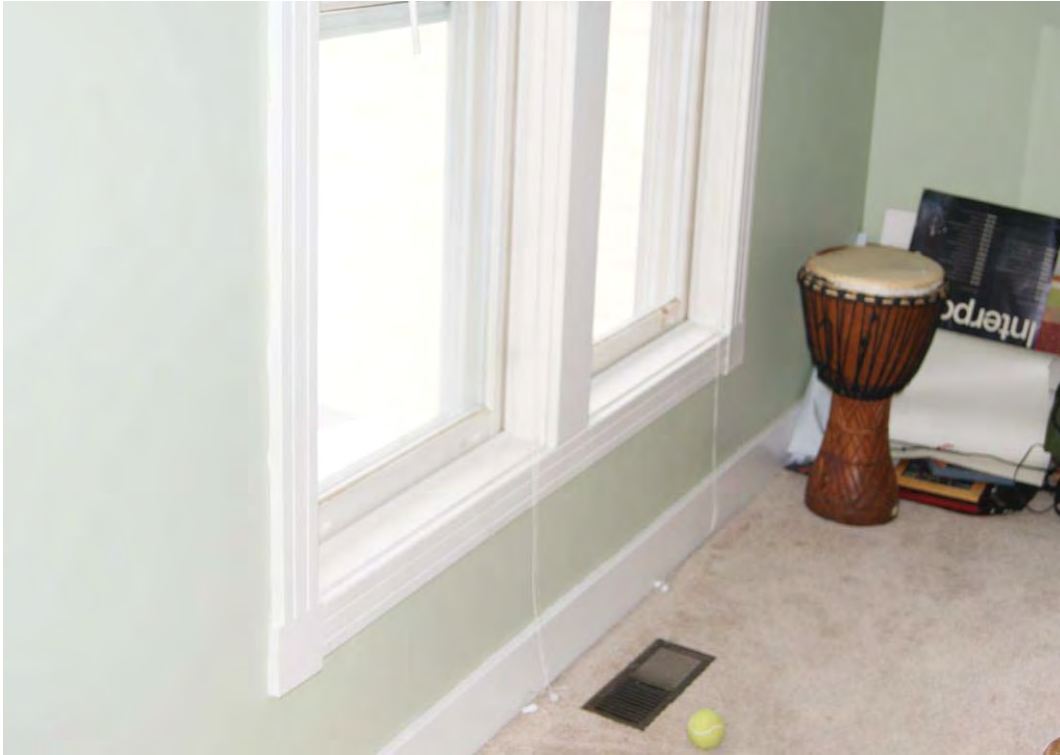
***Typical base and window casing***

***All exterior and interior trim was replaced after 1978. No historic trim remains.***

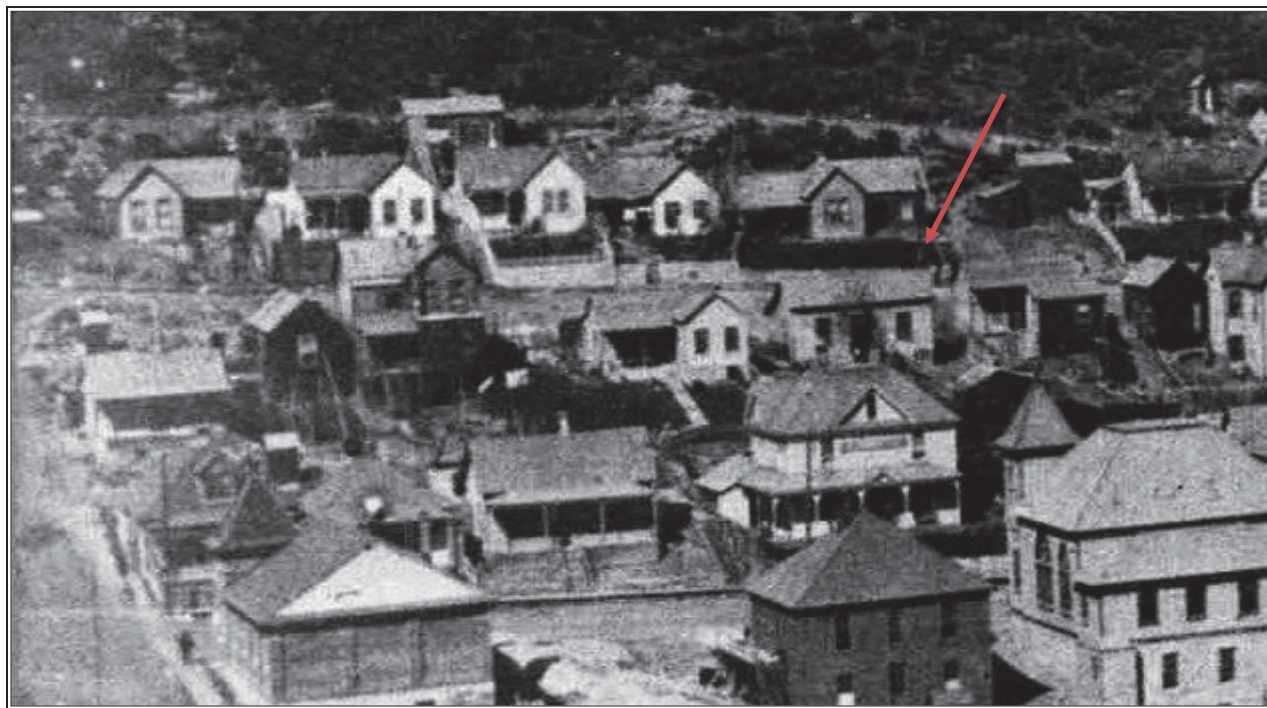
**Figure 3.** View of property at 424 Woodside in 1907, facing west-northwest. Note simple hall-parlor form, east-facing aspect with a view across canyon, and access via a footpath leading north from Fourth Street behind the Park Avenue houses. Note the absence of a front porch on east side, although according to the 1907 Sanborn map a porch was added in this year. Also note the mix of house orientations along the downhill (east) side of Woodside, with some facing the street and others the canyon. Photograph provided by Jonathan DeGray.

- As visible in historic photographs, the principal façade was composed of a central doorway flanked by a window on each side (Figures 2 and 3). Woodside Avenue was present to the west but, in the pedestrian-oriented city of the time, access to the house was also via a footpath leading north from Fourth Street behind the Park Avenue houses, and then a short staircase leading up to the east façade (obscured by houses in the foreground). The orientation of houses along the uphill (west) side of Woodside was uniformly east-facing, while orientations along the downhill (east) side was mixed, with some facing the street and others the canyon.

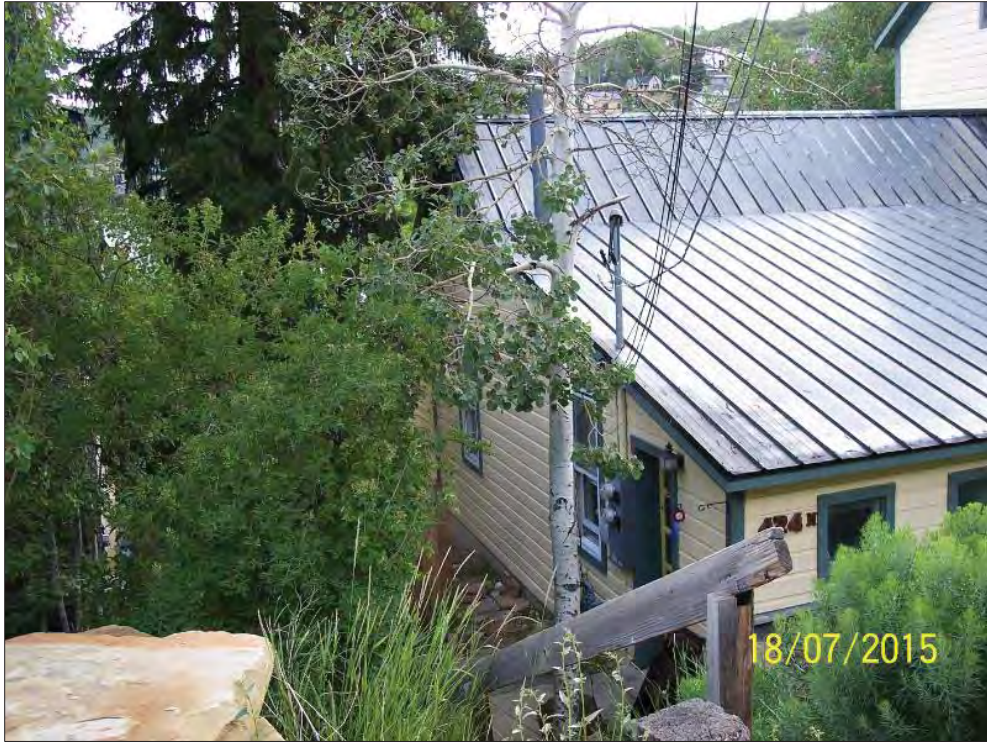
**Figure 6.** North and west sides of historic house at 424 Woodside, facing east-southeast, 2015.

- Between 1978 and 1993, the east façade was modified by the addition of a sunroom across the north two-thirds (which likely was created by enclosing the ca. 1968 front porch), covering the original doorway and north window. The interior floor plan indicates that these historic openings were completely removed or covered at the time. As well, the south window on the east façade was enlarged to accommodate two one-over-one windows (see as-built drawings in DeGray 2016). The asbestos shingles were also removed during this period and replaced with new drop siding; on the west and north elevations this was applied over the original 1 x 12 vertical plank sheathing (Figure 6). It appears that all original windows and doors were replaced as well (DeGray 2016).

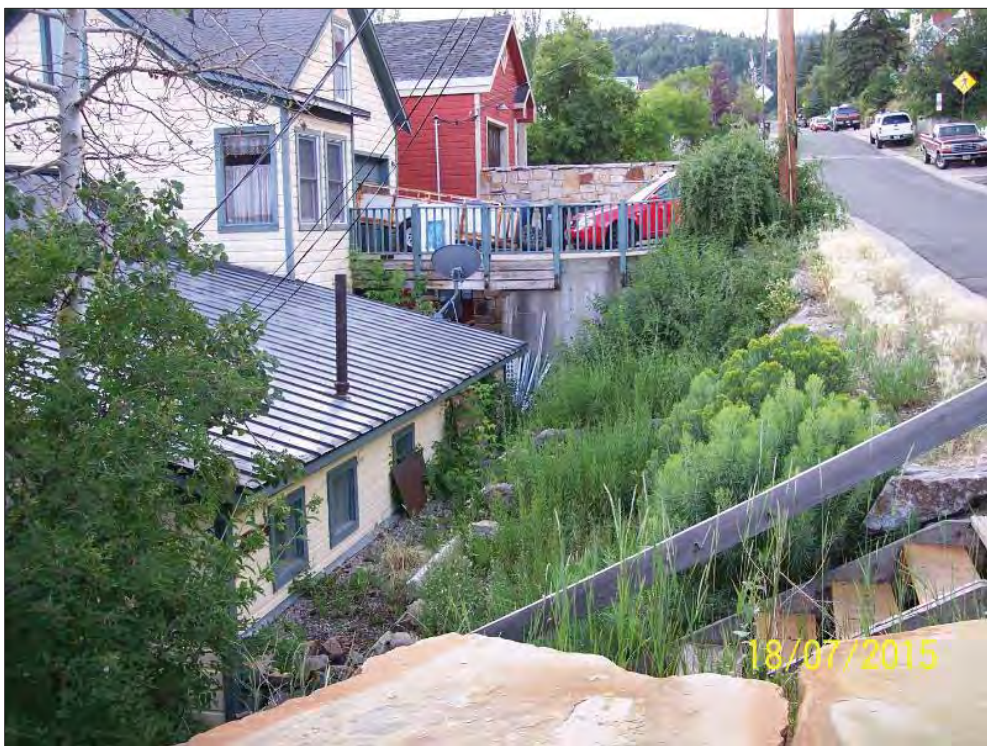
**Figure 7.** West side of historic house at 424 Woodside, facing south, 2015. South addition dating to 1993 is visible at upper left.

- The historic house was extensively rehabilitated and altered in 1993, when the large south addition was built. The south wall of the historic house (between the historic house and the addition) was completely rebuilt and no original materials remain in the east wall. The south addition was enlarged with an east-facing dormer in about 2005 (DeGray 2016).
- Through time, as Woodside Avenue has been paved, improved, and widened with curb, gutter, and sewer, the level of the road has risen higher above the rear (west) wall and terrace of the house at 424 Woodside. The change in width is uncertain, as is the change in historic grade, but it is likely to be a few feet in both cases (Figure 7).
