**PARK CITY MUNICIPAL CORPORATION
HISTORIC PRESERVATION BOARD
CITY COUNCIL CHAMBERS
February 7, 2018**

173 Daly Avenue - PL-17-03468 —Disassembly/Reassembly and Material Deconstruction—Significant House. The applicant is proposing to disassemble and reassemble the Historic House, Historic shed, and the east and south walls of the Historic single-car garage. The applicant is proposing to panelize the west and north walls of the Historic single-car garage. The non-historic siding will be removed. The applicant will be removing the existing Historic windows, an existing stack rubble wall on the east side of the building, the existing roofs and roof framing, the existing historic doors, and the east wall of the historic shed structure to accommodate a connection to the Historic house.

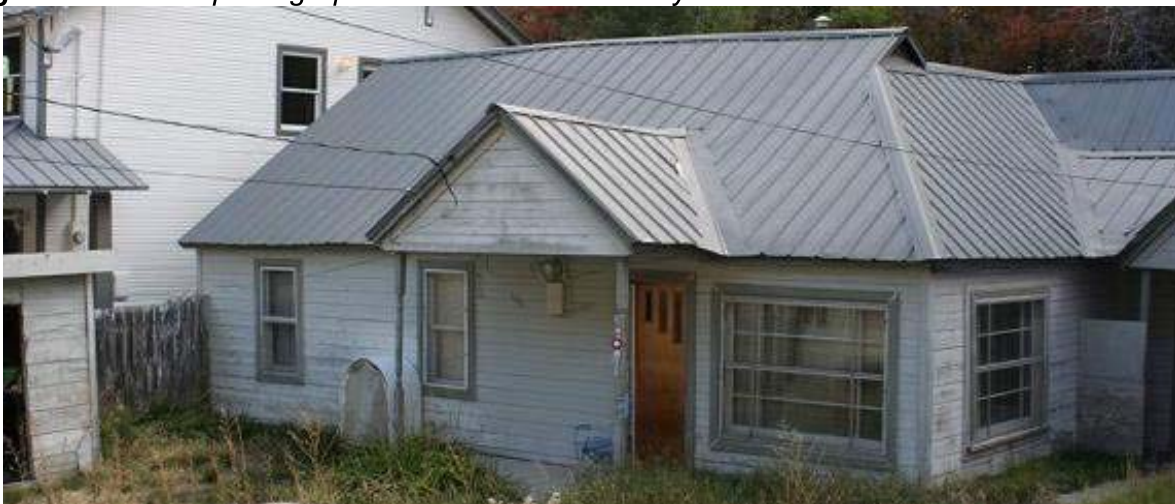
Figure 1: Current photographs of the site at 173 Daly Avenue.

Historic House: West Elevation (northern end)

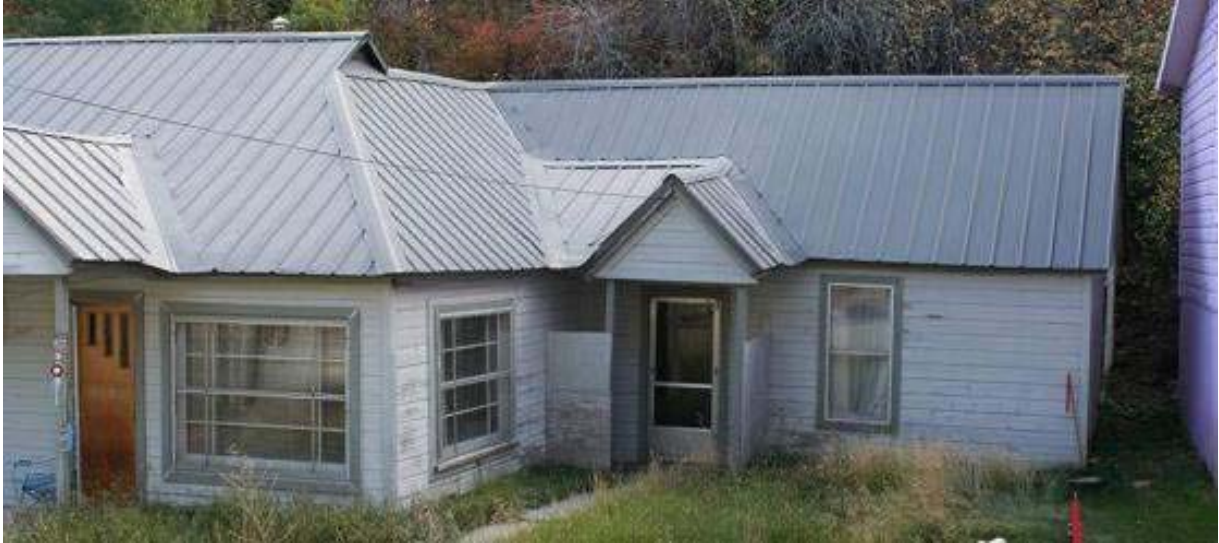
Historic House: West Elevation (southern end)

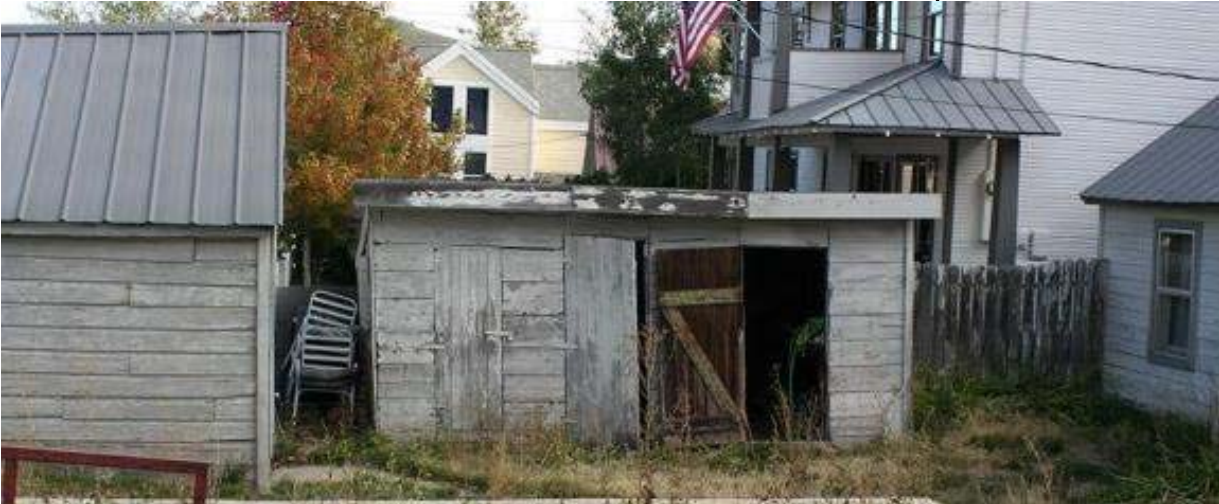
Historic Shed: North Elevation

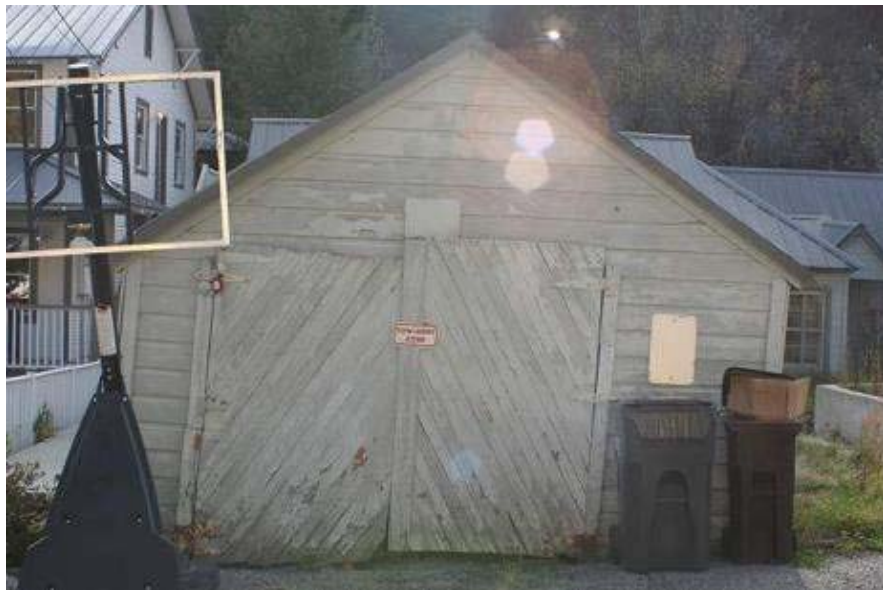
Historic Single-Car Garage: West Elevation

The front yard of the house contains two outbuildings. A wood framed single-car garage fronts on Daly Avenue. With a small hinged opening, this gabled roof single-car garage is historic. A Historic shed-roofed storage building lies between the single-car garage and the house. Figure 1 identifies the Sanborn Fire Insurance Maps between 1889 and 1941. Figure 2 identifies the ca. 1941 tax photograph.

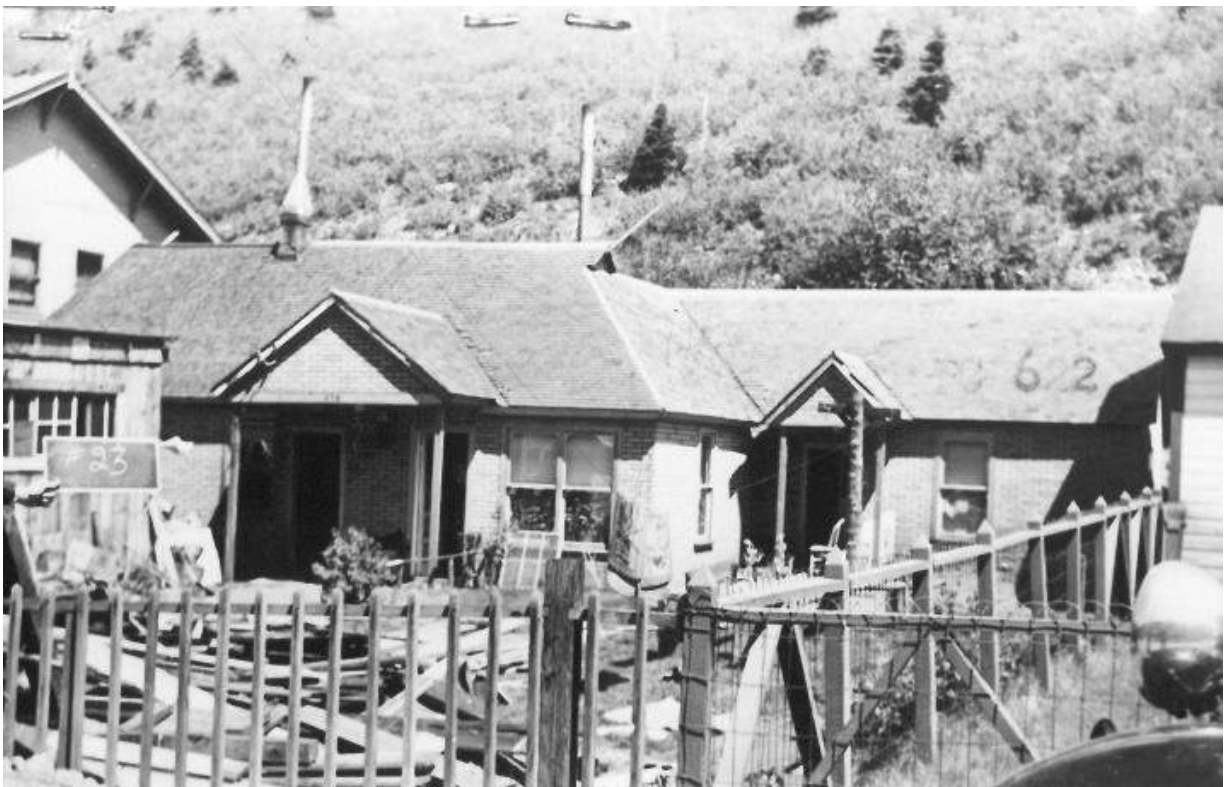
Figure 2: ca. 1941 Tax Photograph

The house is similar in appearance today as it was in c. 1941 tax photograph, although it has since been re-clad in wood siding to replace the Bricktex. Paired double-hung sash windows on the west façade have been replaced with one multi-pane metal window. A similar window type was inserted into an expanded opening in the south façade where there was a double-hung sash window in the tax photo. Many of the doors have been replaced, as well, but the house retains its Historic integrity to be designated as “Significant” on the HSI.

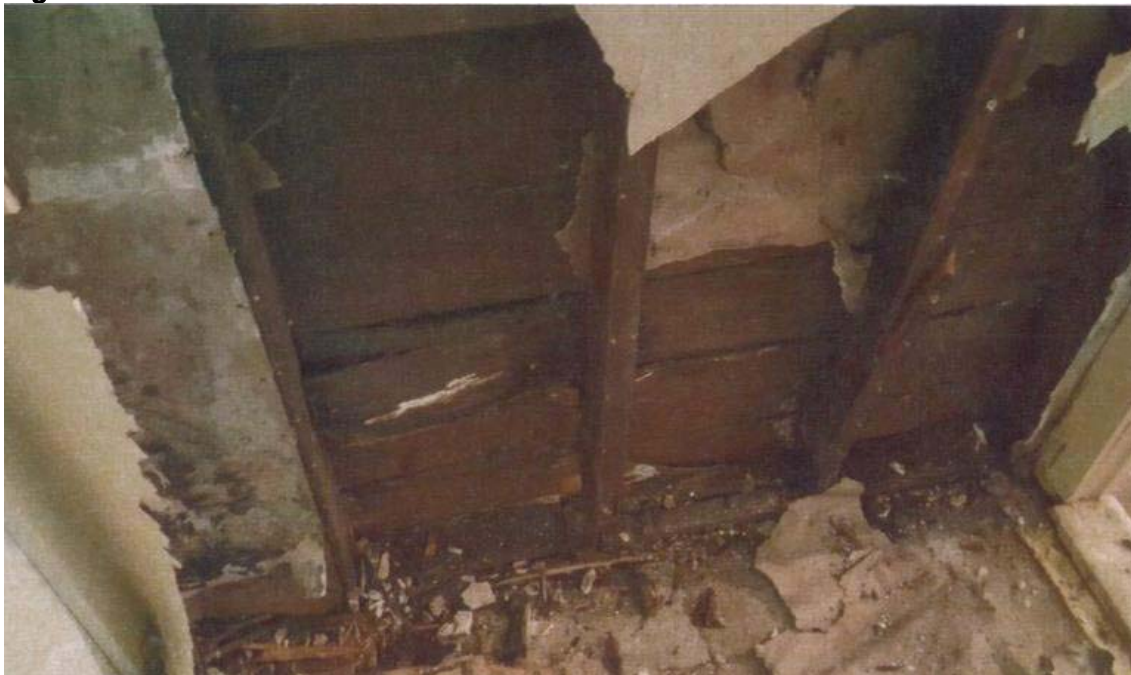
Figure 4: Detailed conditions of the interior of the Historic House.

Rotted wall in the bathroom.

- Due to the lack of foundation beneath the historic house, the floor structure has slumped and has considerably rotted. This has caused the walls to buckle and settle unevenly. It is no longer safe to enter the building due to its structural instability.
- The hillside has settled across the back of the historic house, accelerating the deterioration of the wood sided walls. Moisture has entered the structure through the deteriorated floor and rotted wood siding, causing black mold throughout the interior of the house, this can be clearly seen and creates an extreme health hazard.
- Asbestos has been discovered throughout the structure furthering the need to mitigate.

The Chief Building Official’s Determination Letter has been included as Exhibit I. Staff has included the photographs in Figure 3 that detail the conditions of the interior of the Historic House. These photographs were submitted by the applicant as a part of the Physical Conditions Report (Exhibit D) and supplemental submittals.

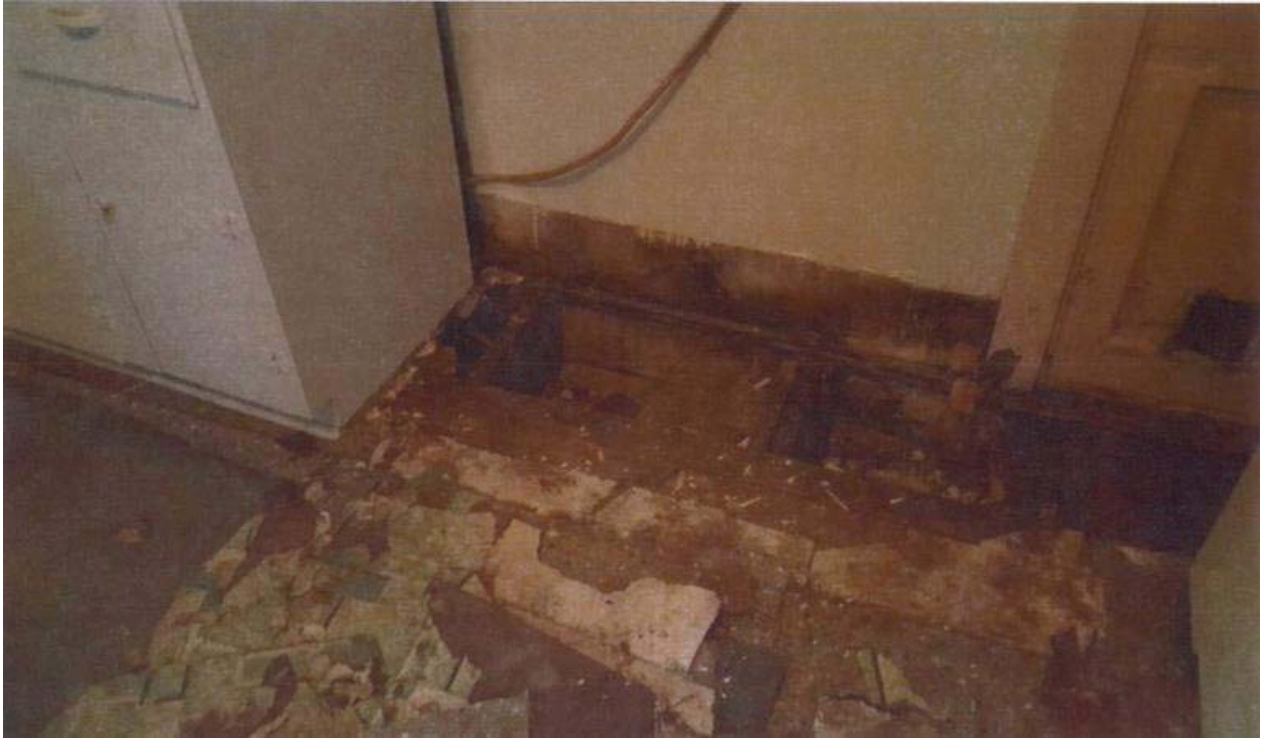
Rotted floor in kitchen against east (rear) wall.

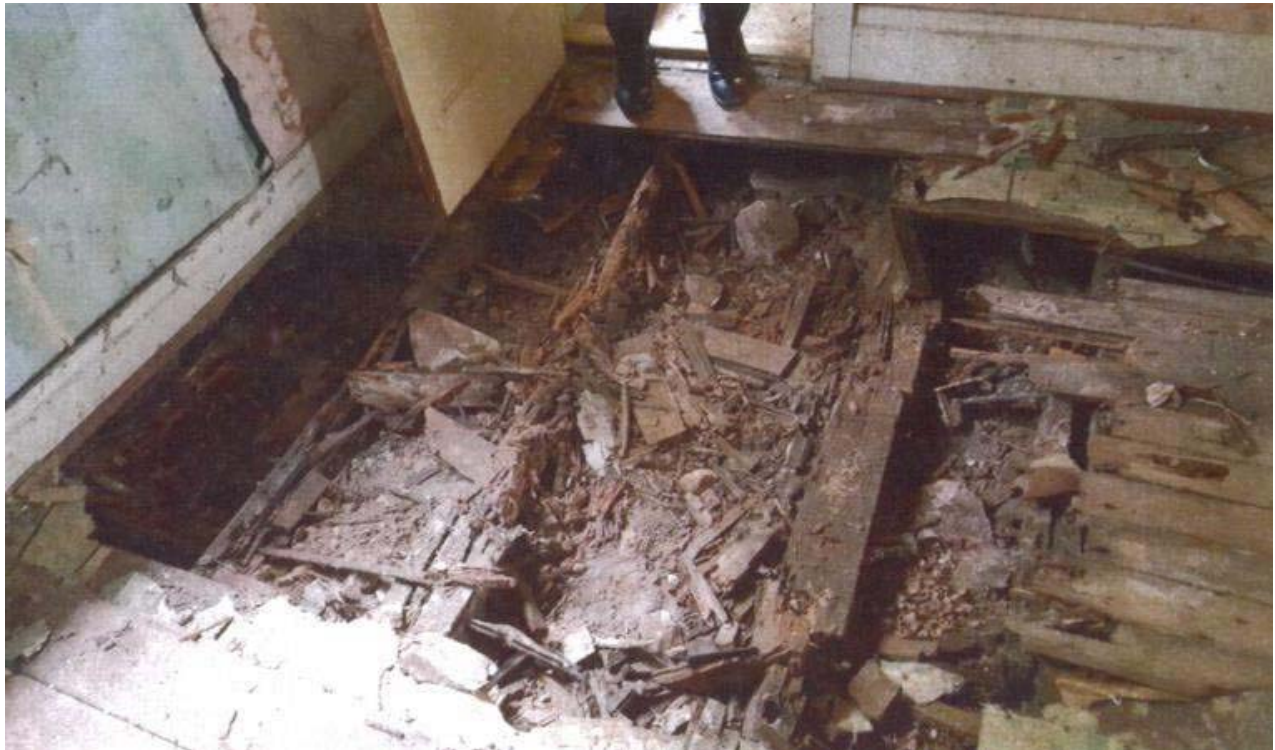
Rotted floor in north bedroom.

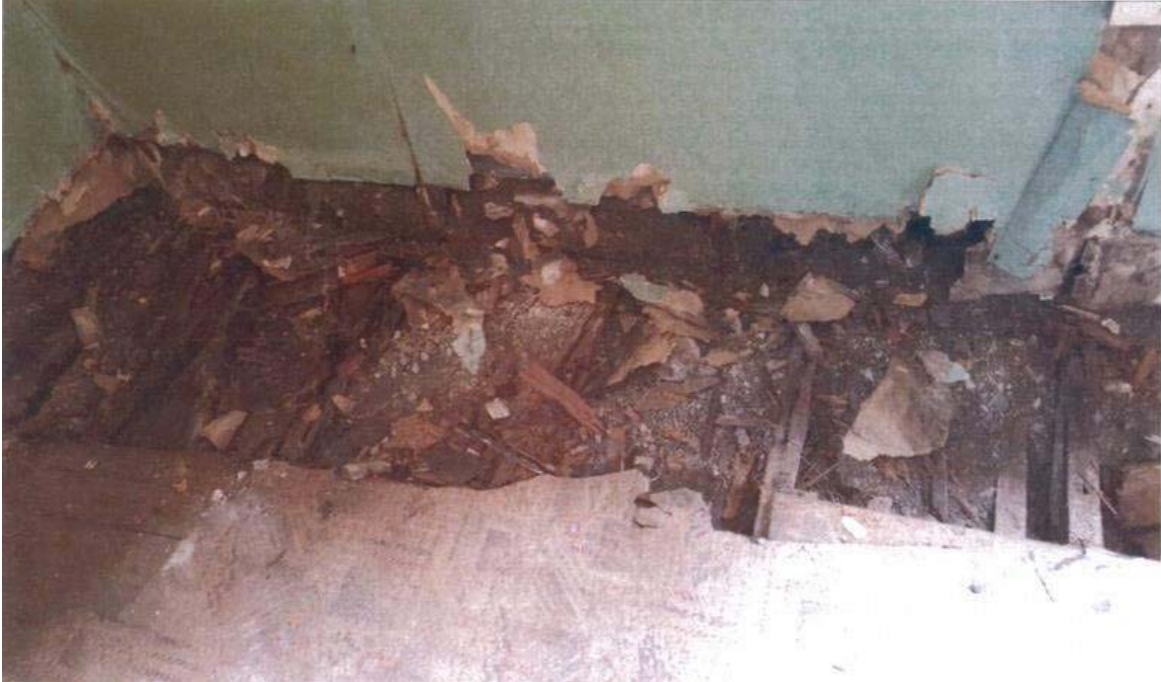
Rotted floor in the south bedroom against the west wall.

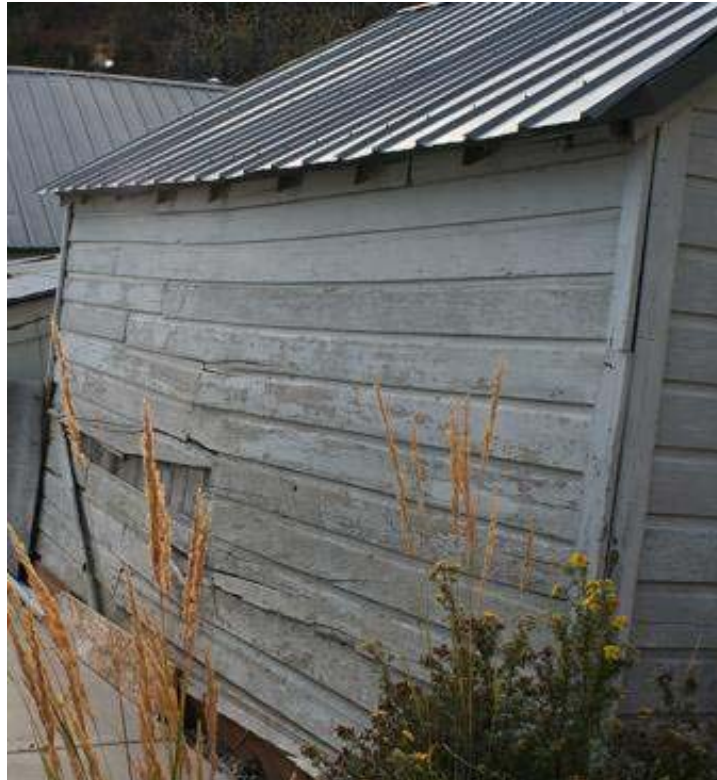
Figure 9: Detailed photograph of the non-historic siding that is to be removed from the Historic House.
