**PARK CITY MUNICIPAL CORPORATION
HISTORIC PRESERVATION BOARD
CITY COUNCIL CHAMBERS
April 18, 2018**

1011 Empire Avenue –Historic District Design Review – Material Deconstruction on Significant Site. The applicant is proposing to impact the following: stacked stone retaining walls, picket fence, and at-grade steps dating post-1981; demolition of additions on the west and south elevations built between 1941-1981, addition to the north elevation built c.1981, and basement expansion addition made in 1995; removal of portions of the c.1900 roof form; removal of portion of the west elevation; demolition of foundation dating from c.1900, c.1981, and c.1995; demolition of c.1995 deck; removal of non-historic and contemporary windows and doors; demolition of post-1960s garage.
Public Hearing & Possible Action

158 Main Street –Historic District Design Review – Material Deconstruction on Significant Site. The applicant is proposing to impact the following: non-historic sidewalk, non-historic concrete block retaining wall, c. 1997 driveway, contemporary stone retaining wall, non-historic wood-steel fence, contemporary wood patio, c.1948 concrete block foundation, portions of c.1997 concrete

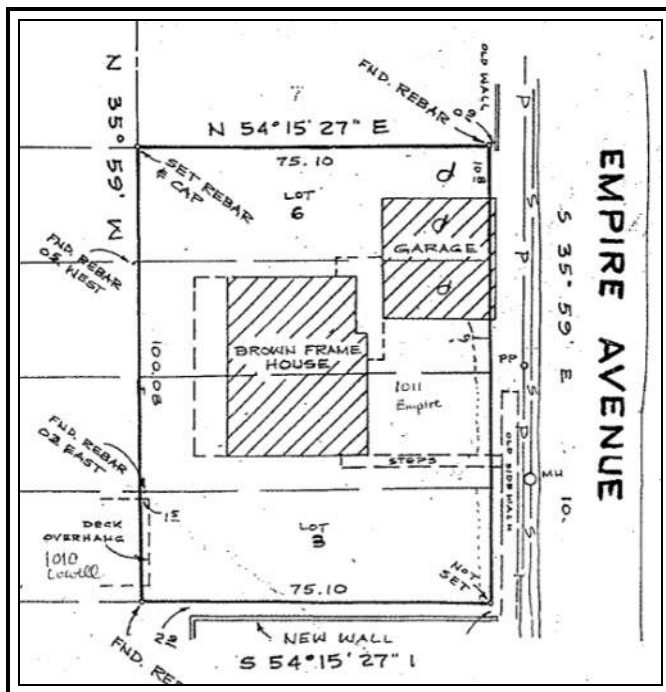
1991 Site Plan

A number of improvements occurred between the 1941 Sanborn Fire Insurance map and 1991. Sometime between the 1941 Sanborn and 1991, a two-car garage was constructed on the northeast corner of the property. By the November 1981 photo, the original lattice porch skirt had been replaced with new horizontal aluminum siding, the porch railings replaced, decorative shutters added to the exterior, and a lien-to addition constructed to the south side of the house. This lien-to addition appears by the time of the 1991 site plan, shown below; however, the north side addition is shown in the site plan.

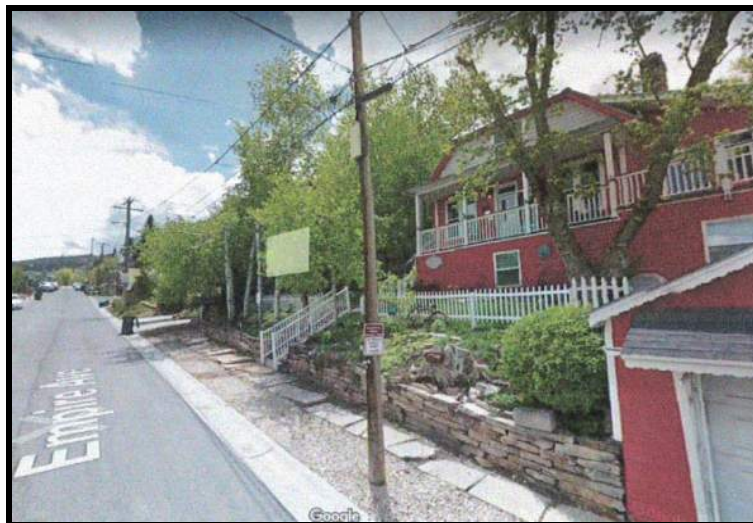
This photograph shows the existing stacked stone wall as it exists today. Note that the rubble wall of the c.1941 tax photograph has been replaced with a dry-stacked stone wall comprised of square and rectangular stones.

Staff is unsure when the existing stacked stone wall was constructed, but, based on its construction method, it may have been built when the non-historic garage was added to the northeast corner of the site. The retaining wall extends across the front of the historic lot as well as the lot to the south. The 1941 tax photograph shows a rubble wall constructed of rounded, rubble stones; the wall that exists today is more of a dry-stacked wall with square and rectangular stones. Staff believes the existing stone wall is not historic as it was constructed between 1941 and 1995. The applicant intends to preserve the existing wall, where feasible; a portion will be removed to accommodate a new driveway.

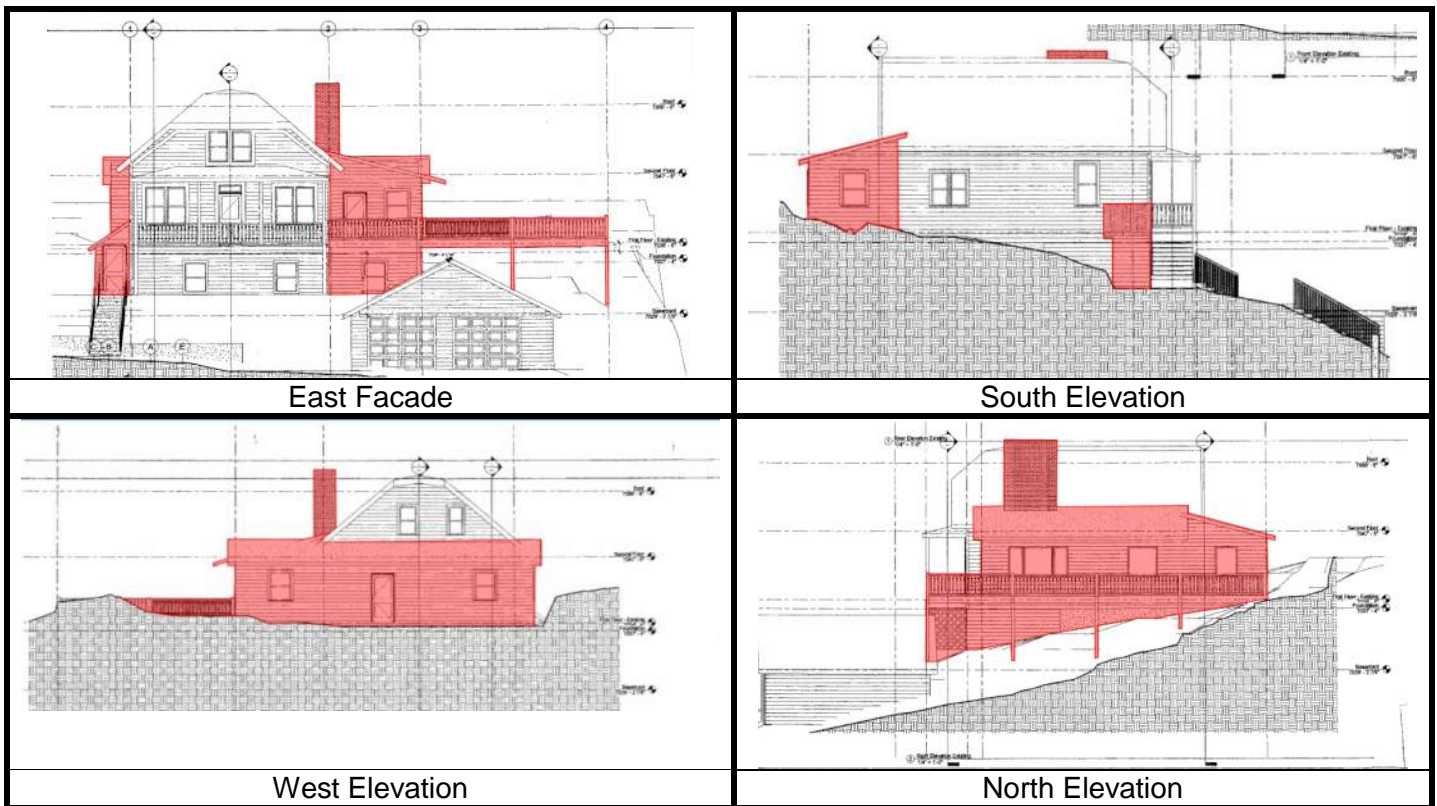
These additions are highlighted in red below.

The applicant is proposing to remove these later additions to restore the original rectangular form and appearance of the clipped-roof bungalow that was constructed c.1900. The material deconstruction is required for this restoration; however, these additions have also been found to be non-contributing to the historic integrity and historical significance of the structure.

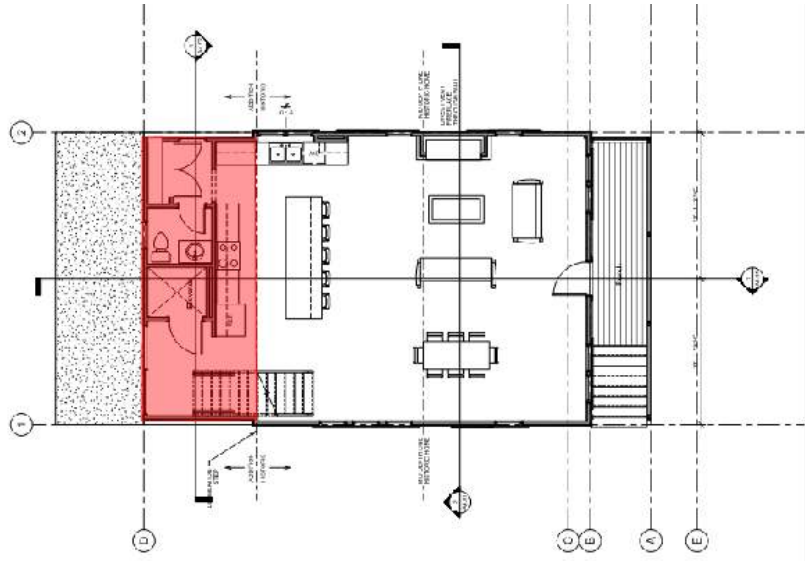
The applicant is also proposing to construct a small, two-story addition to the back of the house on the west side. The addition will replace an existing one-story addition that extends across the entire elevation of the west façade. The proposed addition will be built up to the Rear Yard Setback line and be subordinate to the historic house in height and width. Staff continues to work with the applicants to ensure that it does not appear as an in-line addition by differentiating it through changes in the siding materials. The addition will impact about 26 linear feet of the historic wall plane on the west side and has been highlighted in red below.

Staff finds that the proposed work on the exterior walls is routine maintenance and does not require Historic Preservation Board Review (HBPR). The proposed impacts of the addition to the west elevation mitigates any impacts that will occur to the historical significance of the building as the addition is to the back of the building and will not be largely visible from the primary right-of-way.

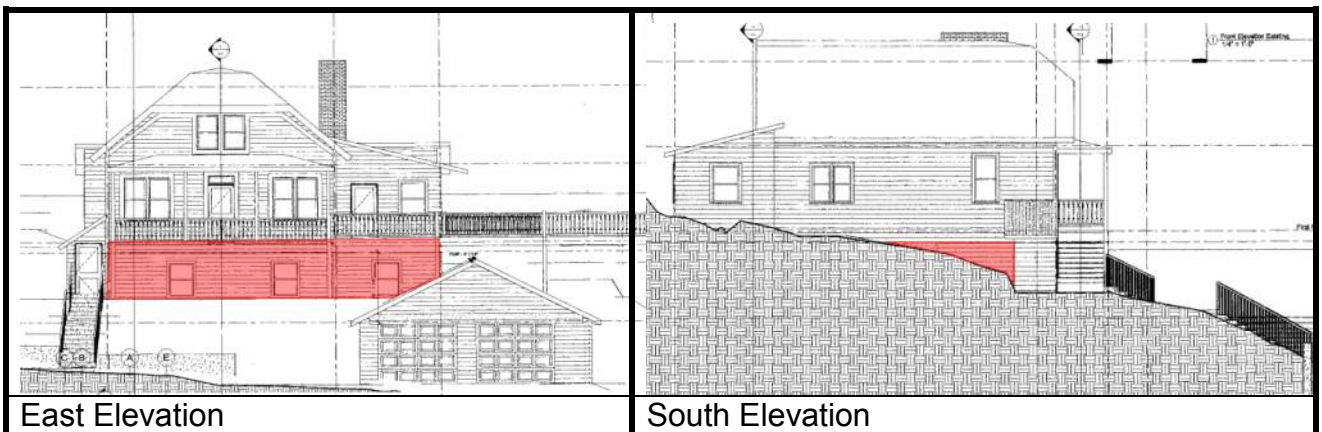
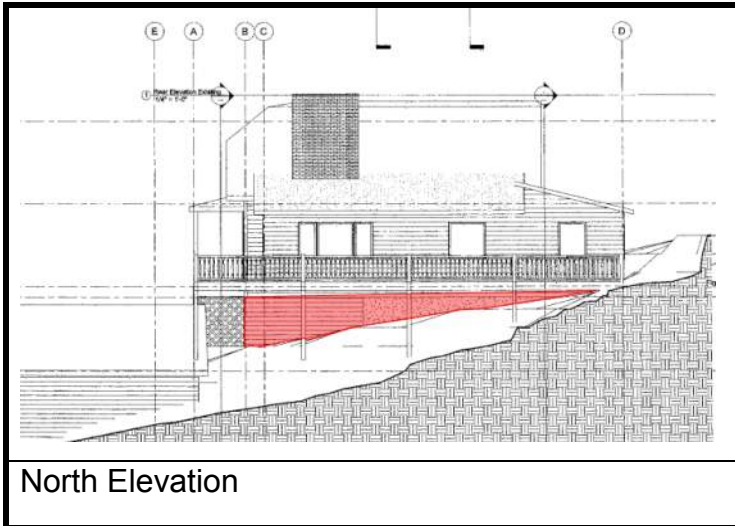
The applicant is proposing to demolish the existing foundation and pour a new foundation as part of this renovation. Below grade, the new basement will extend to create a garage entrance two stories beneath the house. The garage entrance will be constructed into the hillside and be visually separated from the historic house. It will have a green roof to help preserve the hillside associated with the house.

Staff finds that the proposed exterior changes will not damage or destroy the exterior architectural features of the subject property which are compatible with the character of the historic site and are not included in the proposed scope of work.

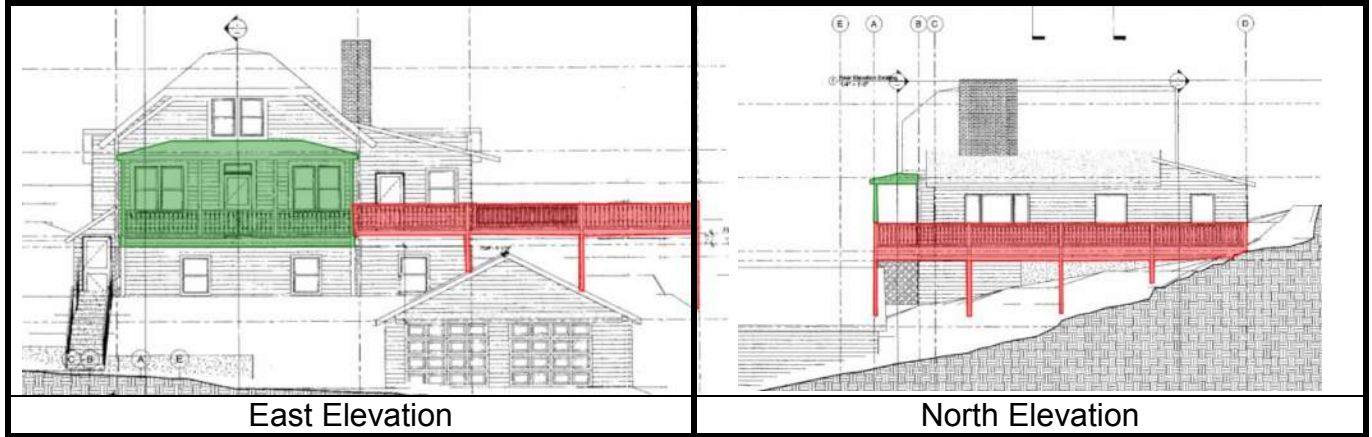
The porch was extended into a deck that wraps around the north side addition. The decking material is poured concrete and the railing is constructed of wood. This addition was likely built between 1995 and 2007 based on photographs; no building permit files exist for the deck expansion. The applicant is proposing to remove this non-historic addition including the wrap-around deck as part of the restoration of the historic house.

Staff finds that the proposed material deconstruction on the historic front porch is required for the restoration of the building. The deck wrapping around the north addition has been found to be non-contributory to the historic integrity or historical significance of the structure and site.

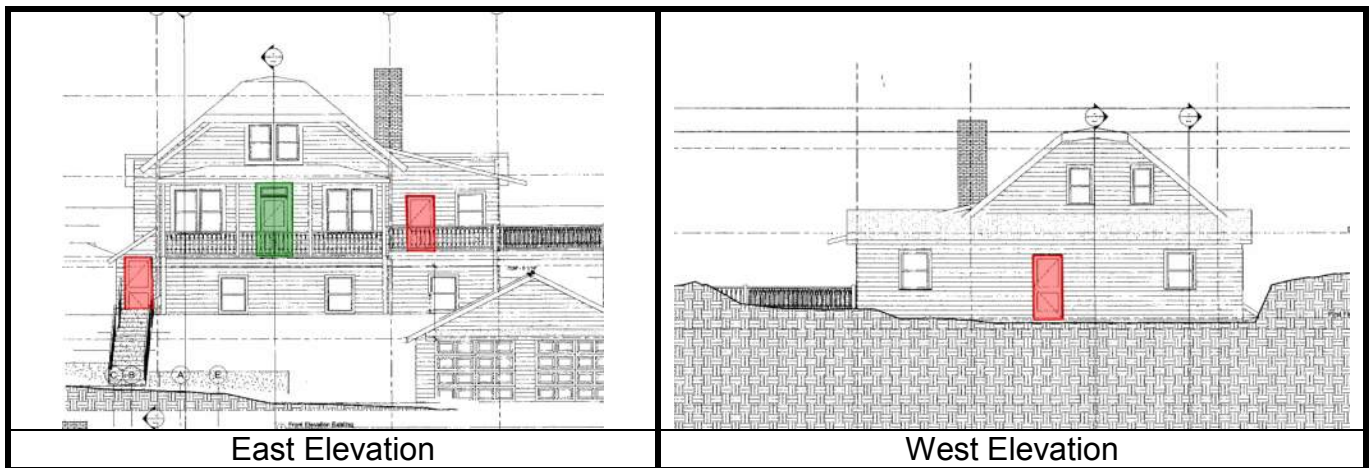
There are no historic doors on this building. The historic front door opening with transom window is original; however, the door has since been replaced. The applicant is proposing to remove the front door temporarily in order to repair it and repaint it; this door is highlighted in green below. The other doors on the building are located on non-historic additions and are proposed to be removed; these doors are highlighted in red below.

Staff finds that the proposed work on the front door (highlighted in green) is routine maintenance and does not require HPB review. The other doors are located on non-historic additions; these additions have been found to be non-contributing to the historic integrity of the house.

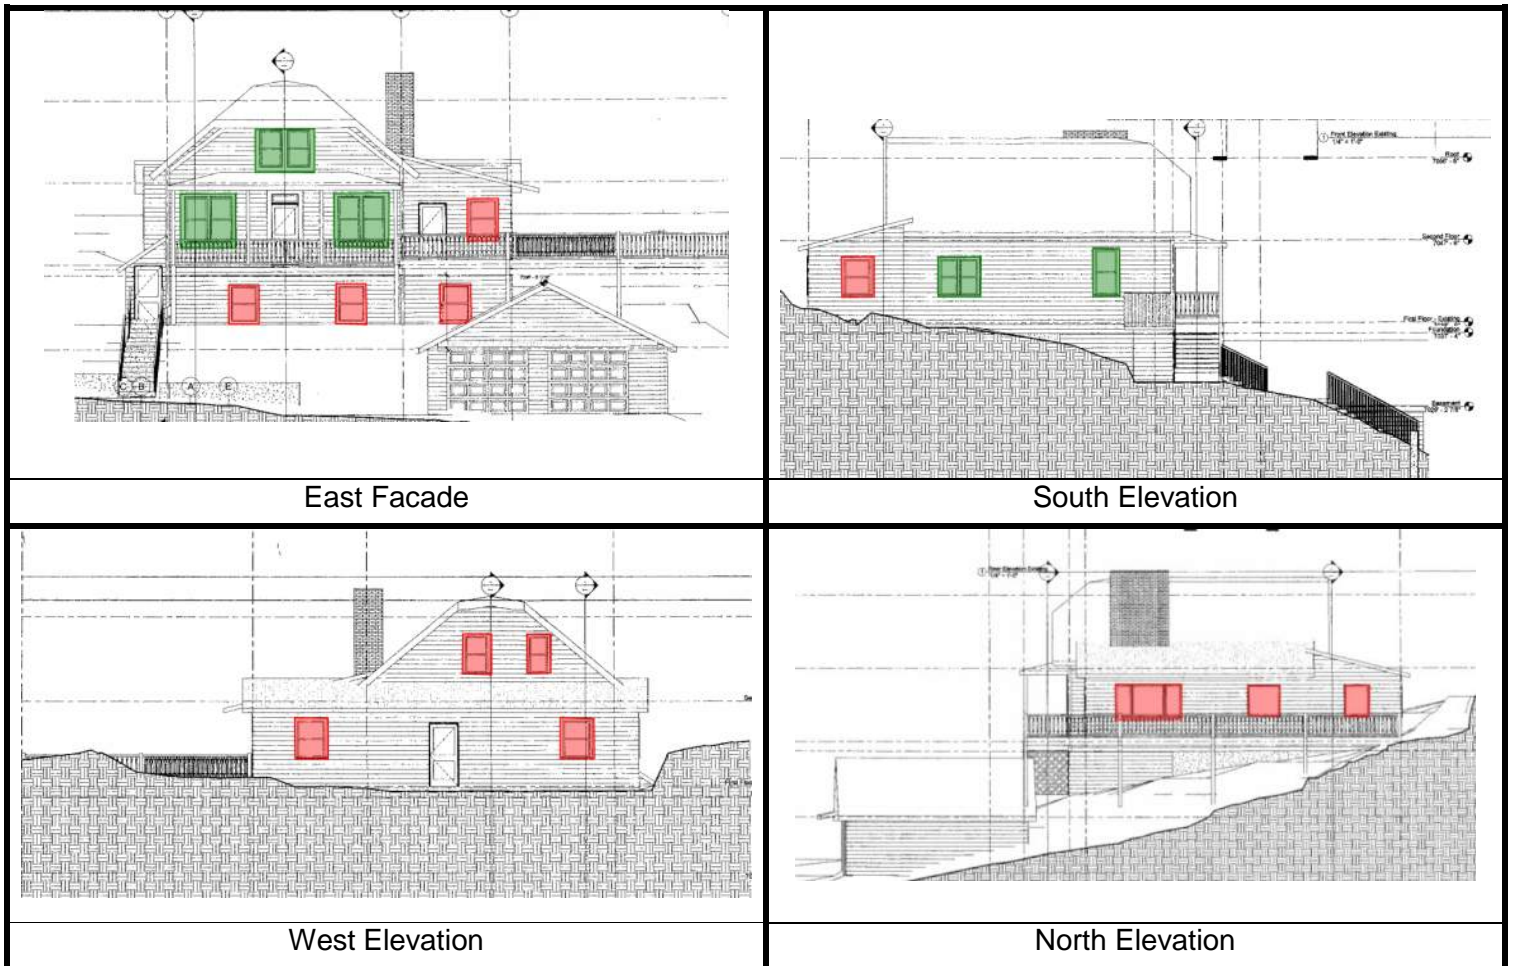
The other existing windows on this house are located on non-historic additions that are proposed to be removed. Staff has highlighted in these windows in red.

Staff finds that the proposed work on the existing wood windows of the historic house is routine maintenance and does not require HPB review. The removal of the basement-level windows on the east façade is required for the restoration of the historic house. The proposed scope of work to remove the windows on the second level of the west elevation to accommodate the new addition mitigates any impacts that will occur to the historical significance of the building. The remaining windows are located on additions that have been found to be non-contributing to the historic integrity or historical significance of the structure.

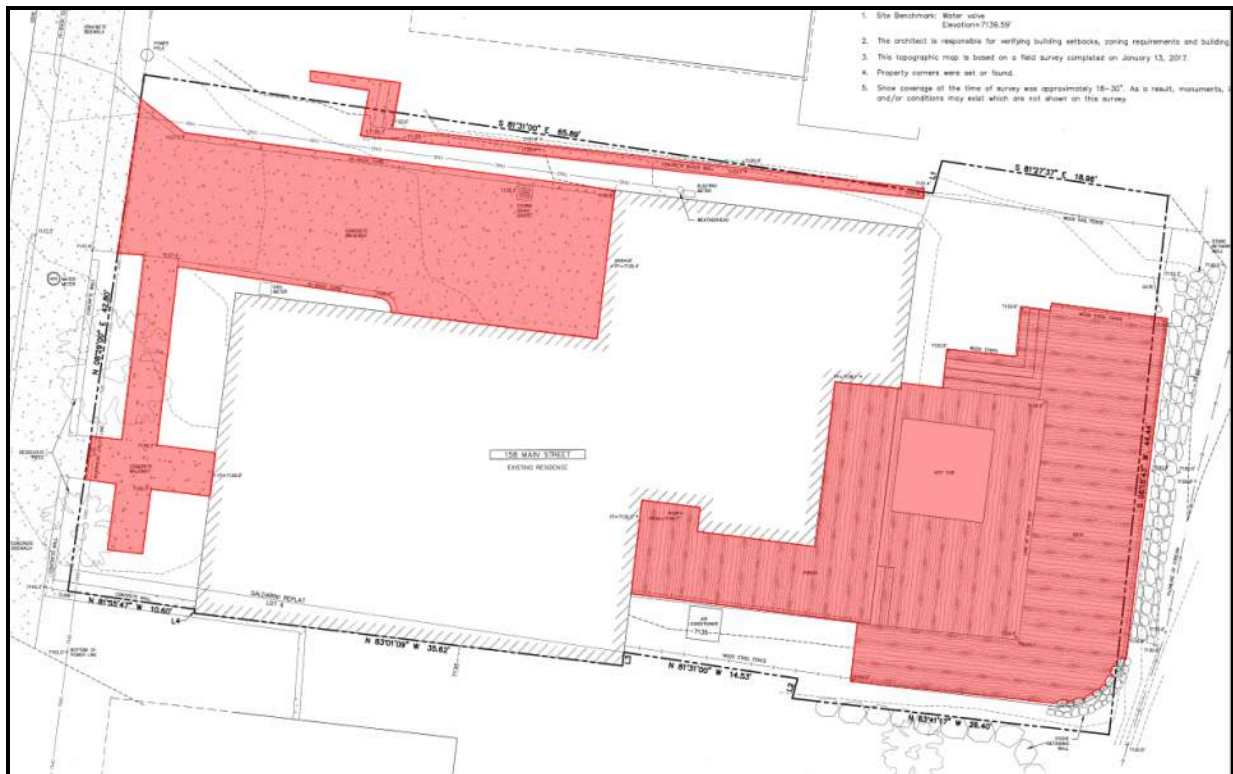
The applicant is proposing to remove or alter the images highlighted in red below:

The applicant is proposing to re-grade the front yard to solve the drainage problems. The driveway will be replaced with a new, steeper driveway in the same location. The sidewalk to the front entry will be rebuilt. On the north side of the property, the applicant will remove the concrete wall that encroaches into the neighbor's property. In the rear yard, the non-historic wood deck, retaining wall, and wood-steel fence will be removed.

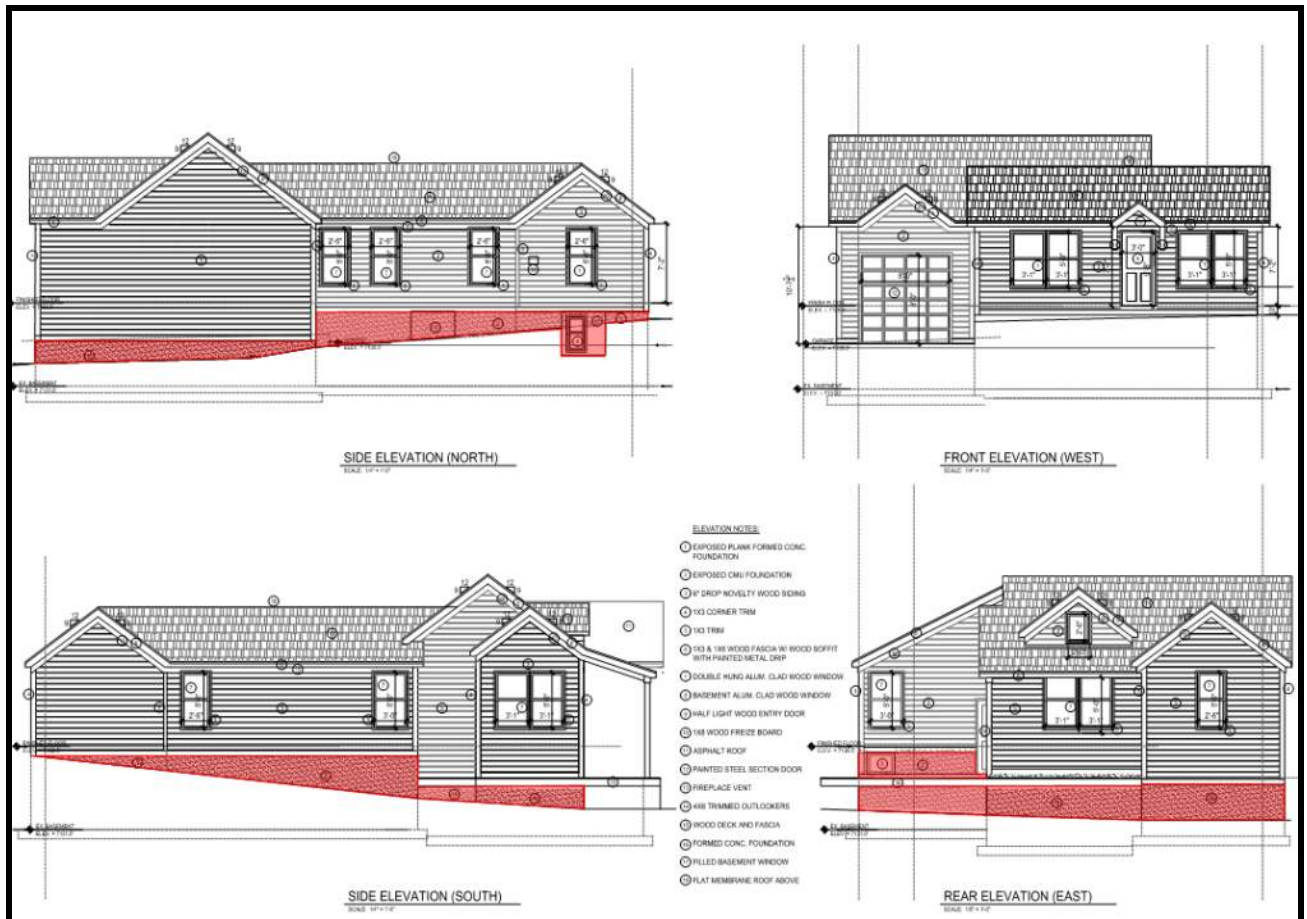
The foundation was largely repaired and replaced during the 1997 remodel, and it does not appear that the house changed elevation with the new basement. At that time, a new basement was constructed. The foundation has 8 to 10 foot ceilings. The tall foundation was filled beneath the garage floor.

The applicant is proposing to raise the house 2 feet in order to mitigate drainage issues. Areas of the foundation are already in need of replacement and repair, and the applicant proposes to address this as part of their foundation work. In order to access the area beneath the garage floor, the applicant is proposing to dig out the fill and use this space as a new basement-level garage. (This will convert the existing garage level to living space.) Foundation level windows already exist close to the

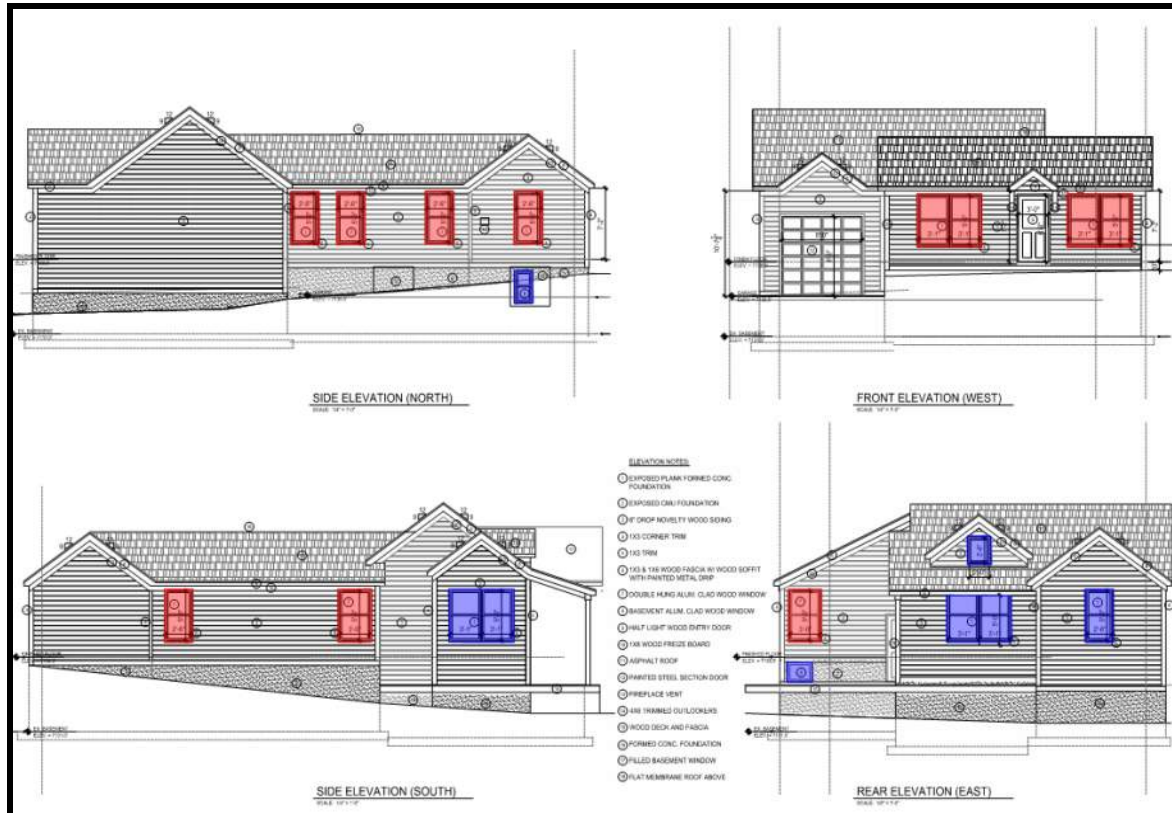
Staff has highlighted the windows on the historic portions of the house in red and those on the newer additions in blue:

The applicant is proposing to restore the original window openings on the façade and replace these windows with new casement windows. This will allow the applicant to install screens on the interior of the windows so they no longer detract from the exterior appearance of the historic windows. Staff has added the following Condition of Approval to ensure that the new windows appear like a double hung window:
