**PARK CITY MUNICIPAL CORPORATION  
HISTORIC PRESERVATION BOARD  
CITY COUNCIL CHAMBERS  
May 16, 2018**

115 Sampson Avenue – HDDR Material Deconstruction and Reconstruction – The applicant is proposing to reconstruct the historic house designated as “Significant” on the City’s Historic Sites Inventory. In addition the applicant will be removing existing non-historic parking pad along with its associated wood staircases and railroad tie retaining wall; non-historic stacked stone retaining walls and 1990s wood slat fences; post-1947 addition on the west elevation and an underground root cellar; rebuilding the historic pyramid roof and dormers; reconstructing the existing masonry chimney; raising the house 2 feet to pour a new foundation; reconstructing the historic ca.1900 wraparound porch on the east and south elevations; replacing two non-historic doors; and removing non-historic aluminum windows and restoring 11 window openings.

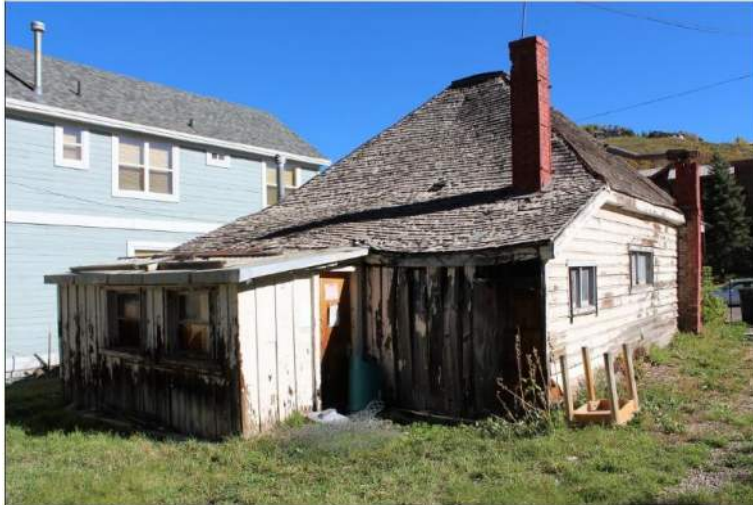
The first addition (highlighted in red) included an original kitchen with metal cabinets, likely dating post-World War II when steel was more readily available. Portions of this addition were clad in new wood siding, likely from c.1995. The back wall (west elevation) of the kitchen had vertical wood plank siding, open to the elements. This led staff to believe that this addition was originally the back porch depicted in the Sanborn Fire Insurance maps, and it had perhaps been altered to create a shed or covered storage area to the house. It was in such deteriorated condition, that its actual age was difficult to assess; however, the consultant believed parts of it may have been original to the house.

The second addition (highlighted in blue below) may have originally been built as a secondary storage area, but was later finished with carpet and cabinets. The storage area had a crawlspace beneath it. On the exterior, it was constructed of wood board and batten siding. Based on the materials and construction method of this addition, the consultant believed it may have dated from the 1950s.

*This photograph shows the condition of the two additions in 2014. The additions had begun to pull away from the original pyramid-shaped roof and had significantly deteriorated due to inadequate foundations.*

These later additions were lien-to additions that had been haphazardly added to the west elevation of the historic house. Overtime, they had been significantly altered to create useable living space. Staff found that these later additions do not contribute to the historic integrity or historical significance of the structure or site and do not need to be reconstructed.

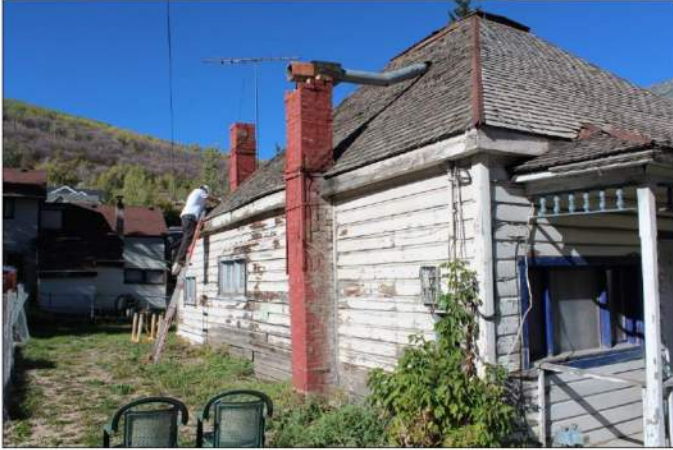
***South Elevation***

In 2013, the chimney had started to pull away from the original roof form. The mortar had deteriorated and later repairs had compromised the stability of the chimney. It was difficult to determine if these chimneys had even been original to the historic structure as historically, most pyramid-roof cottages had a central chimney through the top of the roof; they did not have a chimney configuration like this where the chimney had been added to a side elevation. For that reason, staff concluded that the chimney was likely added after the original date of construction.

At the time of the documentation in 2013, this house had two chimneys. The first chimney was attached to the south side of the historic four-room house and the second chimney was on the west (rear) side of the historic house and had been enclosed by the first addition. These chimneys were in disrepair and did not appear to be original to the pyramid-roof cottage.

Staff does not believe these chimneys were original to the pyramid-roof cottage as they were constructed on exterior walls. Staff finds that these chimneys do not need to be reconstructed as they do not contribute to the historic integrity or historical significance of the structure or site.

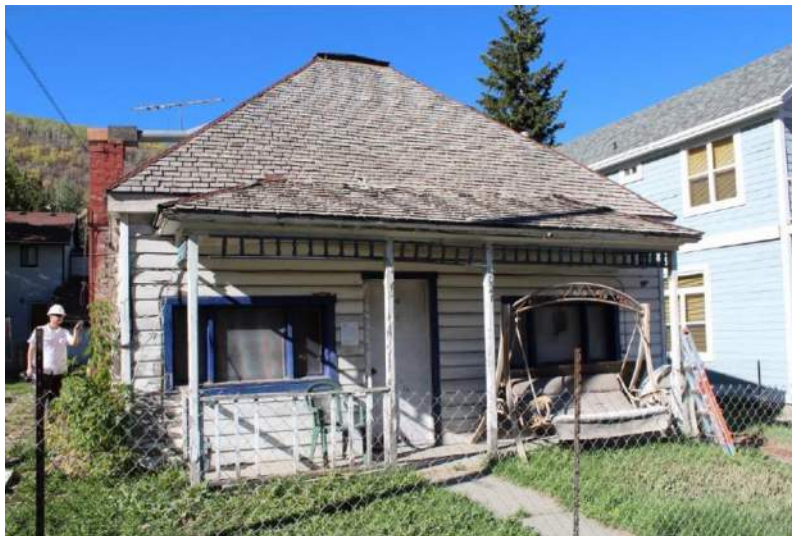
*Porch as it existed in 2014*

It was typical of pyramid-roof cottages in Park City to have a full-width hip roof front porch. According to previous surveys, the porch on this house was added between 1941 and 1949. The 1978 site form discusses how the overall form of the building, with the porch, contributes to the Park City vernacular architectural style.

Staff finds that the porch added between 1941 and 1949 was constructed in the traditional Park City style. While it may not have been original to the historic structure, it does contribute to its overall form and architectural style. The applicant

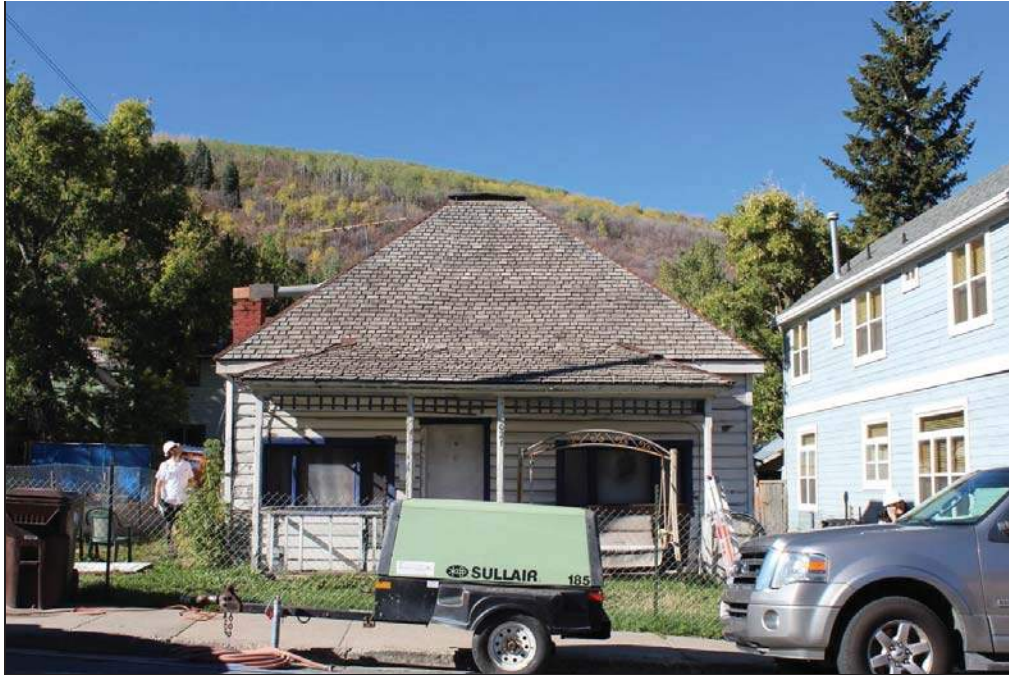
**A.1. TOPOGRAPHY:** General view of site, facing west.

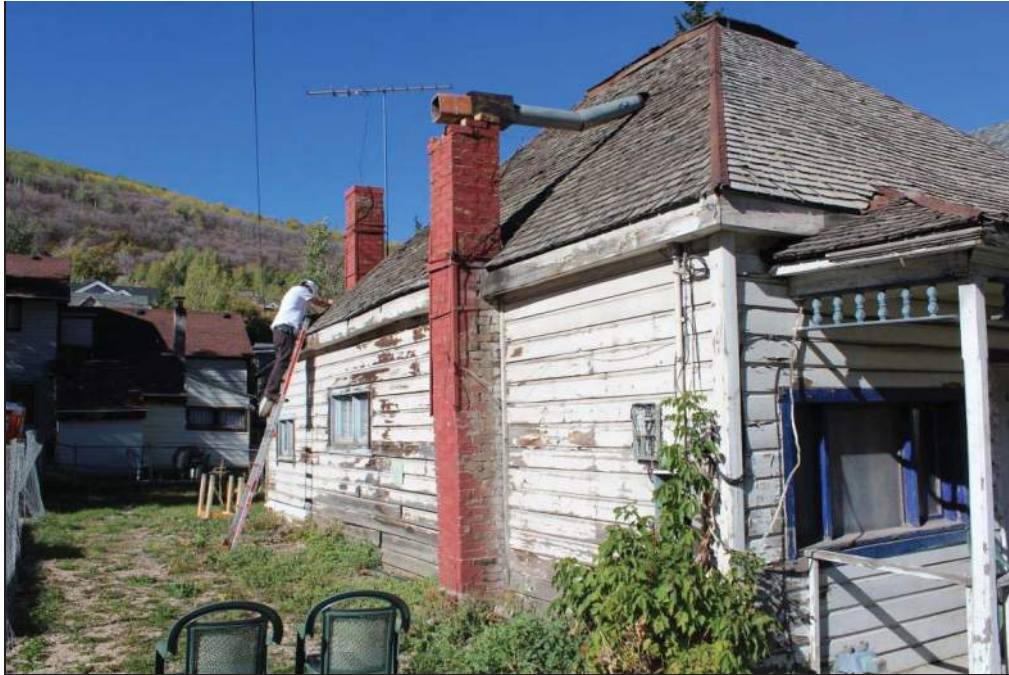
**A.2. LANDSCAPING:** Gravel parking area on south side, facing northwest.

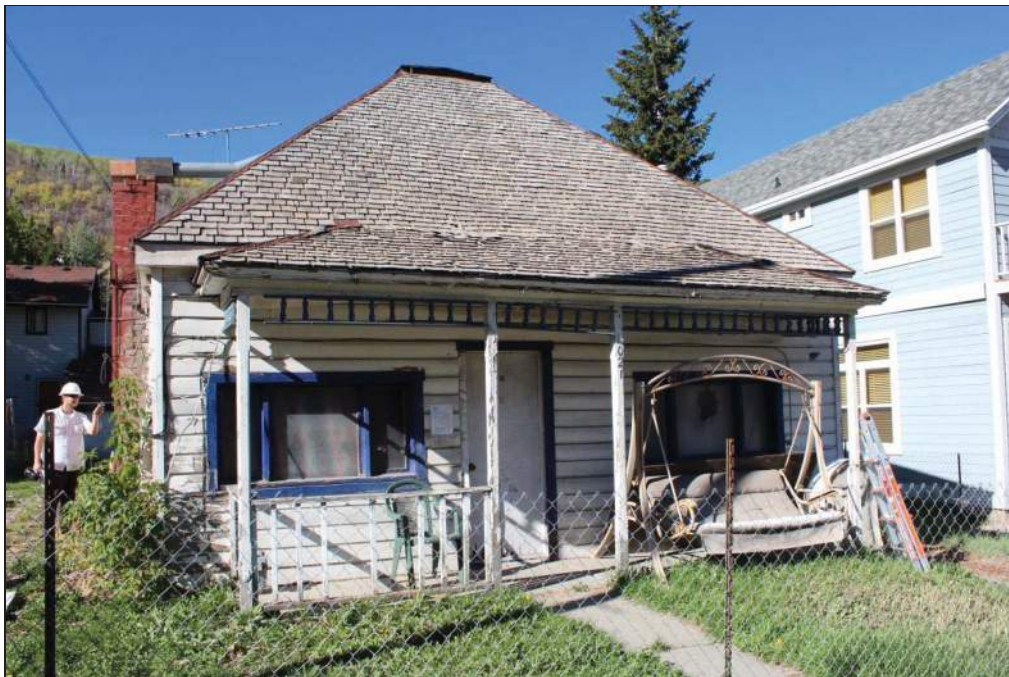
**A.4. FENCES:** Temporary chain link fence in foreground, facing west.

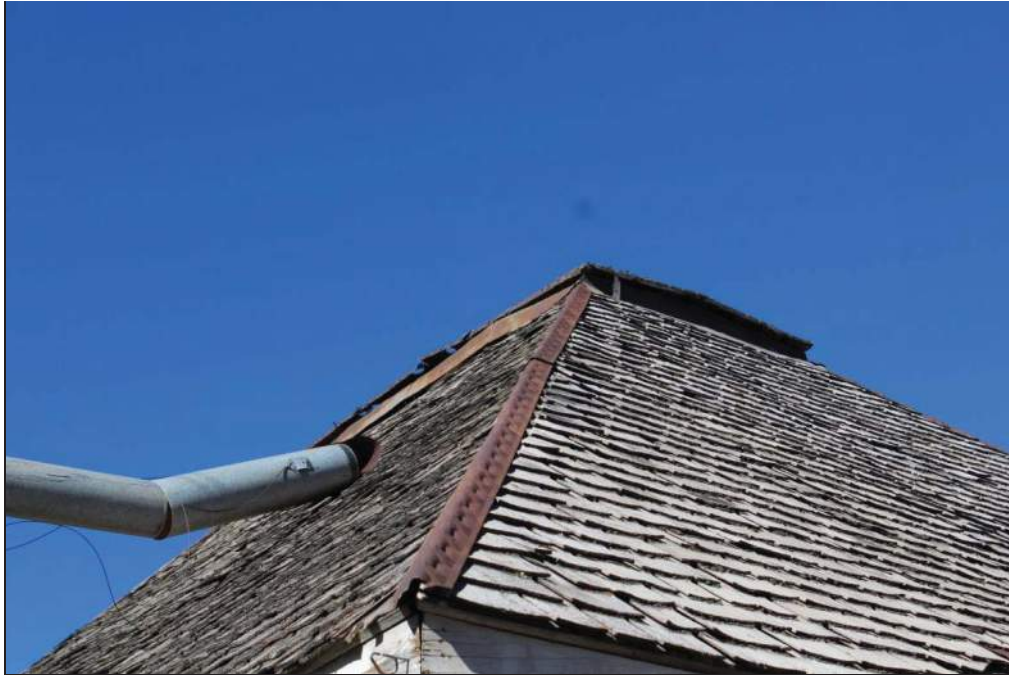
**B.1. ROOF:** East and south sides relatively planar, older wood shingles, metal ridges and cap.

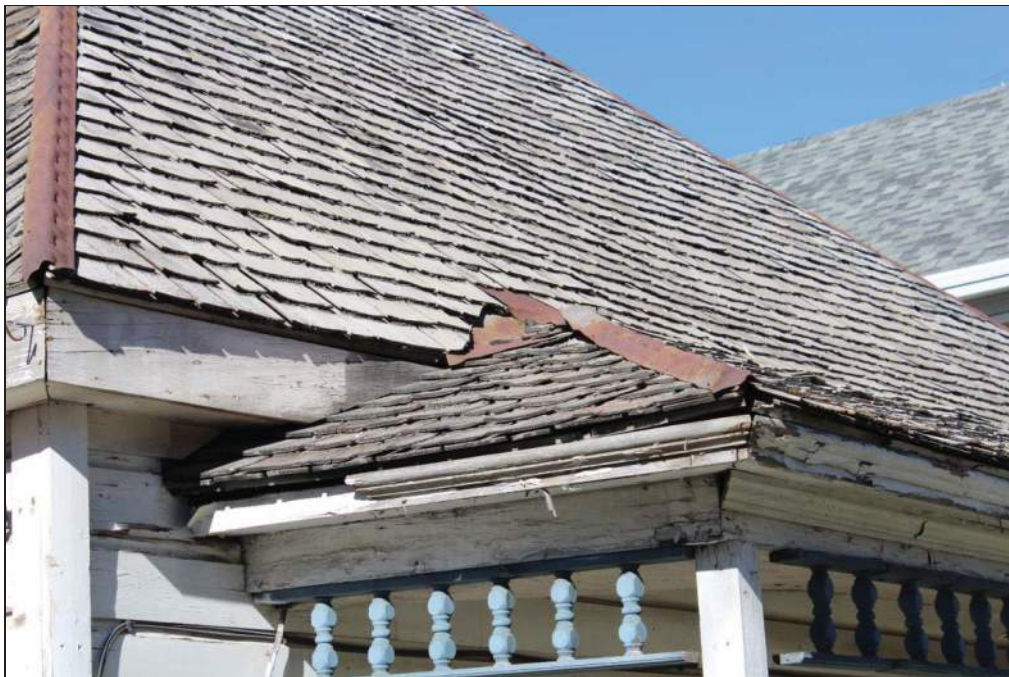
**B.1. ROOF:** East side and porch, showing similar materials and age of porch roof and cornice.

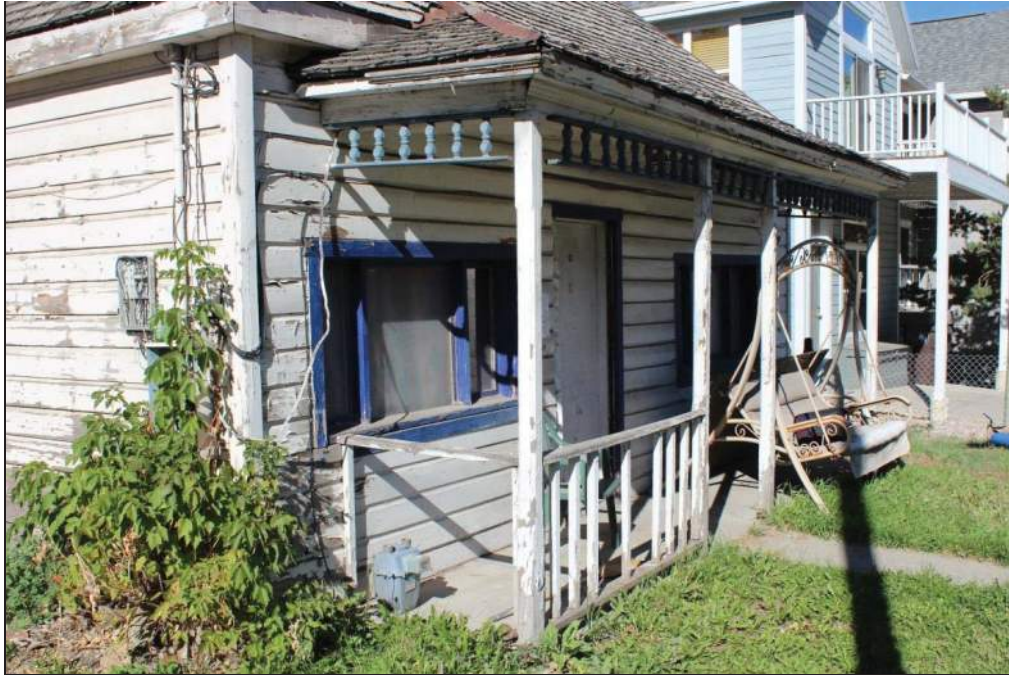
### B.2. EXTERIOR WALL – PRIMARY FAÇADE: Facing northwest.

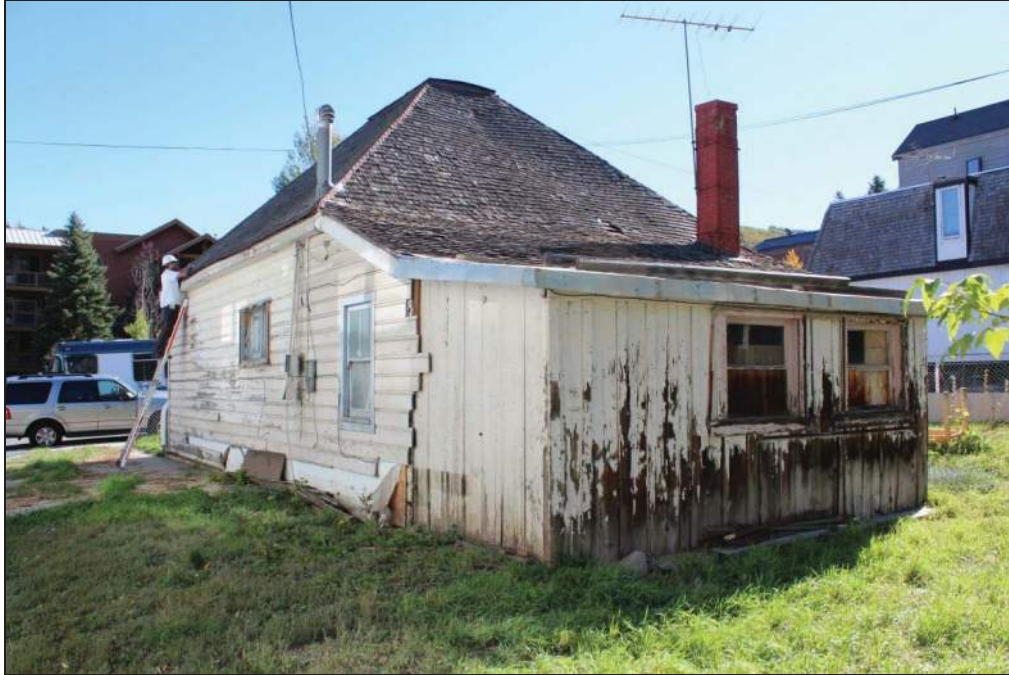
### B.3. EXTERIOR WALL – SECONDARY FAÇADE 1: North wall, facing southeast.

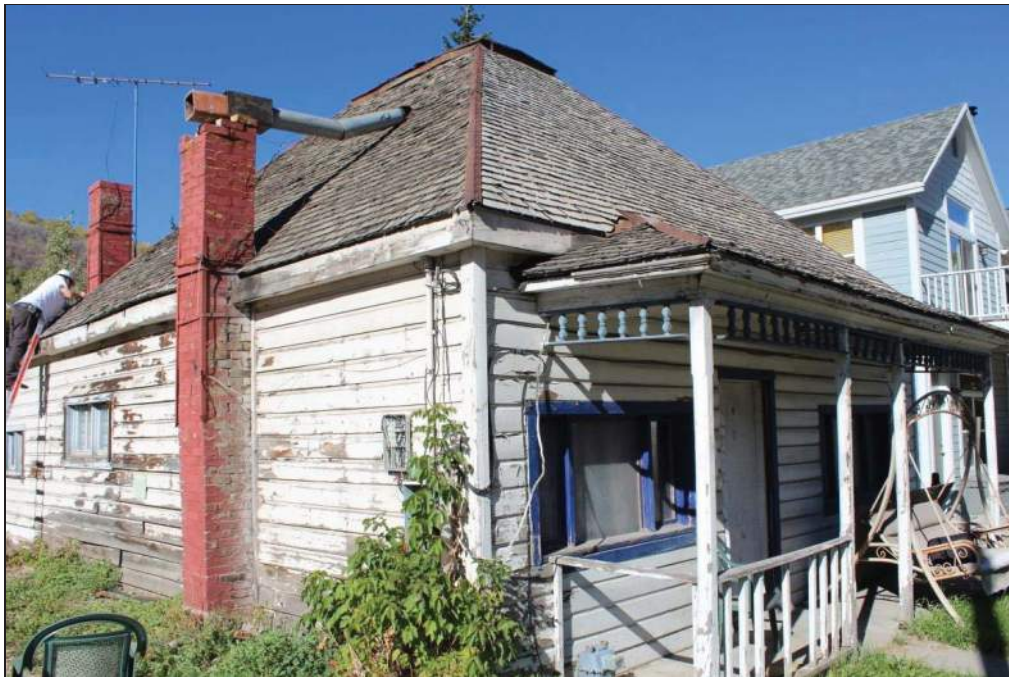
**B.4. EXTERIOR WALL – SECONDARY FAÇADE 2:** South wall, facing northwest.

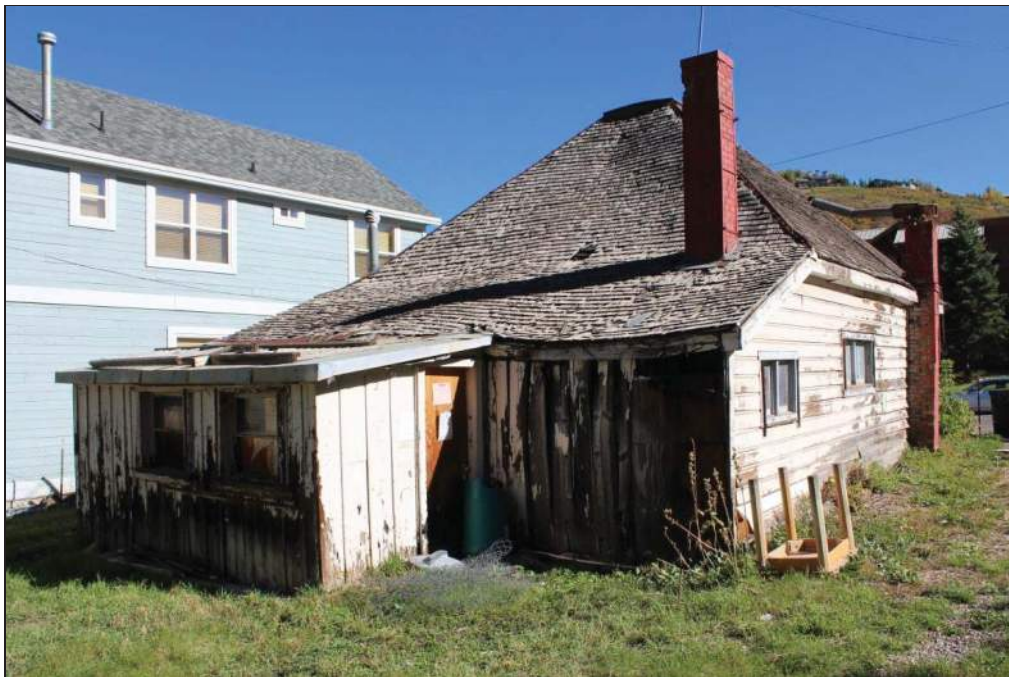
**B.5. EXTERIOR WALL – REAR FAÇADE:** West side, facing northeast. Rear wall formed by west walls of Addition 2 (at left) and Addition 1 (at right).

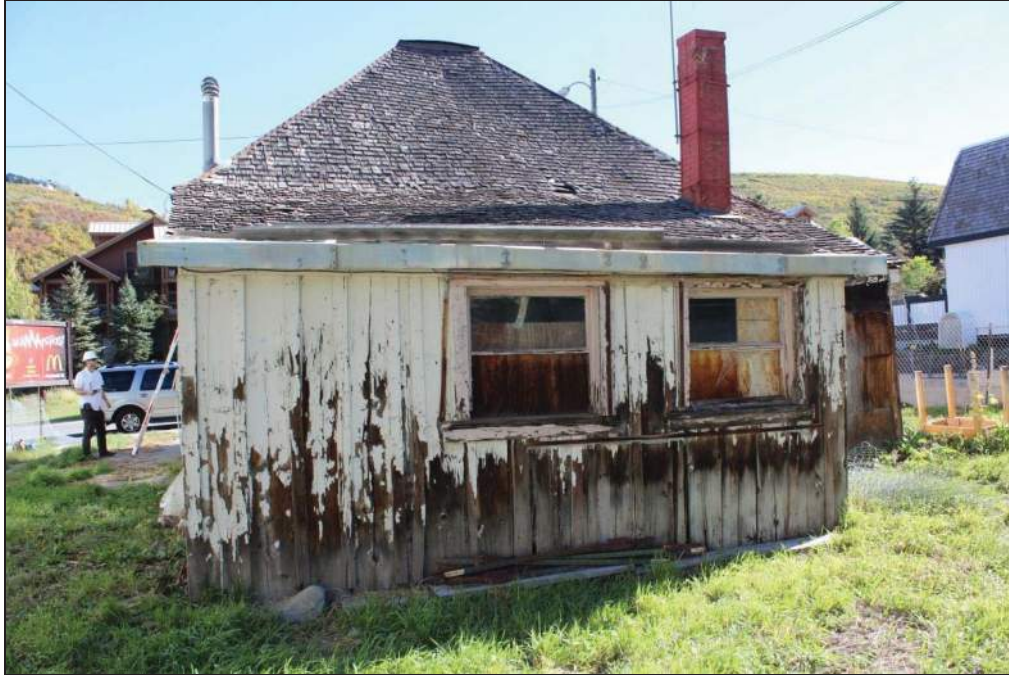
**B.4. EXTERIOR WALL – REAR FAÇADE:** West side, detail of Addition 2, facing east.

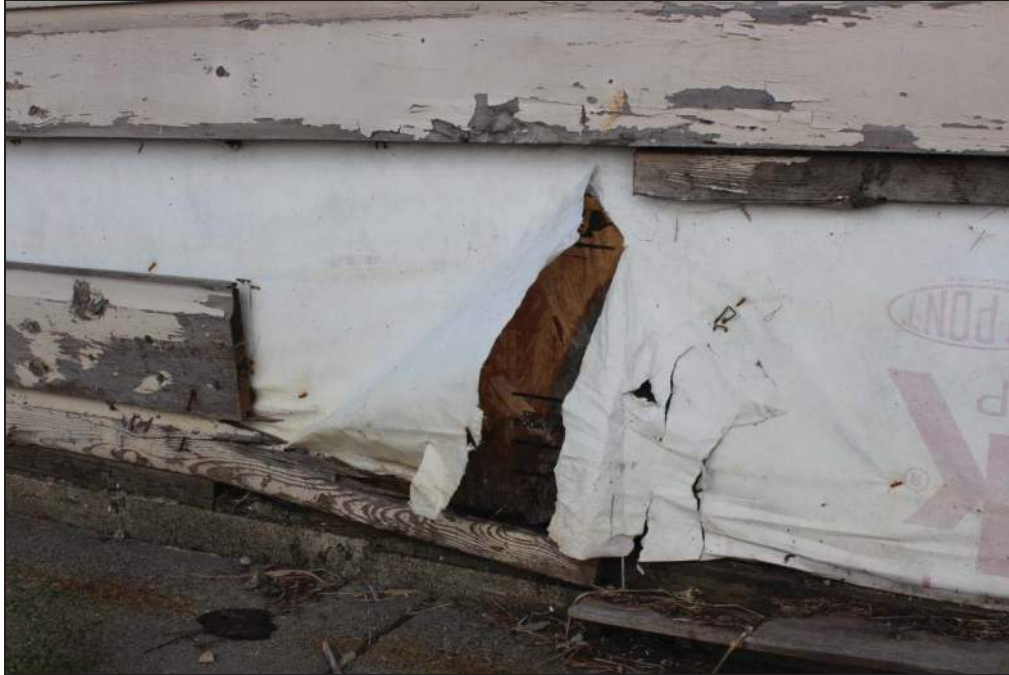
SWCA's Physical Conditions Report in 2014 found that the majority of the house and later additions had been constructed without a foundation. A concrete foundation and intermittent piers had been added where possible c.1995; however, the foundation was not continuous. Where the new foundation was not present, the sill plate and lower ends of the original siding and wall materials sat directly on the dirt. The foundation and lower levels of the wall had rotted out and were deteriorated beyond repair in 2013.

**B.6. FOUNDATION:** Base of north wall, facing south, low concrete foundation visible.

The applicant is proposing to construct a new basement foundation. The historic house will be lifted two feet (2') to construct this foundation; however, the site will be re-graded so the house does not appear to sit taller than it did historically. The remnants of the c.1995 concrete foundation work do not contribute to the historic integrity or historical significance of the structure and can be removed.

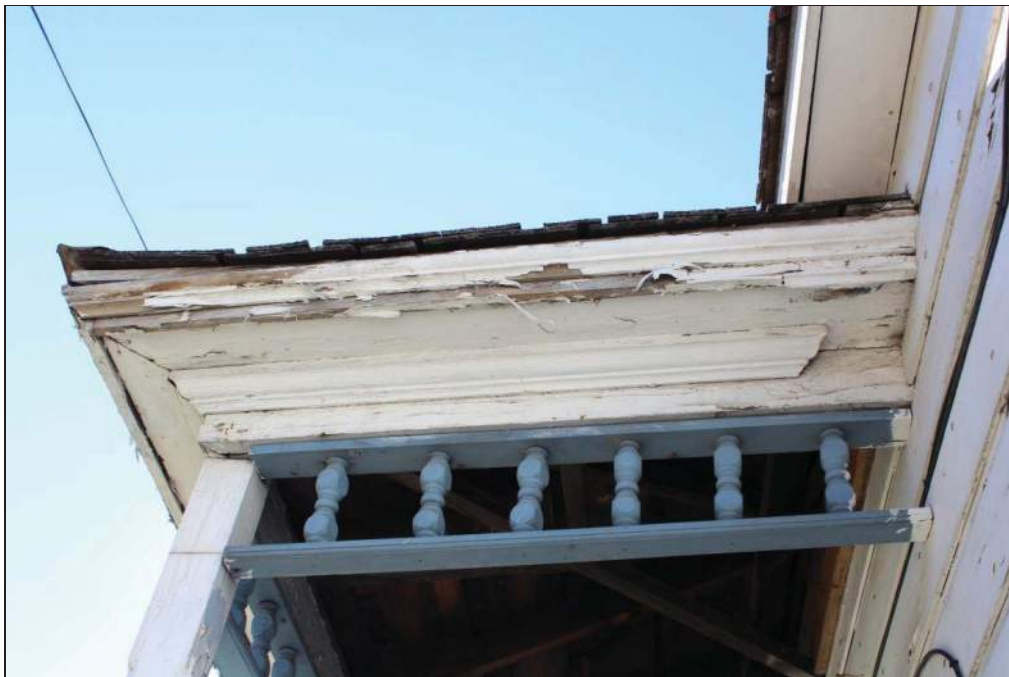
**B.7. PORCH:** See photos A.4., B.1., B.2., and B.4. Detail of older eave/cornice and newer spindles, north side of porch roof.

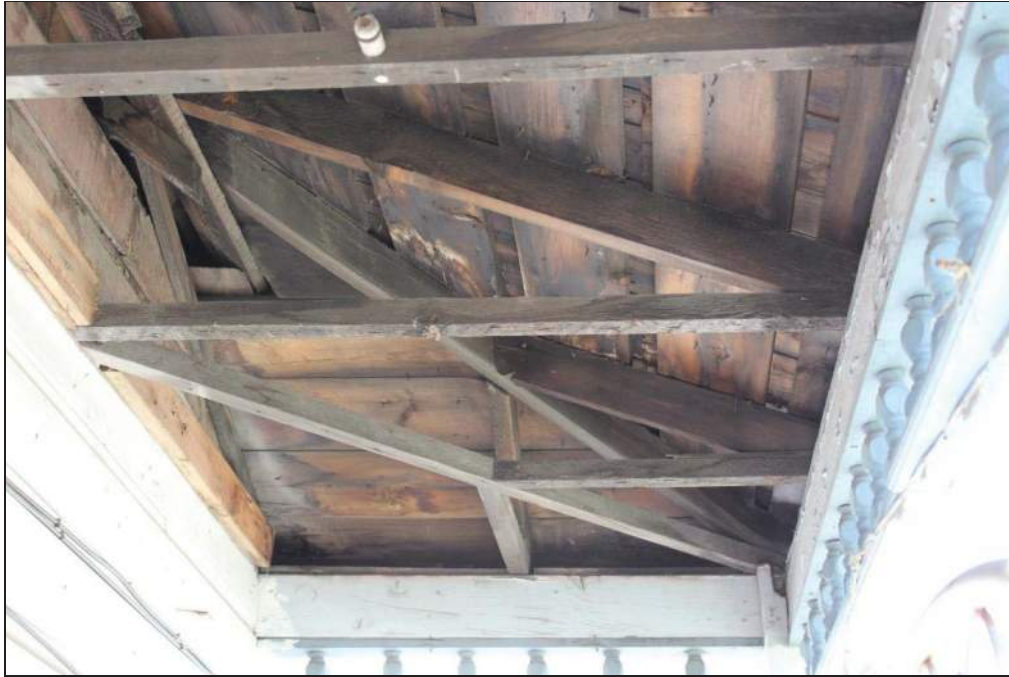
**B.7. PORCH:** Detail of older roof framing and sheathing. Also note porcelain knob for early electrical system at top of photo.

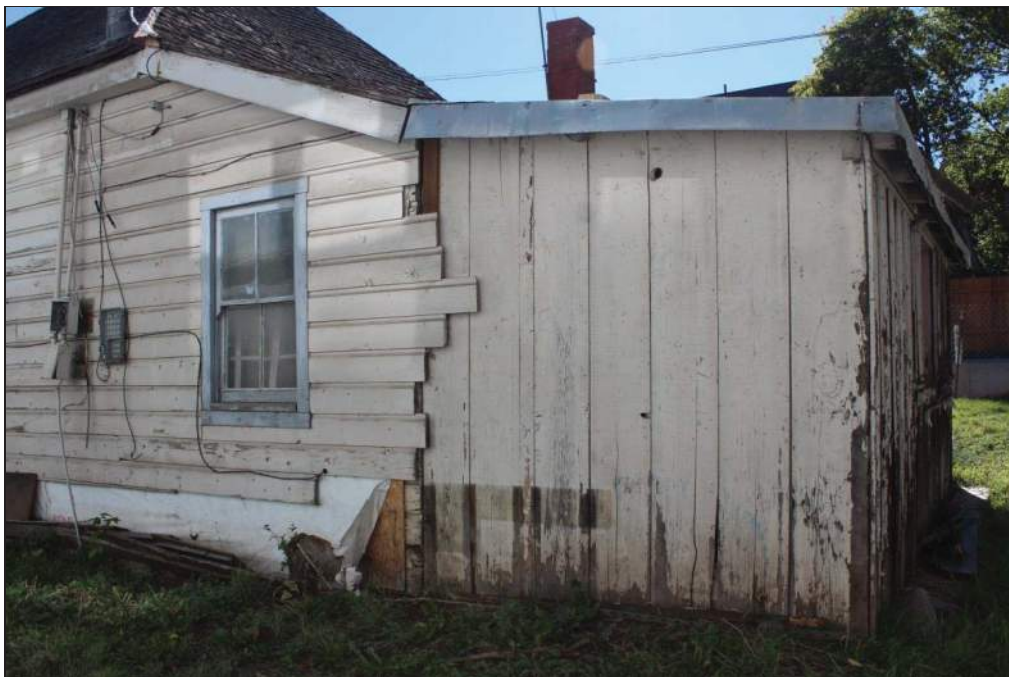
**B.9. ADDITIONS:** North wall of Addition 1 (with window) and Addition 2 (with vertical boards), facing south.

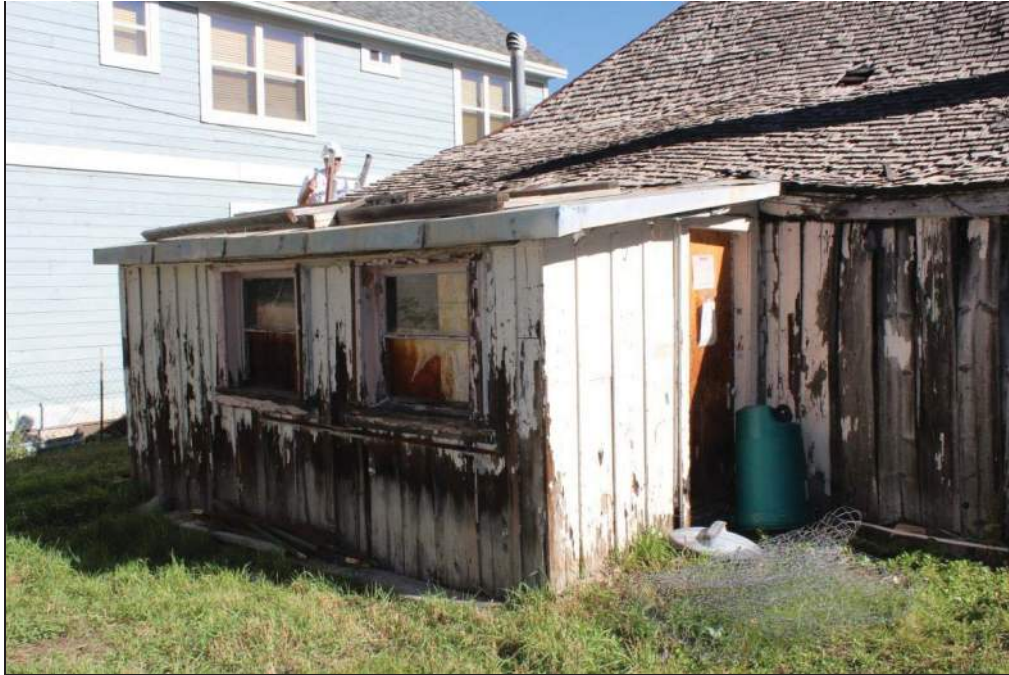
**B.9. ADDITIONS:** West and south walls of Addition 2, facing northeast.

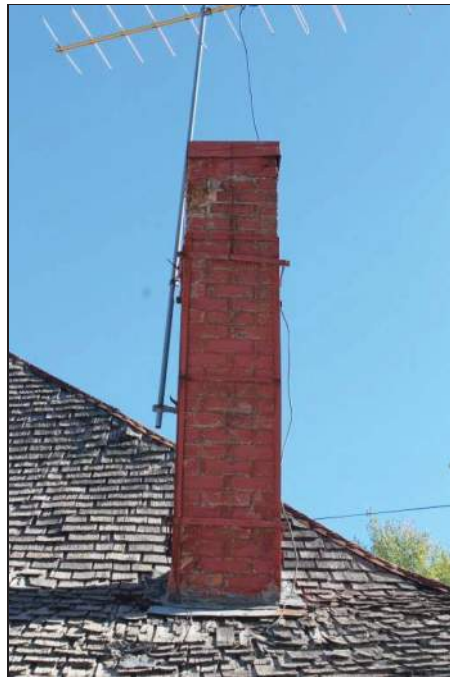
**B.10. MECHANICAL SYSTEM:** East side of brick chimney constructed around or in place of metal stovepipe, facing east.

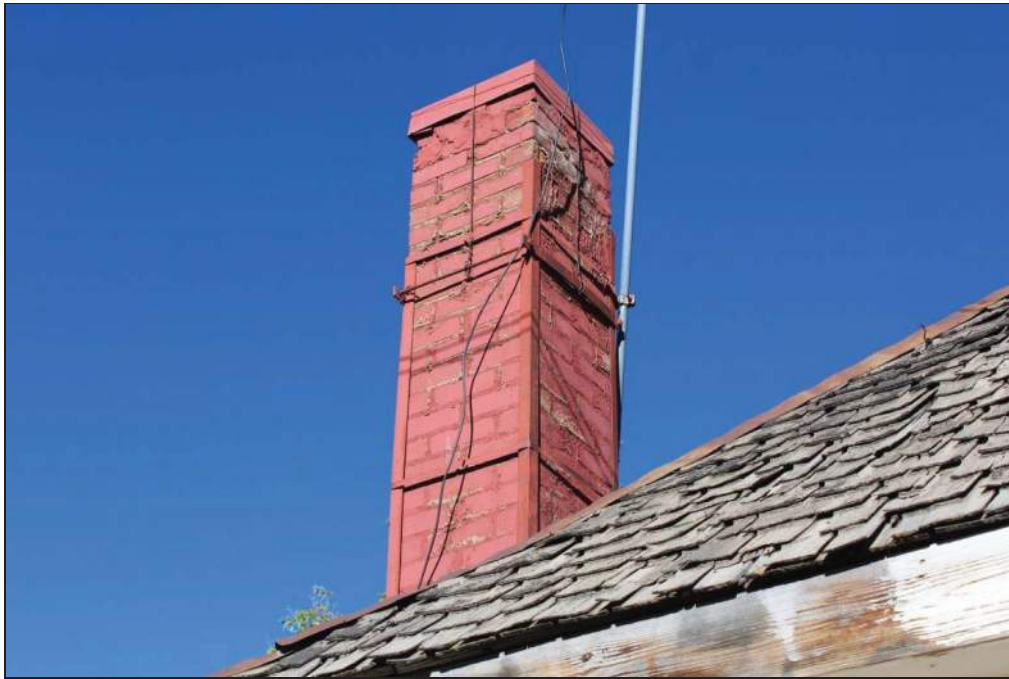
**B.10. MECHANICAL SYSTEM:** South and east sides of brick chimney constructed around or in place of metal stovepipe, facing northwest.

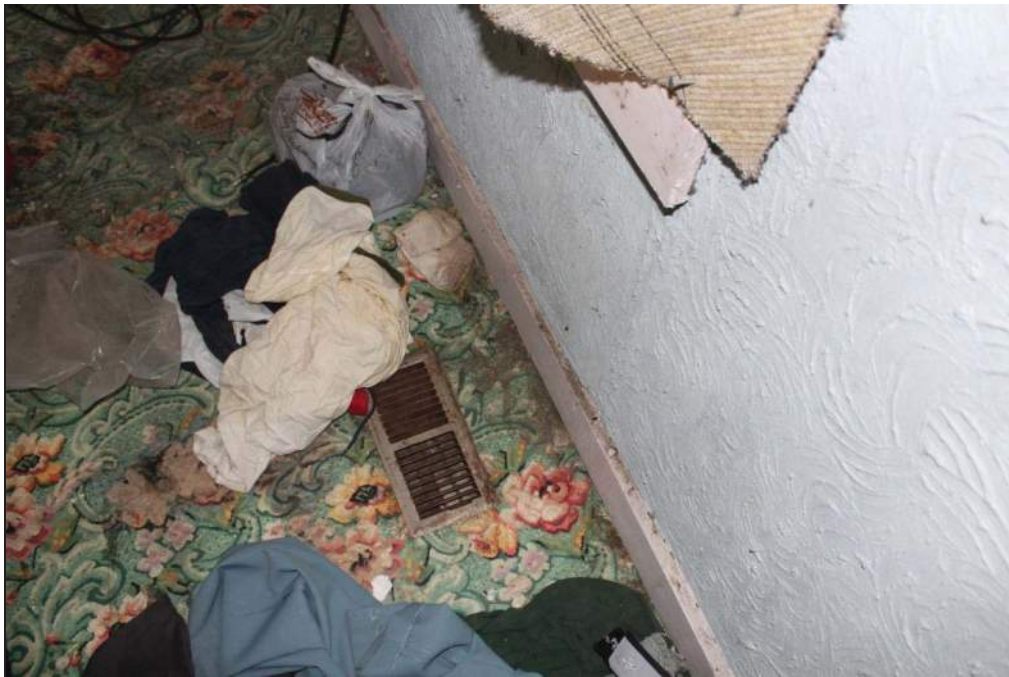
**B.10. MECHANICAL SYSTEM:** Newer forced-air duct cover in floor of house.

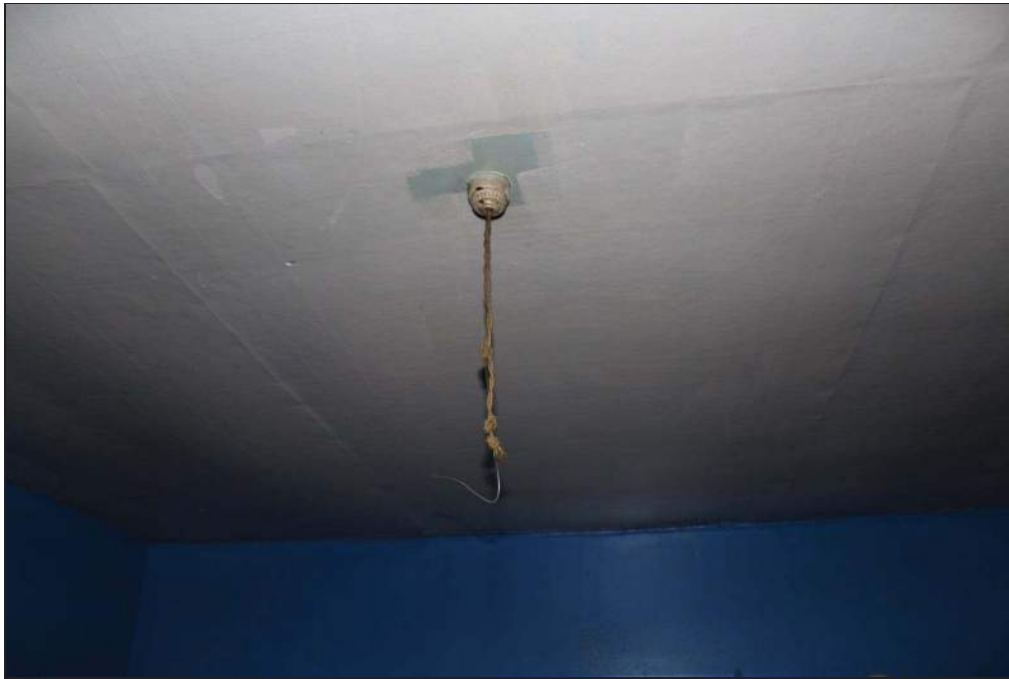
**B.11. ELECTRICAL SYSTEM:** Ceiling fixture connected to cloth-covered wiring on interior. See also B.7. showing porcelain knob for older knob-and-tube wiring system.

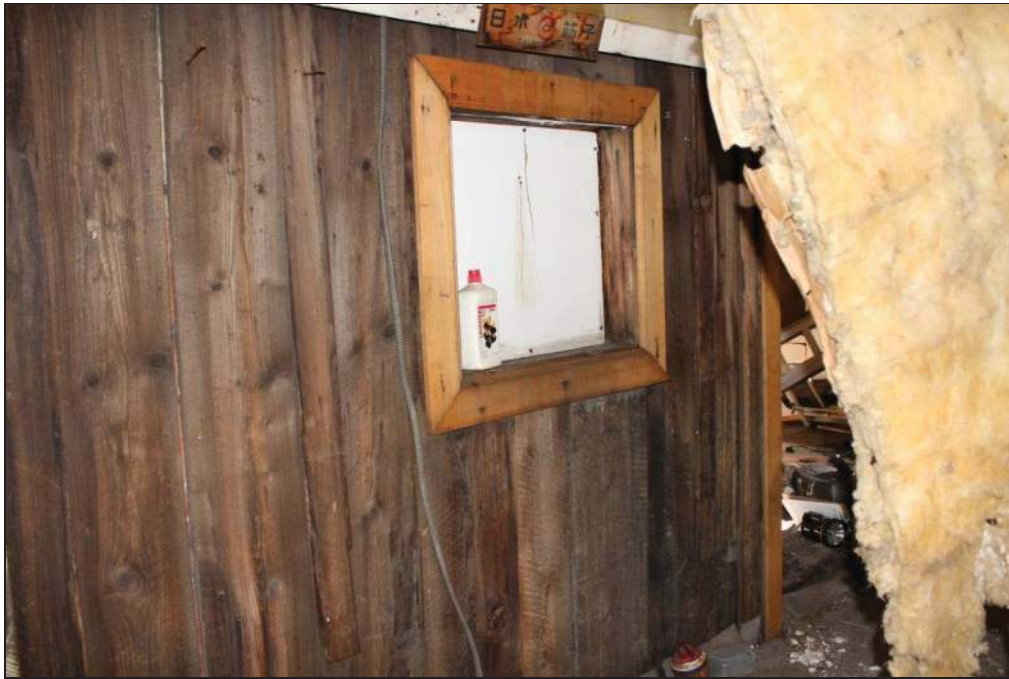
**B.12. STRUCTURAL SYSTEM:** Original vertical-board wall in good condition on west interior side of Addition 2, facing southeast.

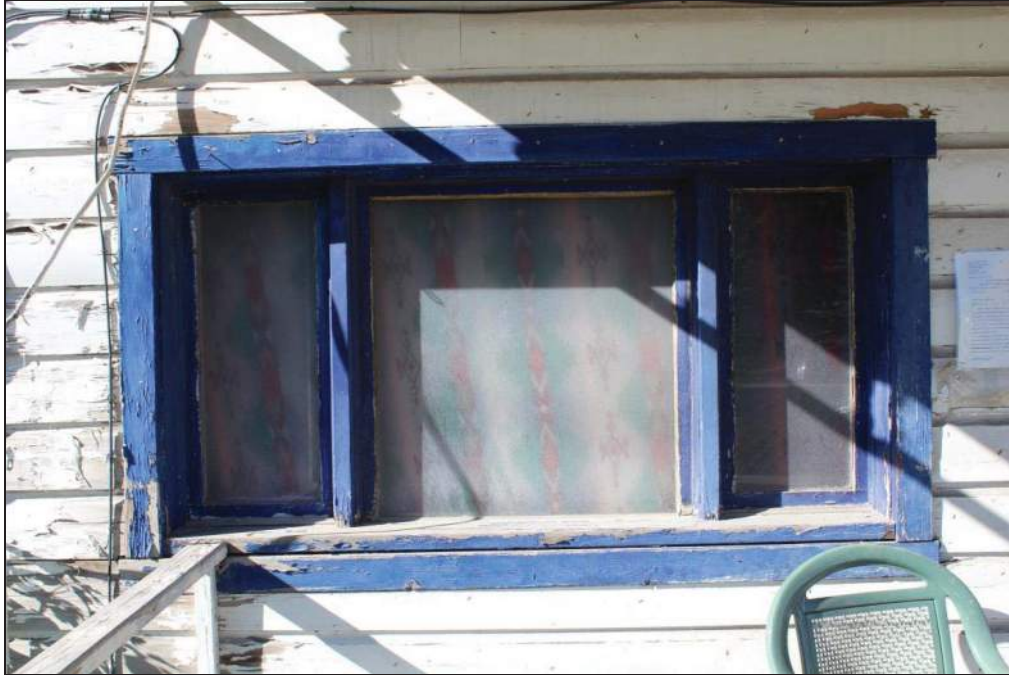
**C.1. WINDOWS:** Ca. 1920s wood replacement window on east façade.

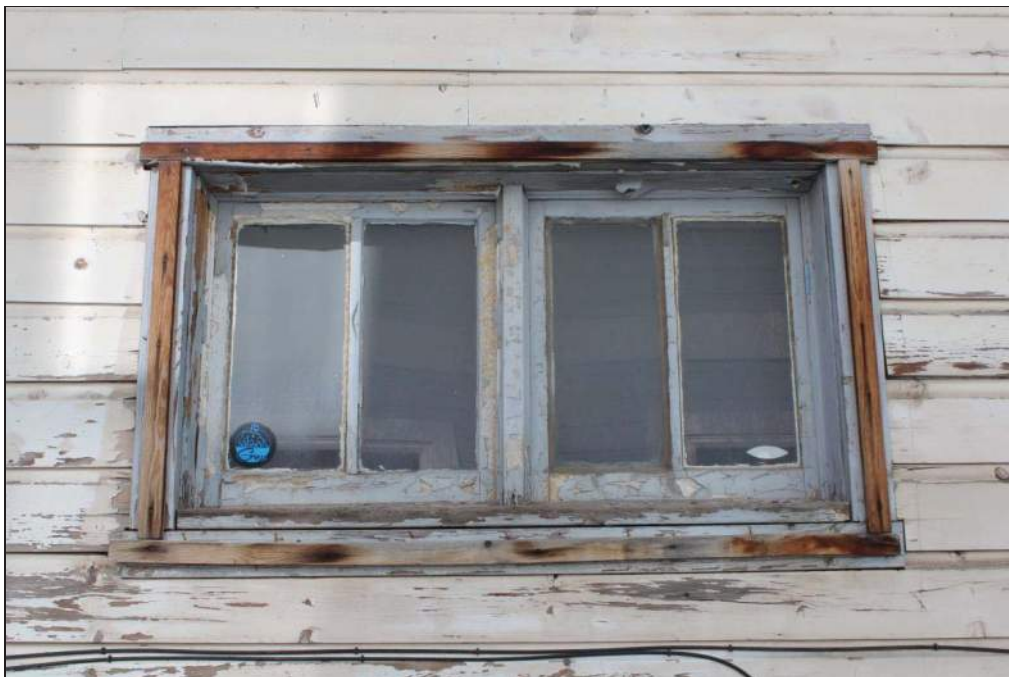
**C.1. WINDOWS:** Ca. 1920s pair of wood casement windows on north wall.

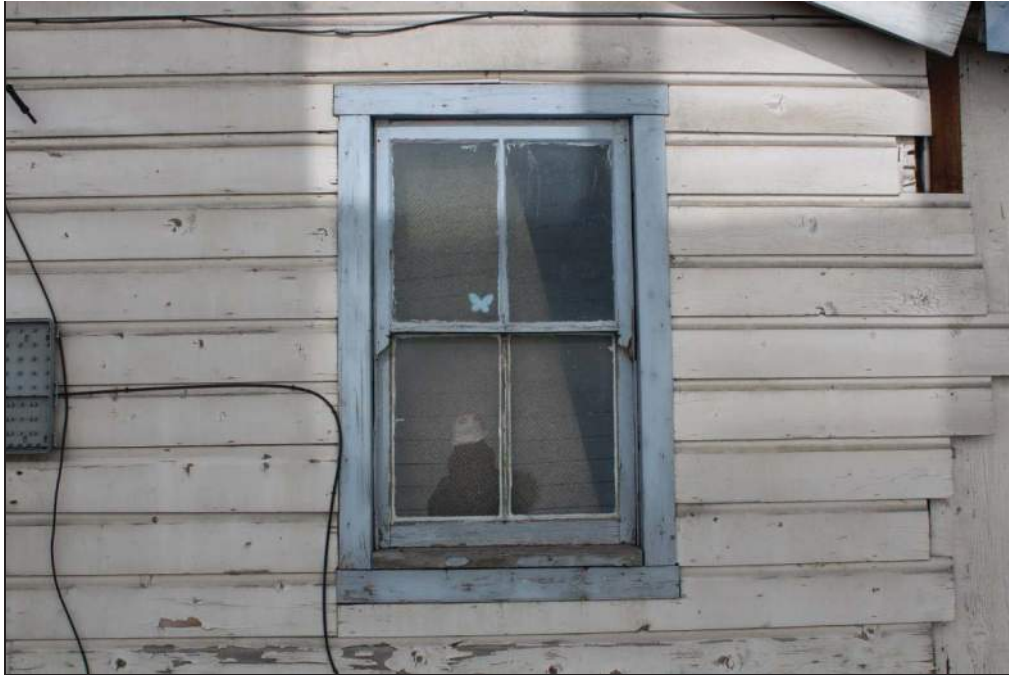
**C.1. WINDOWS:** Possible original, double-hung wood window on north wall of Addition 1.

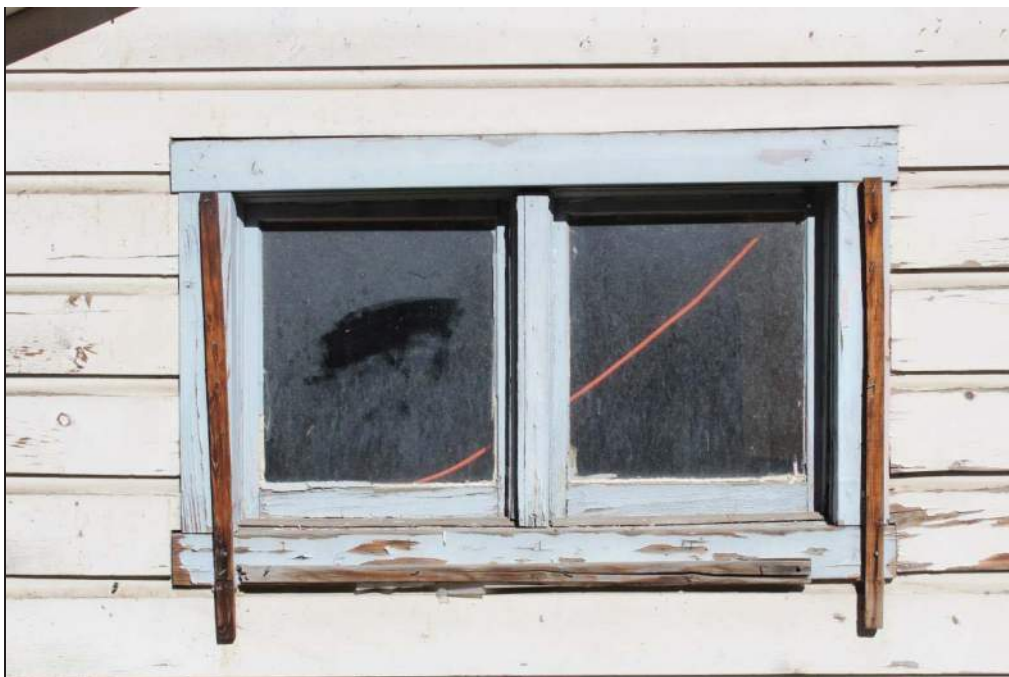
**C.1. WINDOWS:** Ca. 1920s pair of wood casement windows on south wall of Addition 1.

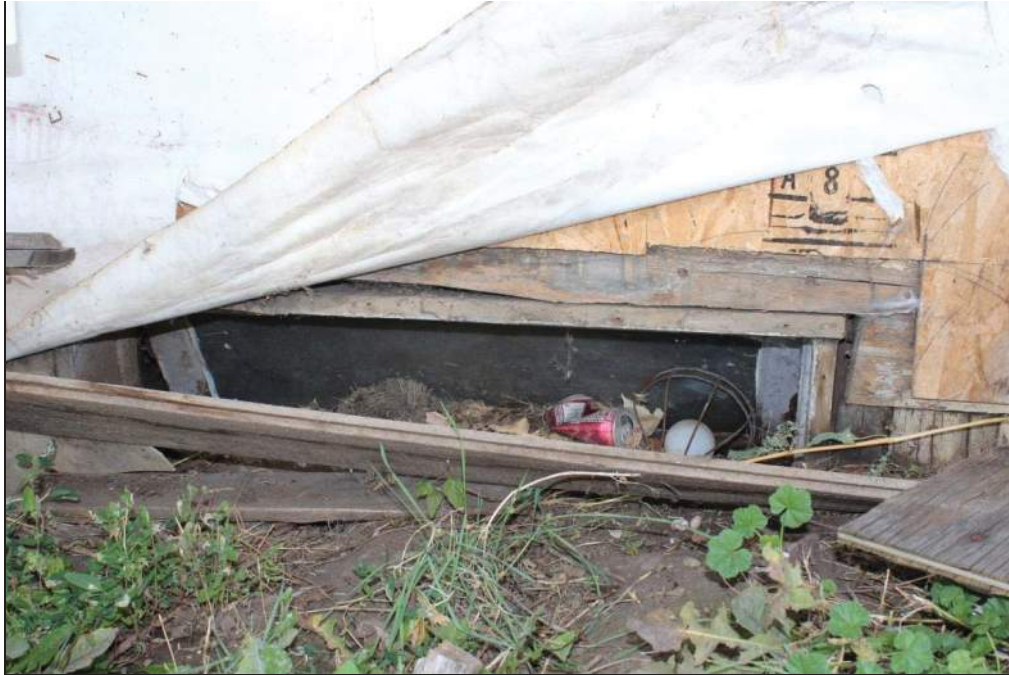
**C.1. WINDOWS:** Wood-framed window lighting crawl space on north side.

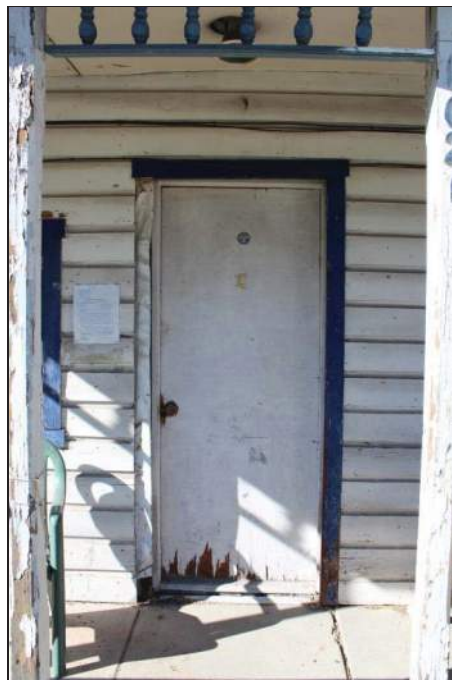
The doorway on the east facade appears to be an older or original opening for either a door or window based on paint shadows visible on the original siding south of the door; the door itself is a ca. 1990s unglazed plywood door in fair condition. A second exterior doorway dating to between 1907 and 1929, and possibly present originally, was located on the south side of the house and was protected by a small porch roof by 1929. This doorway was blocked in ca. 1995 when new siding was added but its location is visible on the interior. An original (ca. 1950s) doorway in the south wall of Addition 2 is fitted with an older five-panel wood door with a porcelain knob that is covered with plywood on the exterior side; on the interior side, the wood panels have been replaced. On the west wall of Addition 1 is a former exterior doorway (soon made an interior doorway by the two successive additions built on the west end of the house) fitted with an early or original four-panel wood door with a metal knob, which is in good to fair condition; this and another interior door like it may be original to the house.

**C.2. DOORS:** Ca. 1990s replacement door on east façade, facing west.

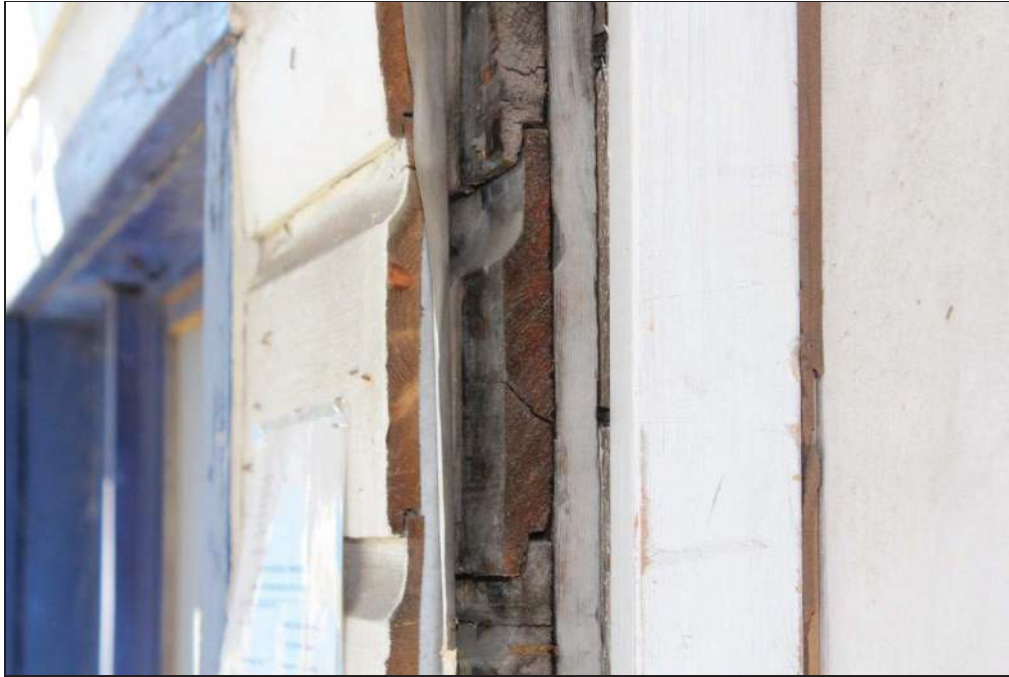
**C.2. DOORS:** South side of door jamb on east façade showing paint shadow on original siding, indicating early or original presence of door or window opening in this location, facing south.

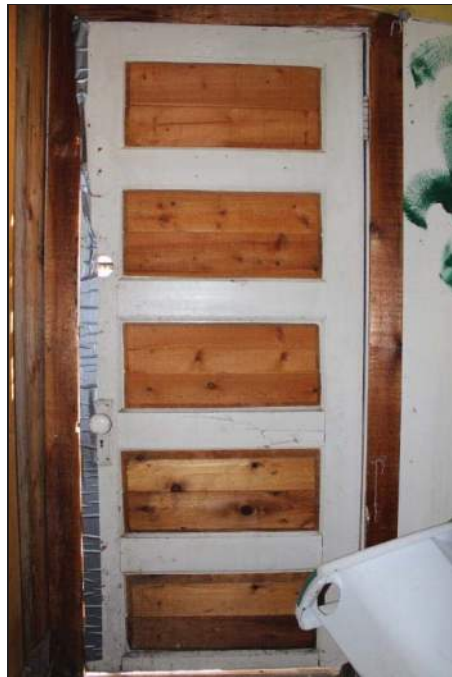
**C.2. DOORS:** Interior side of five-panel wood door in south wall of Addition 2, facing south. See B.4. for exterior view.

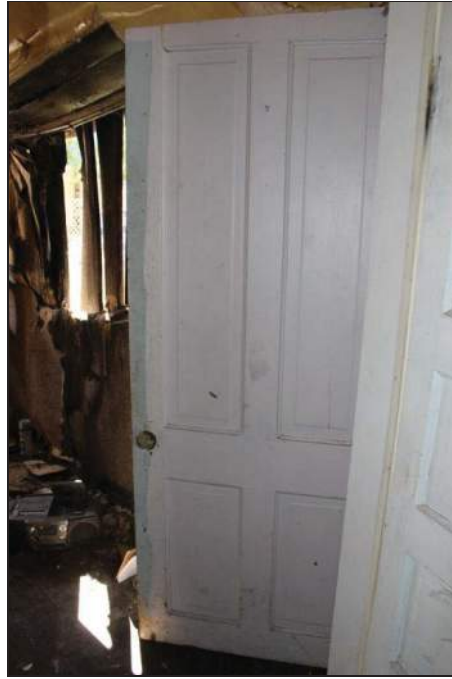
**C.2. DOORS:** Older or original four-panel wood door between Addition 1 and Addition 2, facing southwest.

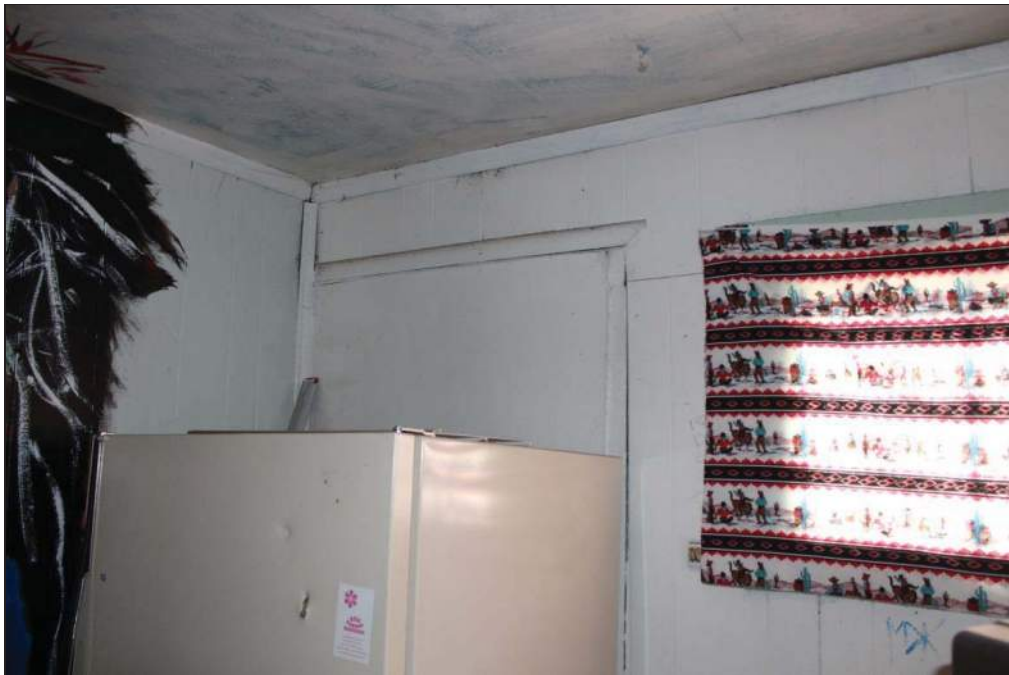
**C.2. DOORS:** Location of blocked south door visible behind refrigerator in southwest room of original building, facing southeast.
