**PARK CITY MUNICIPAL CORPORATION  
HISTORIC PRESERVATION BOARD  
CITY COUNCIL CHAMBERS  
May 16, 2018**

115 Sampson Avenue – HDDR Material Deconstruction and Reconstruction – The applicant is proposing to reconstruct the historic house designated as “Significant” on the City’s Historic Sites Inventory. In addition the applicant will be removing existing non-historic parking pad along with its associated wood staircases and railroad tie retaining wall; non-historic stacked stone retaining walls and 1990s wood slat fences; post-1947 addition on the west elevation and an underground root cellar; rebuilding the historic pyramid roof and dormers; reconstructing the existing masonry chimney; raising the house 2 feet to pour a new foundation; reconstructing the historic ca.1900 wraparound porch on the east and south elevations; replacing two non-historic doors; and removing non-historic aluminum windows and restoring 11 window openings.

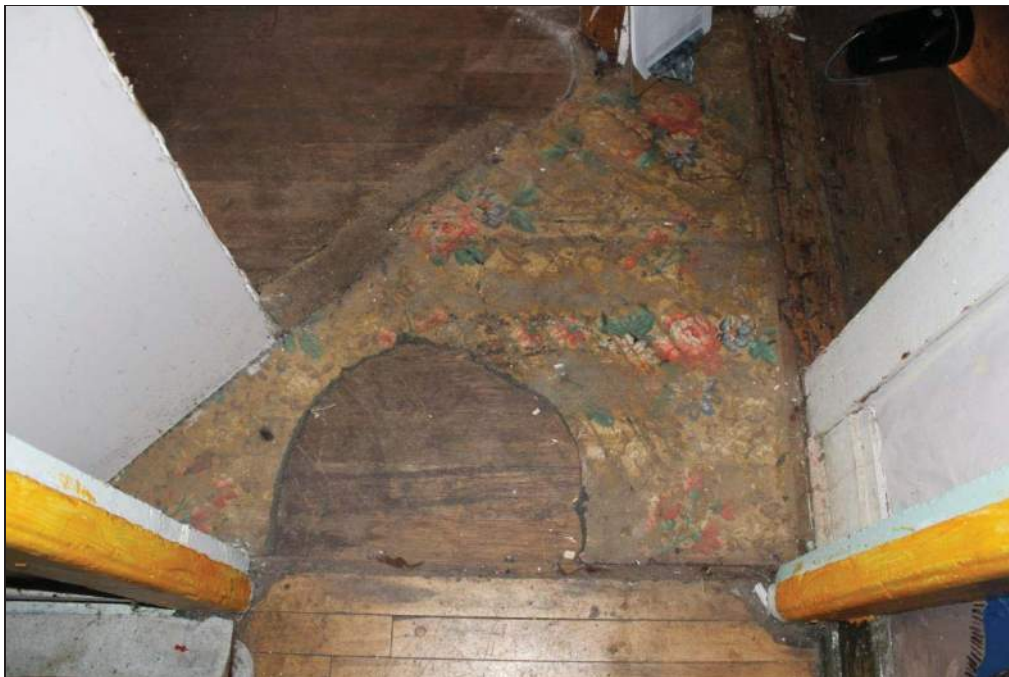
**C.5. OTHER (INTERIOR):** Interior flooring, including original wide fir boards, sometimes covered with older resilient flooring/linoleum, and newer, narrow oak boards.

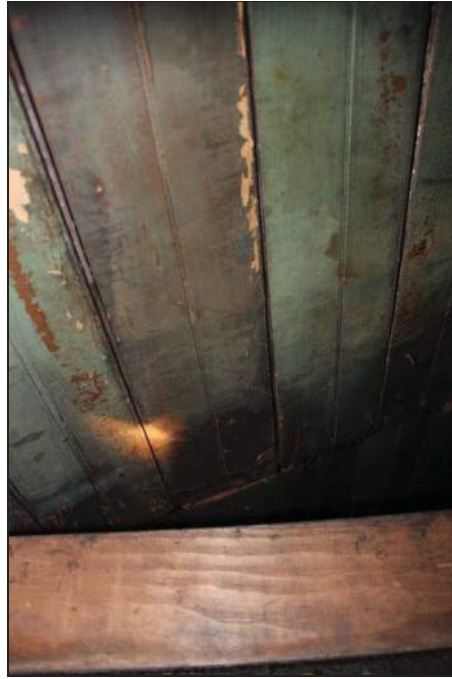
**C.5. OTHER (INTERIOR):** Original sloping, painted-board ceiling above flat, false ceiling in Addition 1.

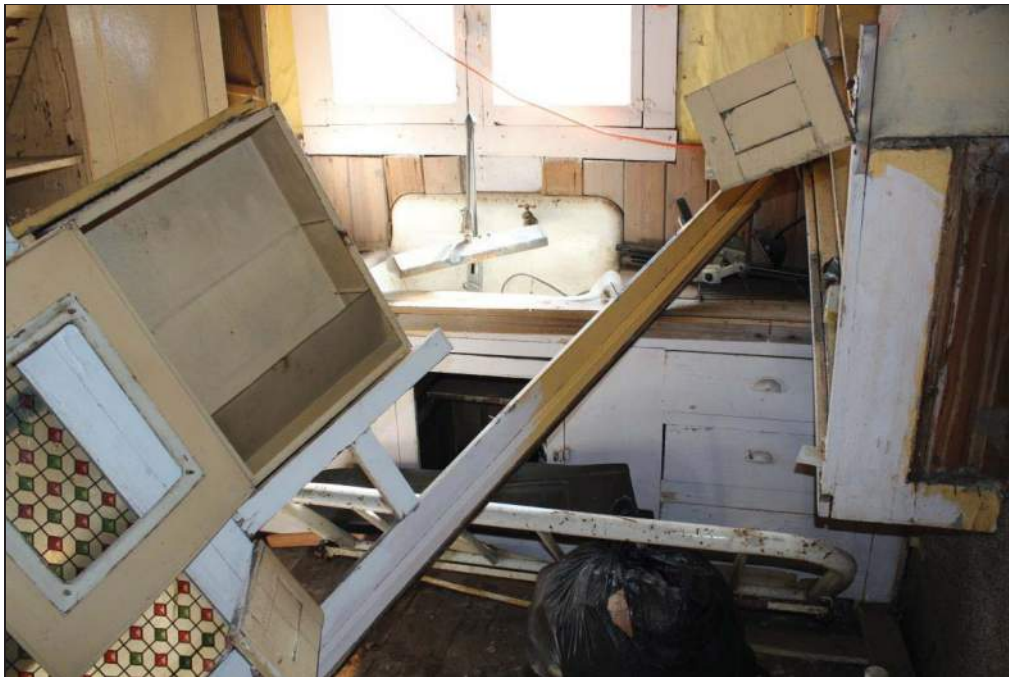
**C.5. OTHER (INTERIOR):** Ca. 1920s kitchen sink and cabinetry at south end of Addition 1, facing south.
